Appendix F: Facility Reports

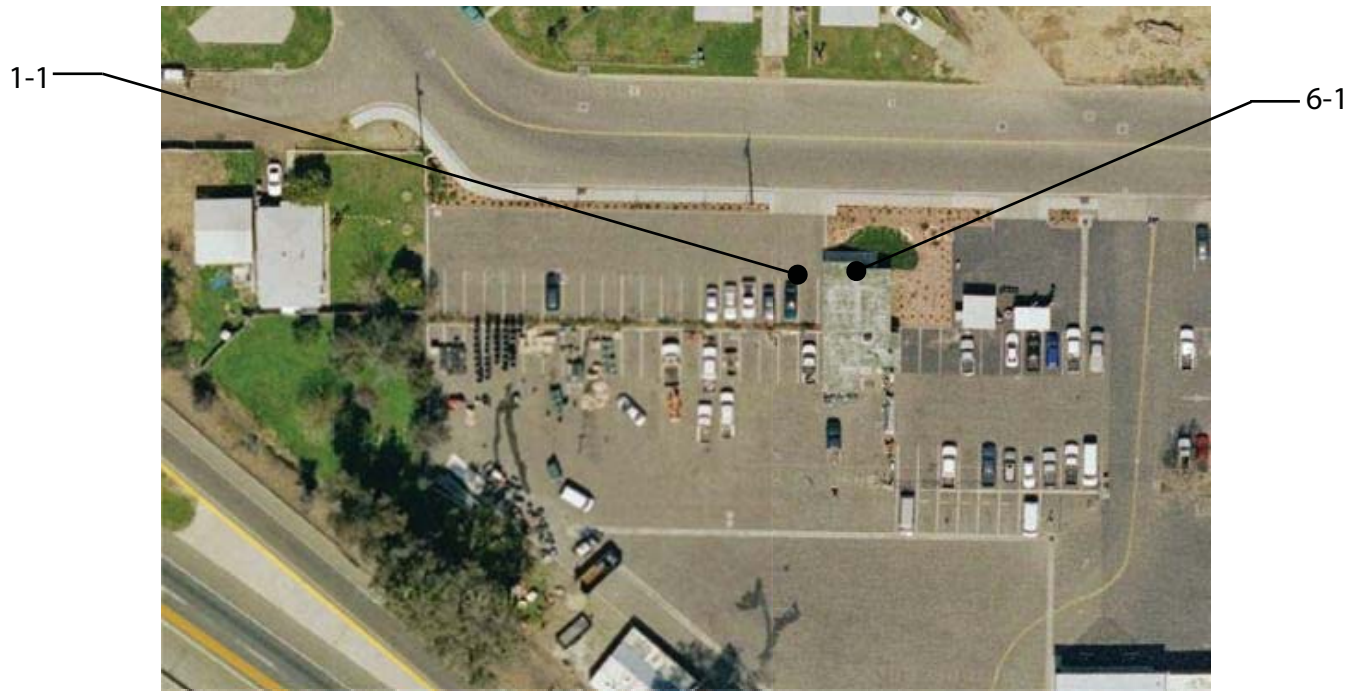
Casa House - Exterior
40 West Olive Street, Madera

Exterior		
1 - 1	Parking Area	Priority: 4
Provide or modify accessible spaces		\$2,950
Notes: There are a total of 17 parking spaces and 0 accessible parking space. Provide 1 accessible parking space closest to the building entrance.		
State: 1129B		
Federal: 4.1.2(5)(b)		
6 - 1	Stairway	Priority: 4
Install or modify handrails		\$2,000
Notes: Handrails are not provided. There are 2 risers.		
State: 1133B.4.1.1		
Federal: 4.9.4		
Install tread striping		\$30
Notes: Indicator stripes are not provided. There are 2 risers.		
State: 1127B.4, 1133B.4.4		
Federal: -		
Replace stairs		\$750
Notes: Treads are not uniform. There are 2 risers.		
State: 1007.3, 1009.1, 1133B.4.5.3		
Federal: 4.9.2

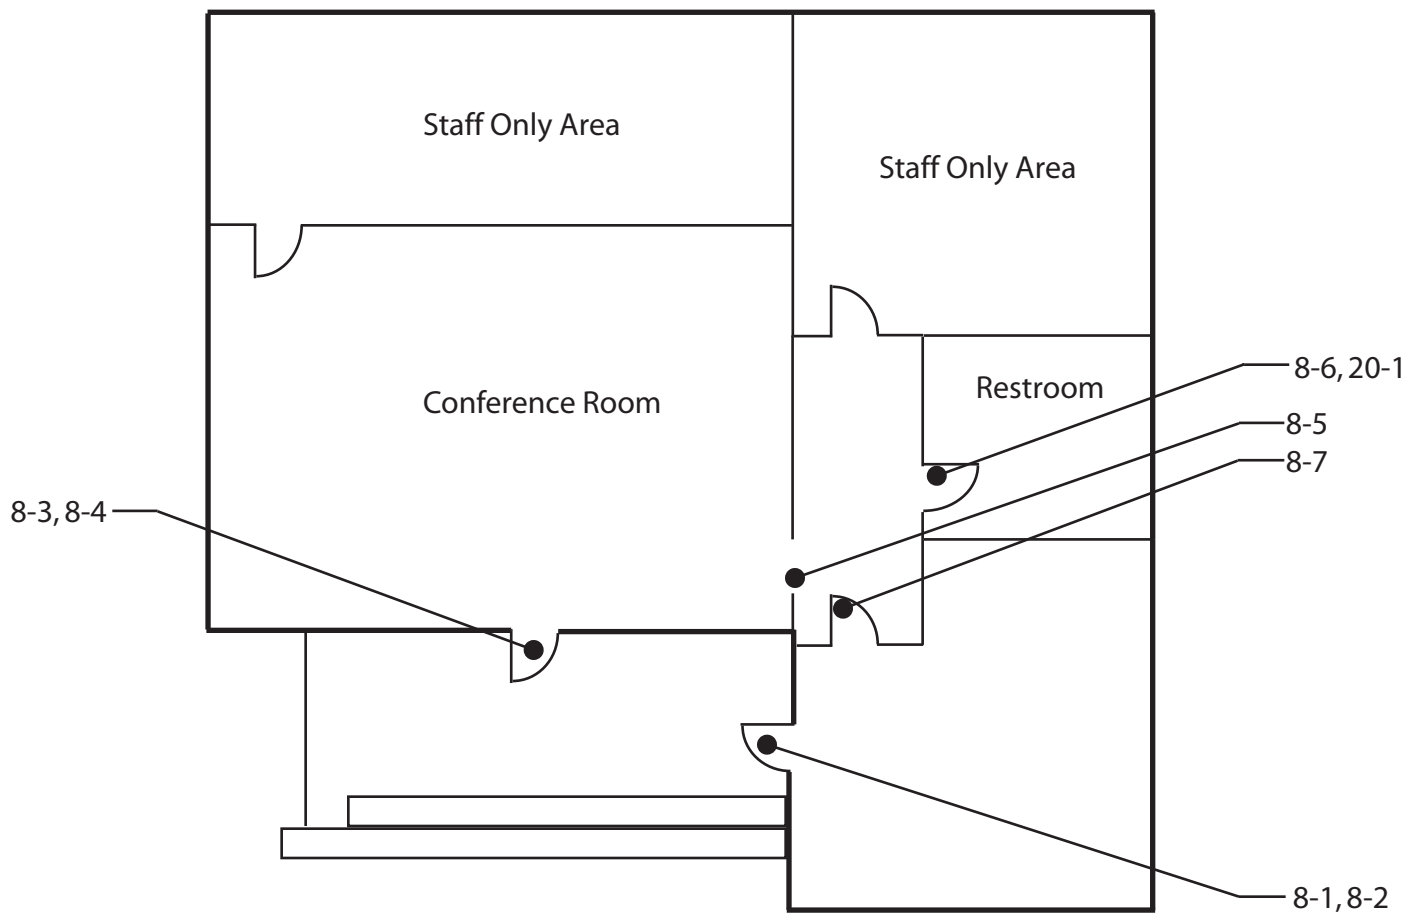
Casa House - First Floor
40 West Olive Street, Madera

Floor 1		
8 - 1	Door/Gate	Priority: 4
Provide an accessible path of travel		\$2,000
Notes: Accessible path of travel to the door is not provided due to stairs on the path of travel.		
State: 1133B.1.1.1.1		
Federal: 4.3.2		
Replace or adjust door hardware		\$300
Notes: Doorknob requires grasping and twisting.		
State: 1133B.2.5.2		
Federal: 4.13.9		
Replace or modify door threshold		\$300
Notes: Threshold is 2" (1/2" max) high.		
State: 1133B.2.4.1		
Federal: 4.13.8		
Provide additional strike edge clearance		\$3,000
Notes: Strike-edge clearance on the swing-side is 15" (24" min for exterior).		
State: 1133B.2.4.3		
Federal: 4.13.6		
8 - 2	Door/Gate	Priority: 4
Replace or adjust door hardware		\$300
Notes: Screen door - Doorknob requires grasping and twisting.		
State: 1133B.2.5.2		
Federal: 4.13.9		
8 - 3	Door/Gate	Priority: 4
Replace or adjust door hardware		\$300
Notes: Doorknob requires grasping and twisting.

State: 1133B.2.5.2		
Federal: 4.13.9		
Replace or modify door threshold		\$300
Notes: Threshold is 2.5" (1/2" max) high.		
State: 1133B.2.4.1		
Federal: 4.13.8		
8 - 4	Door/Gate	Priority: 4
Replace or adjust door hardware		\$300
Notes: Screen door - Doorknob requires grasping and twisting.		
State: 1133B.2.5.2		
Federal: 4.13.9

Floor 1		
8 - 5	Door/Gate	Priority: 4
Enlarge door opening		\$3,500
Notes: Width of clear opening is 31" (32" min).		
State: 1133B.2.2, 1133B.2.3		
Federal: 4.13.5		
8 - 6	Door/Gate	Priority: 4
Enlarge door opening		\$3,500
Notes: Width of clear opening is 27.5" (32" min).		
State: 1133B.2.2, 1133B.2.3		
Federal: 4.13.5		
8 - 7	Door/Gate	Priority: 4
Enlarge door opening		\$3,500
Notes: Width of clear opening is 29.5" (32" min).		
State: 1133B.2.2, 1133B.2.3		
Federal: 4.13.5		
Replace or adjust door hardware		\$300
Notes: Doorknob requires grasping and twisting.		
State: 1133B.2.5.2		
Federal: 4.13.9		
Provide additional strike edge clearance		\$3,000
Notes: Strike-edge clearance on swing-side is 3.5" (18" min).		
State: 1133B.2.4.3		
Federal: 4.13.6

Floor 1		
20 - 1	Single User Restroom	Priority: 4
Install sign		\$250
Notes: California required signage not provided on the door.		
State: 1115B.6		
Federal: 4.30.4		
Install sign		\$250
Notes: Federal required signage not provided on the latch side of the door. ISA not provided.		
State: 1115B.6, 1117B.5.1 #1, 1117B.5.5 #3, 1117B.5.8.1.2		
Federal: 4.30.4		
Replace or reposition dispensers or mirrors		\$200
Notes: Mirror is mounted so bottom of reflecting surface is 48" (40" max) AFF.		
State: 1115B.8.1		
Federal: 4.19.6		
Modify lavatory/counter clearances		\$3,500
Notes: Lavatory centerline is 14" (18" min). The space under the bowl is 24" (27" min) when measured 8" in from the front edge.		
State: 1115B.4.3 #1, 1115B.4.3 #2		
Federal: 4.19.2		
Replace or adjust water controls		\$500
Notes: Control requires grasping and twisting.		
State: 1115B.8.3		
Federal: 4.19.5, 4.27.4		
Insulate water lines		\$100
Notes: Hot water pipe not insulated.

State: 1115B.4.3 #4		
Federal: 4.19.4		
Replace or reposition fixtures		\$1,000
Notes: Space from the edge of the toilet to the nearest fixture is 4" (28" min).		
State: 1115B.4.1 #1		
Federal: 4.17.3		
Replace or reposition fixtures		\$1,000
Notes: Space from the wall to the centerline of the water closet is 13" (18" absolute).		
State: 1115B.4.1 #1		
Federal: 4.17.3

Floor 1		
20 - 1	Single User Restroom	Priority: 4
Increase or provide maneuvering or clear floor area		\$2,500
Notes: Space in front of the water closet is 34" (48" min).		
State: 1115B.3.1 #4.1		
Federal: 4.17.3		
Replace toilet or adjust toilet seat height		\$200
Notes: Toilet seat height is 16" (17" to 19") AFF.		
State: 1115B.4.1 #4		
Federal: 4.16.3		
Replace or modify grab bars		\$700
Notes: Grab bars are not provided.		
State: 1115B.4.1 #3, 1115B.4.1 #3.1, 1115B.4.1 #3.2		
Federal: 4.17.6

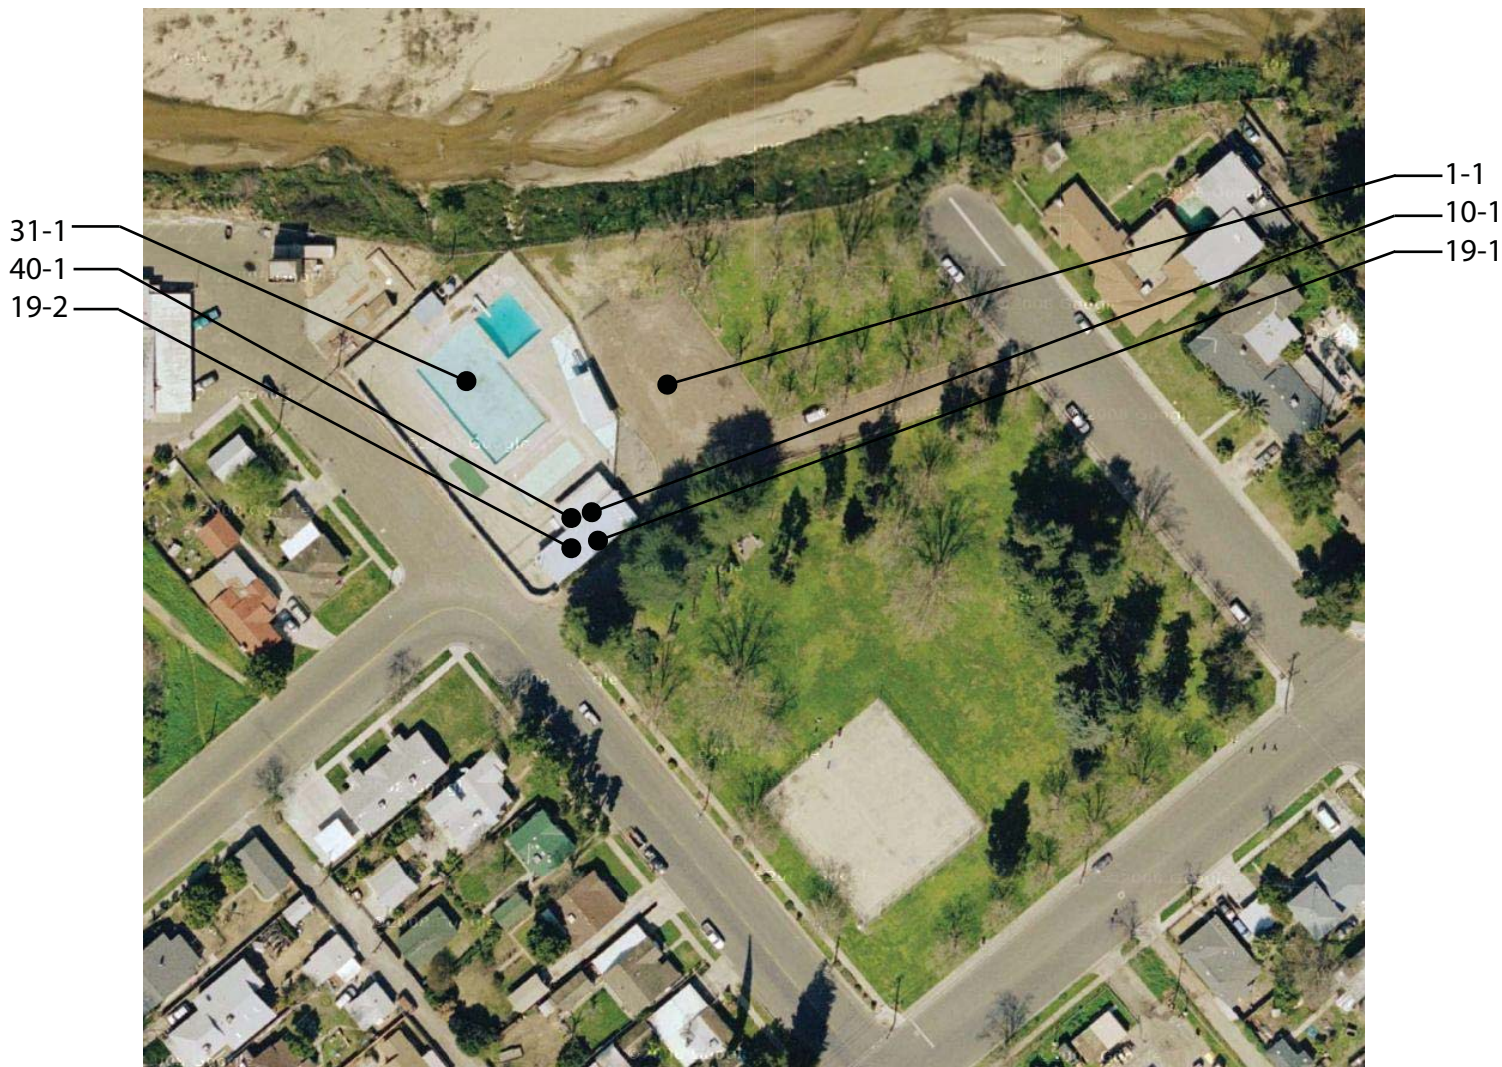
Centennial Park - Exterior
Flume Street & E 4th Street, Madera

Exterior		
1 - 1	Parking Area	Priority: 1
Install sign for unauthorized parking		\$400
Notes: Tow-away sign is not provided.		
State: 1129B.4, 1133B.8.6.3		
Federal: -		
10 - 1	Drinking Fountain	Priority: 3
Provide wing walls or textured floor surface		\$750
Notes: Drinking fountain is not located in an alcove. Provide wing walls.		
State: 1115B.4.6 #3		
Federal: 4.15.5		
19 - 1	Multiple User Restroom	Priority: 2
Insulate water lines		\$100
Notes: Women's Restroom (Under Construction) - Pipes are not insulated.		
State: 1115B.4.3 #4		
Federal: 4.19.4		
Provide or replace stall door hardware		\$200
Notes: Women's Restroom (Under Construction) - U-shaped handle have not been installed on the front and back of compartment door.		
State: 1115B.3.1 #4.5		
Federal: 4.13.9		
Replace or reposition fixtures		\$1,000
Notes: Women's Restroom (Under Construction) - Space from the wall to the centerline of the toilet is 18-1/4" (18" absolute).

State: 1115B.7.1.3		
Federal: 4.17.3		
Replace or reposition dispensers or mirrors		\$250
Notes: Women's Restroom (Under Construction) - Toilet paper dispenser have not yet been installed.		
State: 1115B.8.4		
Federal: 4.16.6		
Replace or reposition dispensers or mirrors		\$250
Notes: Women's Restroom (Under Construction) - Paper towel dispenser have not yet been installed.		
State: 1115B.8.3		
Federal: 4.23.7

Exterior		
19 - 2	Multiple User Restroom	Priority:2
Modify lavatory/counter clearances		\$3,500
Notes: Men's Restroom (Under Construction) - Height of lavatory counter is 34-3/4" (34" max). Dimensions: 8'8"L x 25.25" W.		
State: 1115B.4.3 #2		
Federal: 4.19.2		
Replace or reposition dispensers or mirrors		\$250
Notes: Men's Restroom (Under Construction) - Paper towel dispenser have not yet been installed.		
State: 1115B.8.3		
Federal: 4.23.7		
Modify stall partitions and doors		\$500
Notes: Men's Restroom (Under Construction) - Compartment stall partitions have not yet been installed.		
State: -		
Federal: 4.17.3		
Replace or reposition urinal		\$1,500
Notes: Men's Restroom (Under Construction) - Urinal is mounted 19-3/4" (17" max) AFF.		
State: 1115B.4.2 #1		
Federal: 4.18.2		
31 - 1	Swimming Pool / Wading Pools / Spas (int. or ext.)	Priority:2
Provide an accessible swimming pool lift		\$0
Notes: Swimming pool lift is not provided. However, pool life is on order.

State: 1104B.4.3		
Federal: 15.8.5.1		
40 - 1	Outdoor Rinsing Shower	Priority:2
Replace or modify grab bars		\$350
Notes: Grab bars are not provided.		
State: -		
Federal: 320.3, 320.5

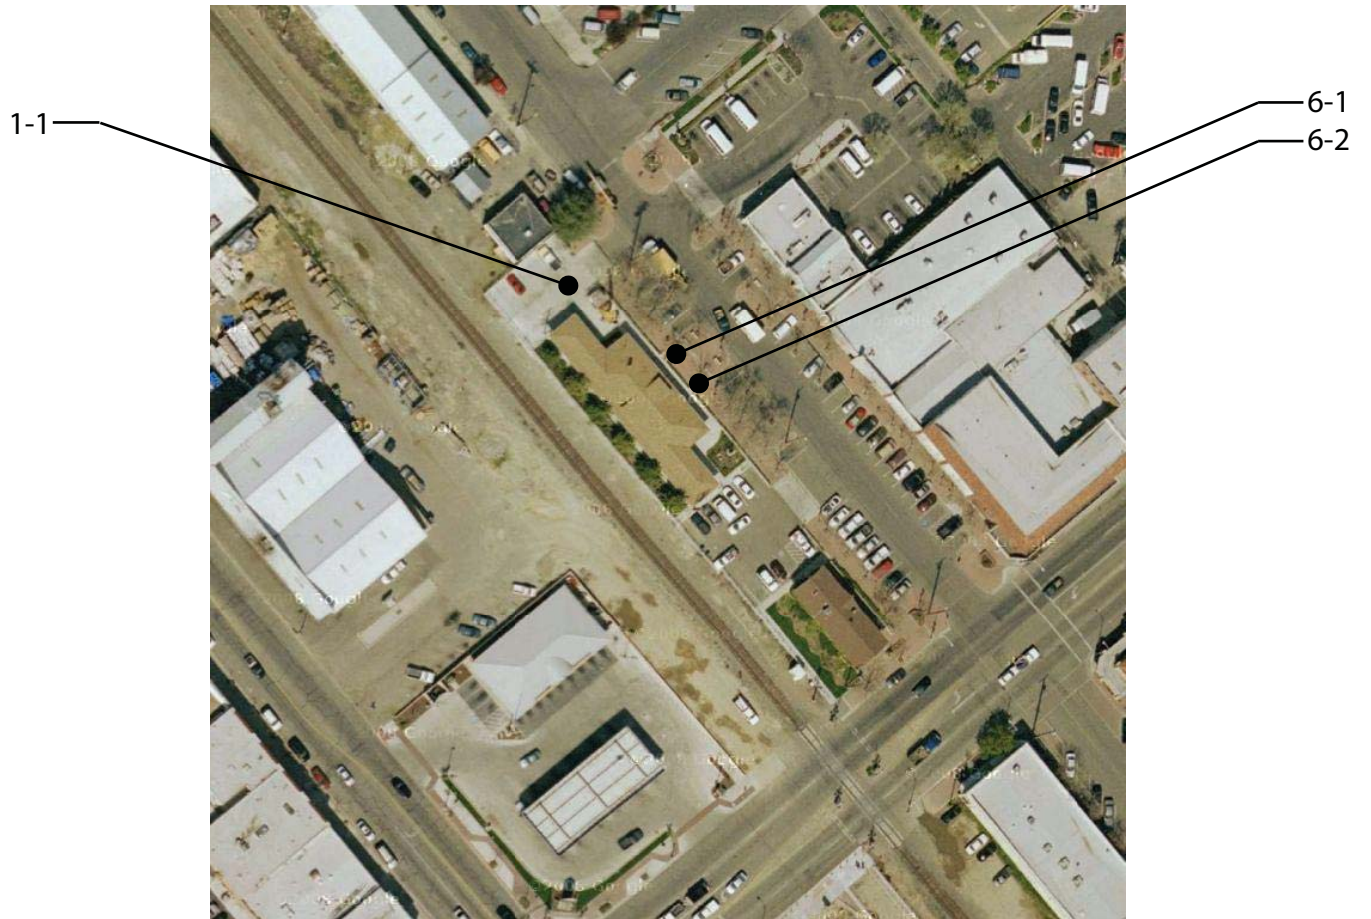
Chamber of Commerce - Exterior
120 North East Way, Madera

Exterior		
6 - 2	Stairway	Priority: 4
Install tread striping		\$45
Notes: Indicator stripes are not provided on exterior stairway. There are 3 risers.		
State: 1127B.4, 1133B.4.4		
Federal: -		
Install or modify handrails		\$2,400
Notes: Handrails are 32" (34" to 38") AFF. Bottom extensions do not extend 12" and one tread width. There are 3 risers.		
State: 1133B.4.2.1, 1133B.4.2.2		
Federal: 4.9.4 #2, 4.9.4 #5

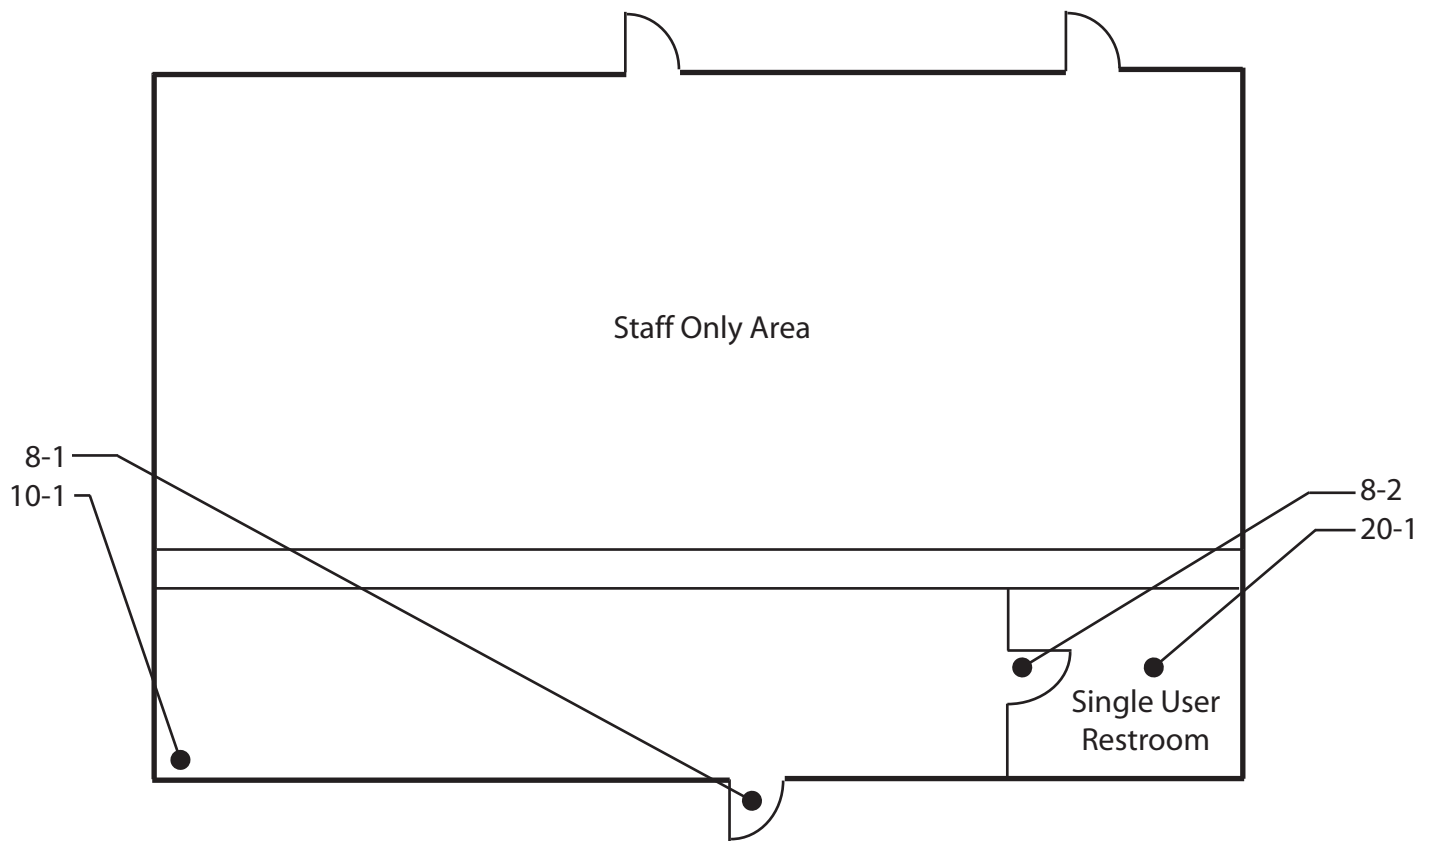
Chamber of Commerce - First Floor
120 E Street, Madera

Floor 1		
8 - 1	Door/Gate	Priority: 1
Provide sign(s) indicating accessible entries and facilities		\$100
Notes: International Symbol of Accessibility is not provided at the accessible entrance.		
State: 1117B.5.8.1.2, 1127B.3		
Federal: 4.13.6		
Install or modify permanent room signs		\$250
Notes: There is an exit sign but Braille is not provided.		
State: 1011.3 #3		
Federal: -		
8 - 2	Door/Gate	Priority: 2
Adjust door closer		\$100
Notes: Operating effort is 6 lbs (5 lbs max).		
State: 1133B.2.5		
Federal: 4.13.11		
10 - 1	Drinking Fountain	Priority: 3
Replace or reposition drinking fountain		\$3,500
Notes: Hi-low drinking fountain is not provided.		
State: 1115B.4.6 #1		
Federal: 4.1.6

Floor 1		
20 - 1	Single User Restroom	Priority: 2
Install sign		\$250
Notes: California required signage is not provided.		
State: 1115B.6		
Federal: 4.30.4		
Install sign		\$250
Notes: Federal required signage is not provided on the latch side of the door. ISA not provided.		
State: 1115B.6, 1117B.5.1 #1, 1117B.5.5 #3, 1117B.5.8.1.2		
Federal: 4.30.4		
Replace or reposition dispensers or mirrors		\$200
Notes: Mirror is mounted so bottom of reflecting surface is 45" (40" max) AFF.		
State: 1115B.8.1		
Federal: 4.19.6		
Replace or reposition dispensers or mirrors		\$250
Notes: Towel dispenser is 56" (40" max) AFF. Lower towel dispenser.		
State: 1115B.8.3		
Federal: 4.23.7		
Replace or reposition dispensers or mirrors		\$100
Notes: Seat cover dispenser is 45" (40" max) AFF. Lower seat cover dispenser.		
State: 1115B.8.3		
Federal: 4.23.7		
Replace or modify grab bars		\$350
Notes: Side grab bar is centered 33-1/4" (33" absolute) AFF. Side grab bar is positioned so the front end is 50" (54" min) from the back wall. Side grab bar is 20" (24" min) in front of the toilet.

State: 1115B.4.1 #3, 1115B.4.1 #3.1, 1115B.4.1 #3.2		
Federal: 4.17.6

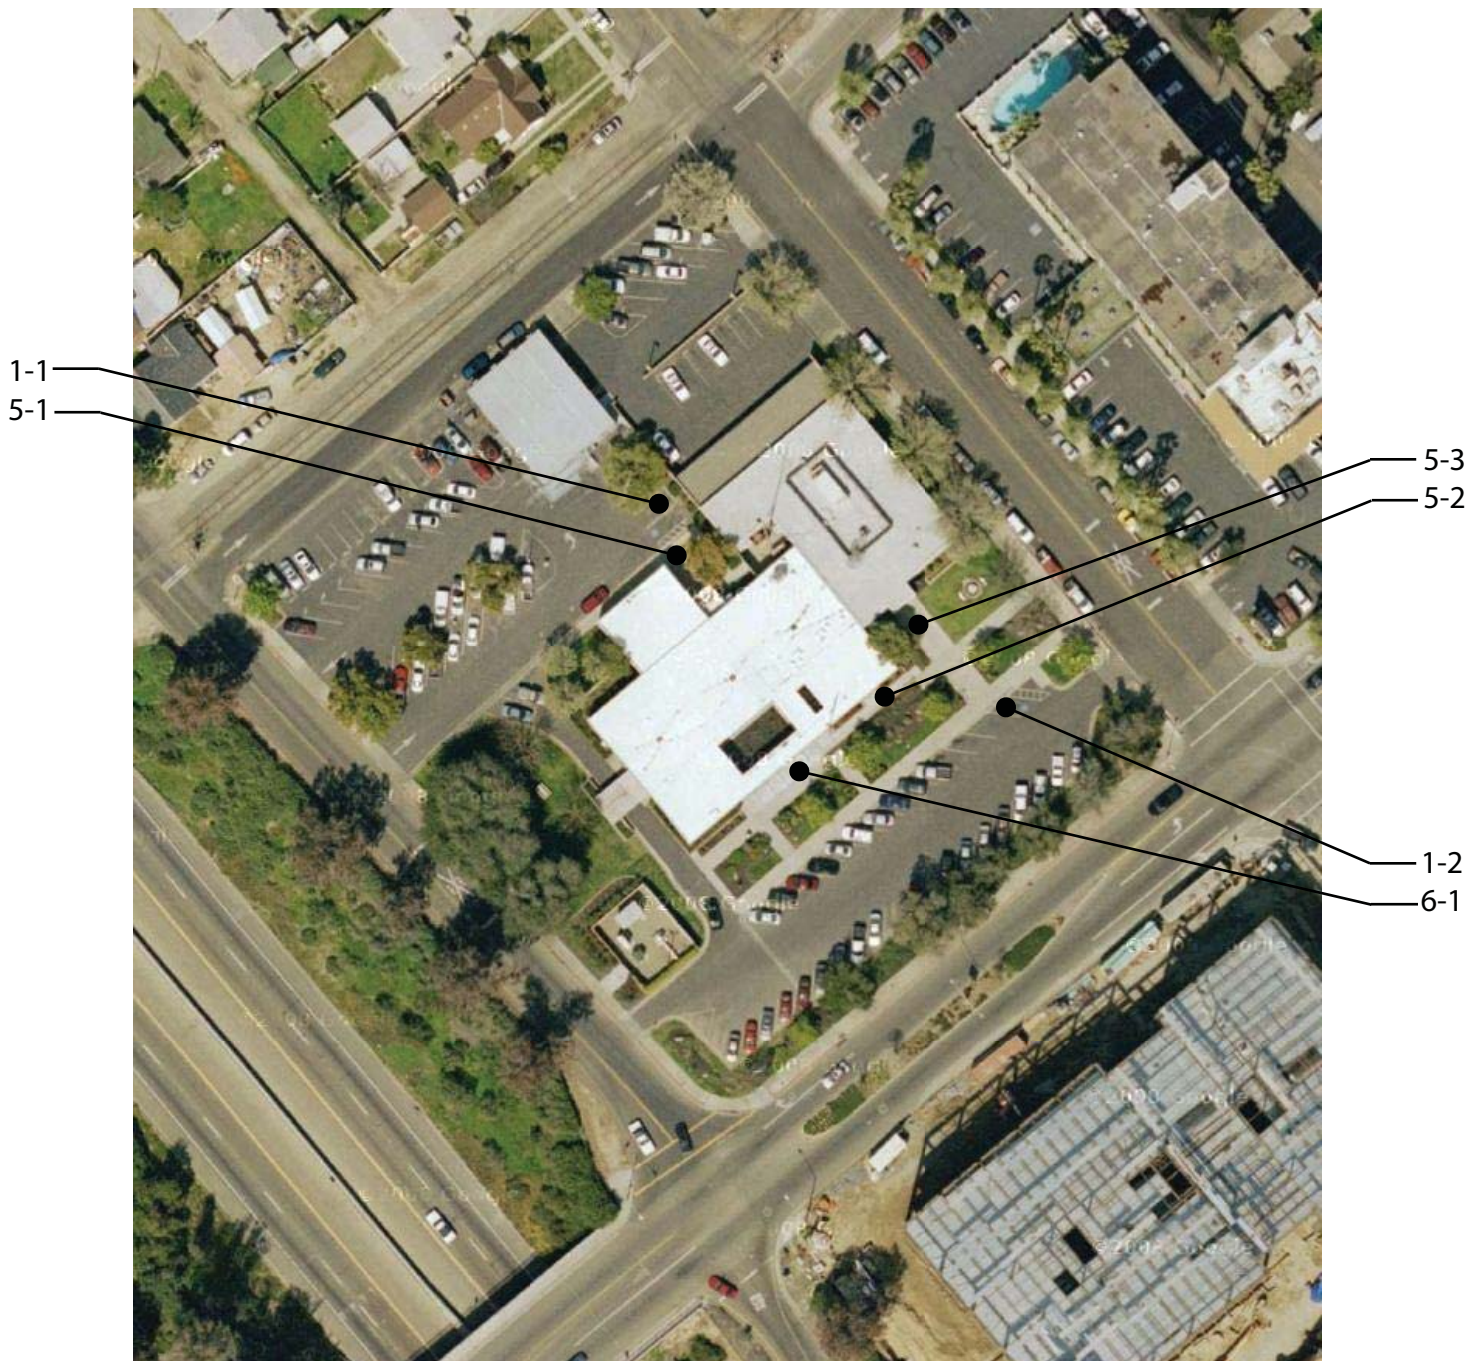
City Hall - Exterior
205 West 4th Street, Madera

Exterior		
1 - 1	Parking Area	Priority: 1
Provide an accessible path of travel		\$2,000
Notes: There is one accessible parking space that requires the wheelchair user to walk behind another parked vehicle, other than their own to access the primary entrance.		
State: 1129B.3 #3		
Federal: -		
Install sign		\$200
Notes: Reflectorized signs are mounted 67" (80" min) AFF. Raise 2 signs.		
State: 1129B.4		
Federal: -		
Install sign for unauthorized parking		\$400
Notes: Warning sign is not provided.		
State: 1129B.4, 1133B.8.6.3		
Federal: -		
Provide or modify accessible spaces		\$250
Notes: Stall width is 8'4" (9' min) for 1 of the accessible parking spaces.		
State: 1129B.4 #1		
Federal: 4.6.3		
Provide or modify accessible access aisles		\$150
Notes: Access aisle does not have blue borders.		
State: 1129B.3 #1, 1129B.4 #1		
Federal: 4.6.3		
Install sign		\$200
Notes: Additional sign stating "Minimum Fine \$250" not provided for the 2 accessible parking spaces.

Exterior		
5 - 3	Ramp	Priority: 1
Install or modify handrails		\$6,400
Notes: Handrail is only provided on one side. Provide handrails on both sides. Ramp is 31'7" long and 14'2" wide. Surface material is concrete.		
State: 1133B.5.5.1		
Federal: 4.8.5 #1		
6 - 1	Stairway	Priority: 1
Install tread striping		\$360
Notes: Indicator stripes are not provided. There are 6 sets of stairs, each with 4 risers.		
State: 1127B.4, 1133B.4.4		
Federal: -

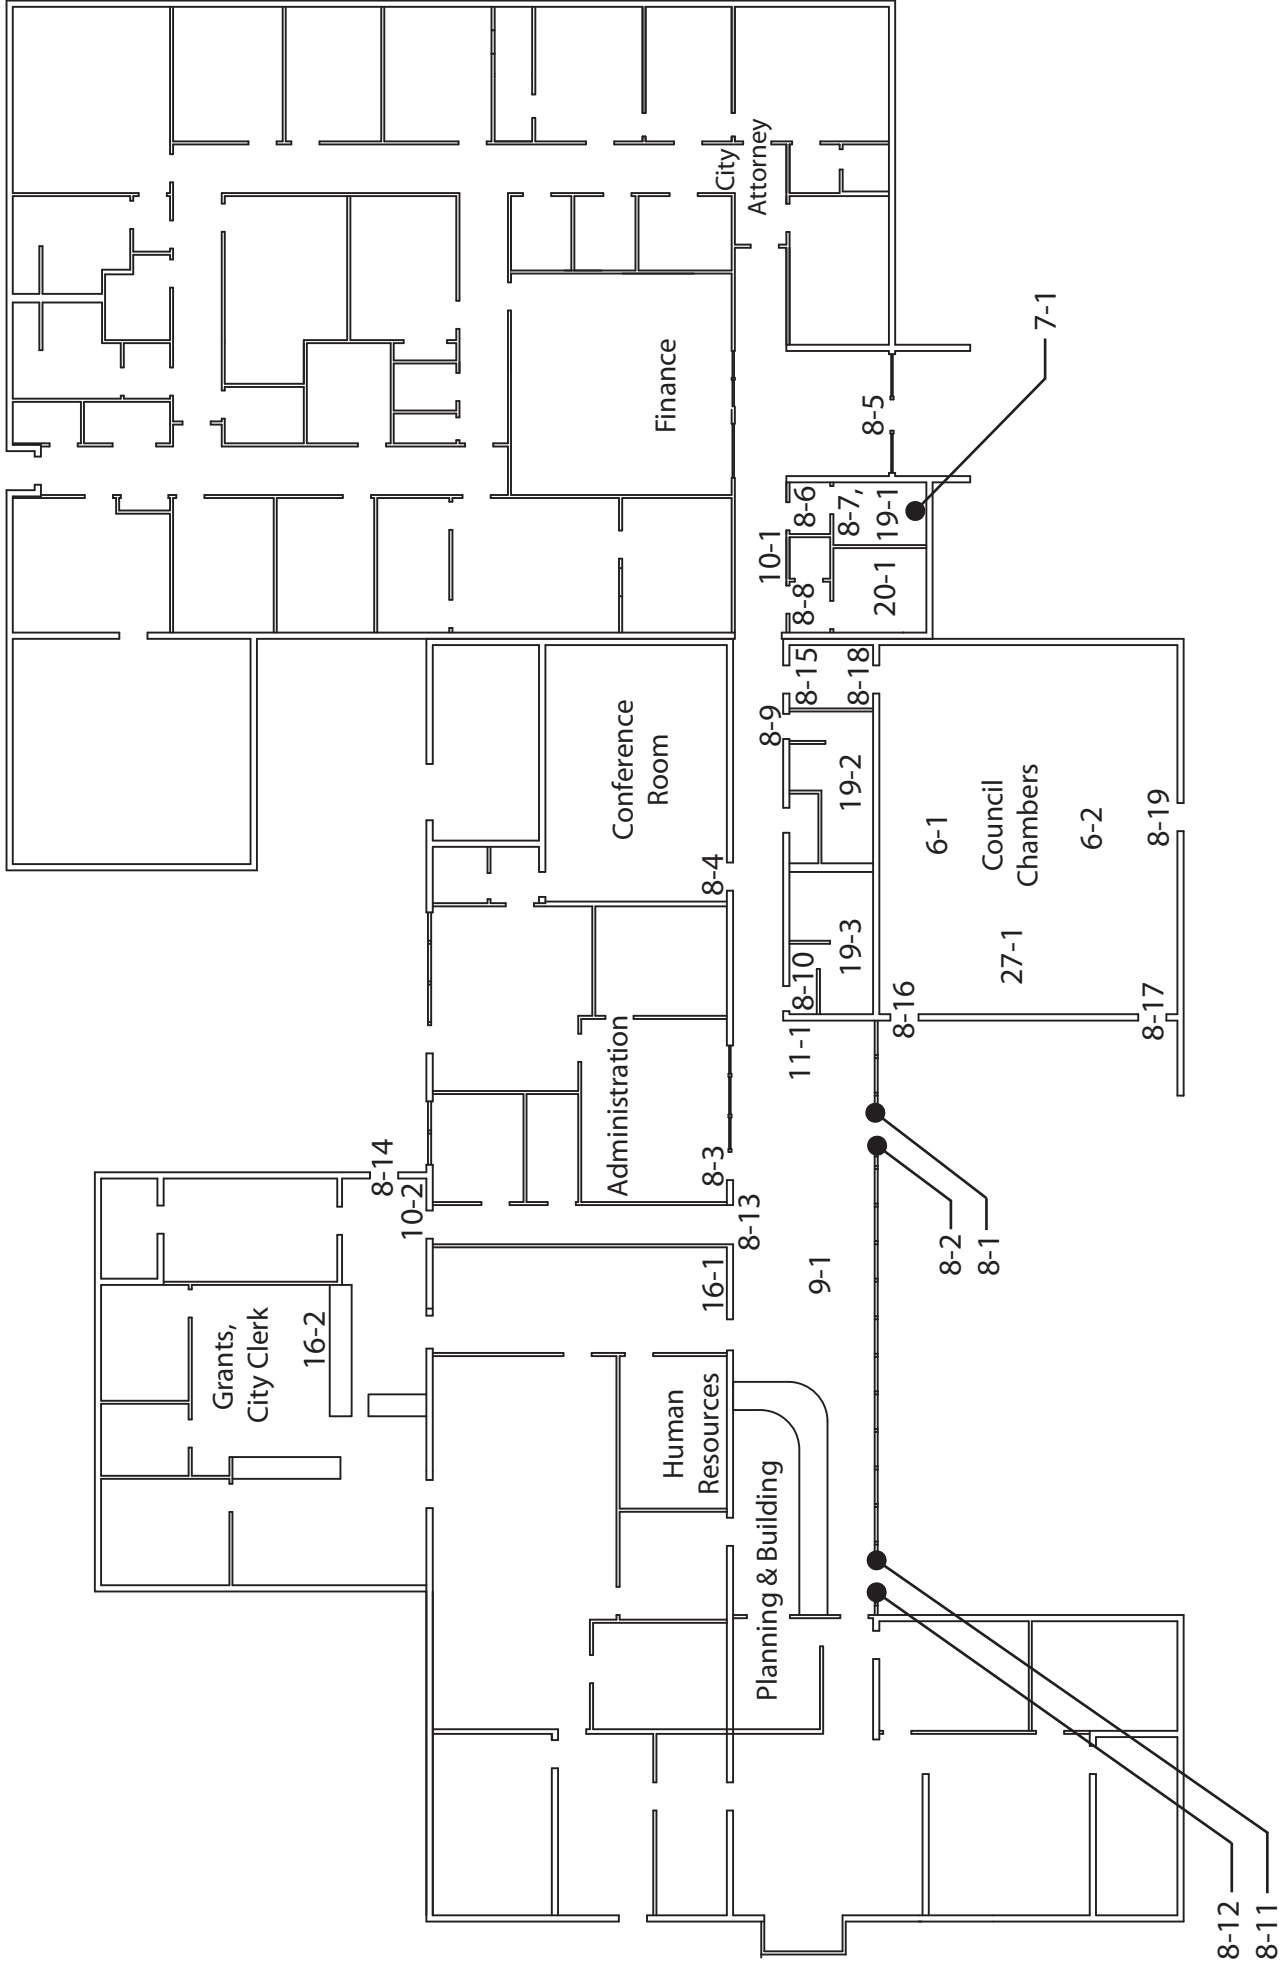
City Hall - First Floor
205 West 4th Street, Madera

Floor 1		
6 - 1	Stairway	Priority: 2
Install tread striping		\$30
Notes: Indicator stripes are not provided. There are 3 risers.		
State: 1133B.4.4		
Federal: -		
Install or modify handrails		\$1,500
Notes: Handrail is not provided on one side. Bottom extensions are not provided. There are 3 risers.		
State: 1133B.4.1.1, 1133B.4.2.2		
Federal: 4.9.4, 4.9.4 #2		
6 - 2	Stairway	Priority: 2
Install tread striping		\$30
Notes: Indicator stripes are not provided. There are 3 risers.		
State: 1133B.4.4		
Federal: -		
Install or modify handrails		\$1,500
Notes: Handrail is not provided on one side. Bottom extensions are not provided. There are 3 risers.		
State: 1133B.4.1.1, 1133B.4.2.2		
Federal: 4.9.4, 4.9.4 #2		
7 - 1	Hazard	Priority: 4
Remove overhanging or protruding objects		\$100
Notes: Ashtry dispenser protrudes 5" (4" max) and is 47" (not between 27" to 80") AFF. Relocate or remove ashtray dispenser.		
State: 1133B.8.6.1

8 - 13	Door/Gate	Priority: 4
Replace or adjust door hardware		\$300
Notes: Doorknob requires grasping and twisting.		
State: 1133B.2.5.2		
Federal: 4.13.9		
Provide or modify door kickplate		\$100
Notes: Doorstop mounted on kickplate.		
State: 1133B.2.6		
Federal: -

10 - 2	Drinking Fountain	Priority: 3
Provide wing walls or textured floor surface		\$750
Notes: Drinking fountain is not provided in an alcove. Provide wing walls.		
State: 1115B.4.6 #3		
Federal: 4.15.5		
Replace or reposition drinking fountain		\$3,500
Notes: Hi-low fountain not provided. Bubbler height is 38" (36" max).		
State: 1115B.4.6 #1, 1115B.4.6 #4		
Federal: 4.1.6, 4.15.2

Floor 1		
19 - 1	Multiple User Restroom	Priority: 4
Install sign		\$250
Notes: Federal required signage is not provided on the latch side of the door.		
State: 1115B.6, 1117B.5.1 #1		
Federal: 4.30.4		
Increase or provide maneuvering or clear floor area		\$2,500
Notes: There is 32.5" (44" min) clear space to access the lavatory.		
State: 1115B.3.1 #4.5		
Federal: 4.17.1		
Increase or provide maneuvering or clear floor area		\$2,500
Notes: Turning area is 50" (60" min) in diameter.		
State: 1115B.3.1 #1		
Federal: 4.23.3		
Replace or reposition dispensers or mirrors		\$500
Notes: Soap dispenser is 47" (40" max), sanitary napkin dispenser is 45" (40" max) and requires grasping and twisting.		
State: 1115B.8.3		
Federal: 4.23.7		
Modify lavatory/counter clearances		\$1,500
Notes: Height of lavatory counter is 36" (34" max) AFF. Lower lavatory.		
State: 1115B.4.3 #2		
Federal: 4.19.2		
Replace or reposition dispensers or mirrors		\$100

Notes: Coat hook is 67.5" (48" max) AFF.		
State: 1118B.5		
Federal: A4.27		
Provide or replace stall door hardware		\$100
Notes: U-shape handle is not provided on the back of compartment door.		
State: 1115B.3.1 #4.5		
Federal: 4.13.9		
Modify stall partitions and doors		\$500
Notes: Door width of end-entry stall is 30" (32" min).		
State: 1115B.3.1 #4.4		
Federal: -

Floor 1		
19 - 1	Multiple User Restroom	Priority: 4
Replace or reposition fixtures		\$1,000
Notes: Space from the wall to the centerline of the toilet is 18.5" (18" req).		
State: 1115B.7.1.3		
Federal: 4.17.3		
Modify stall partitions and doors		\$500
Notes: Space from the wall to the edge of the toilet is 11" (32" min).		
State: 1115B.4.1 #1		
Federal: 4.17.3		
Modify stall partitions and doors		\$500
Notes: Space in front of the water closet is 32" (48" min).		
State: 1115B.3.1 #4.1		
Federal: 4.17.3		
Modify stall partitions and doors		\$500
Notes: Compartment width is 38" (60" min).		
State: -		
Federal: 4.17.3		
Reposition toilet flush controls		\$750
Notes: Flush control is not located on the wide side.		
State: 1115B.4.1 #5		
Federal: 4.16.5		
Replace or modify grab bars		\$350
Notes: Rear grab bar is not provided.		
State: 1115B.4.1 #3.2		
Federal: 4.17.6

Floor 1		
19 - 2	Multiple User Restroom	Priority: 4
Install sign		\$250
Notes: Federal required signage is not provided on the latch side of the door.		
State: 1115B.6, 1117B.5.1 #1		
Federal: 4.30.4		
Replace or reposition dispensers or mirrors		\$250
Notes: Towel dispenser is 56" (40" max) and requires grasping and twisting.		
State: 1115B.8.3		
Federal: 4.23.7		
Provide or replace stall door hardware		\$100
Notes: U-shape handle is not provided on the back of compartment door.		
State: 1115B.3.1 #4.5		
Federal: 4.13.9		
Modify stall partitions and doors		\$500
Notes: Door width of end-entry stall is 22" (32" min).		
State: 1115B.3.1 #4.4		
Federal: -		
Replace or reposition fixtures		\$1,000
Notes: Space from the wall to the centerline of the toilet is 17" (18" req).		
State: 1115B.7.1.3		
Federal: 4.17.3		
Modify stall partitions and doors		\$500
Notes: Space from the wall to the edge of the toilet is 10" (32" min).

Floor 1	
19 - 2 Multiple User Restroom	Priority: 4
Replace or modify grab bars	\$700
Notes: Grab bars not provided.	
State: 1115B.4.1 #3, 1115B.4.1 #3.2	
Federal: 4.17.6	
Widen corridor	\$10,000
Notes: Entry corridor is 36" (44" min) wide for a total of 46".	
State: 1115B.3.1 #4.5	
Federal: 4.17.1	
Replace or adjust water controls	\$500
Notes: Control requires grasping and twisting.	
State: 1115B.8.3	
Federal: 4.19.5, 4.27.4	
Insulate water lines	\$100
Notes: Drain pipes not insulated.	
State: 1115B.4.3 #4	
Federal: 4.19.4	
Replace or reposition urinal	\$1,500
Notes: Urinal is 24" (17" max) from the floor to the lip. Flush control is mounted 51" (44" max) AFF.	
State: 1115B.4.2 #1, 1115B.4.2 #2	
Federal: 4.18.2	
Replace toilet or adjust toilet seat height	\$200
Notes: Toilet seat height is 16.5" (17" to 19") AFF.	
State: 1115B.4.1 #4	
Federal: 4.16.3	
Replace or reposition dispensers or mirrors	\$100
Notes: Seat cover dispenser is 48" (40" max) AFF.

Floor 1		
19 - 3	Multiple User Restroom	Priority: 4
Install sign		\$250
Notes: Federal required signage is not provided on the latch side of the door.		
State: 1115B.6, 1117B.5.1 #1		
Federal: 4.30.4		
Increase or provide maneuvering or clear floor area		\$2,500
Notes: Turning area is 30.5" (60" min) in diameter.		
State: 1115B.3.1 #1		
Federal: 4.23.3		
Replace or reposition dispensers or mirrors		\$250
Notes: Towel dispenser is 56" (40" max) and requires grasping and twisting.		
State: 1115B.8.3		
Federal: 4.23.7		
Replace or reposition dispensers or mirrors		\$100
Notes: Seat cover dispenser is 49" (40" max) AFF.		
State: 1115B.8.3		
Federal: 4.23.7		
Provide or replace stall door hardware		\$200
Notes: U-shape handle is not provided on the back or the front of compartment door.		
State: 1115B.3.1 #4.5		
Federal: 4.13.9		
Modify stall partitions and doors		\$500
Notes: Door width of end-entry stall is 25" (32" min).

State: 1115B.3.1 #4.4		
Federal: -		
Replace or reposition fixtures		\$1,000
Notes: Space from the wall to the centerline of the toilet is 18.5" (18" req).		
State: 1115B.7.1.3		
Federal: 4.17.3		
Modify stall partitions and doors		\$500
Notes: Space from the wall to the edge of the toilet is 12.5" (32" min).		
State: 1115B.4.1 #1		
Federal: 4.17.3		
Modify stall partitions and doors		\$500
Notes: Space in front of the water closet is 32" (48" min).		
State: 1115B.3.1 #4.1		
Federal: 4.17.3

Floor 1		
19 - 3	Multiple User Restroom	Priority: 4
Modify stall partitions and doors		\$500
Notes: Compartment width is 36.5" (60" min).		
State: -		
Federal: 4.17.3		
Reposition toilet flush controls		\$750
Notes: Flush control is not located on the wide side.		
State: 1115B.4.1 #5		
Federal: 4.16.5		
Replace or modify grab bars		\$700
Notes: Grab bars not provided.		
State: 1115B.4.1 #3, 1115B.4.1 #3.2		
Federal: 4.17.6		
Replace or adjust water controls		\$500
Notes: Control requires grasping and twisting.		
State: 1115B.8.3		
Federal: 4.19.5, 4.27.4		
Insulate water lines		\$100
Notes: Drain pipes not insulated.		
State: 1115B.4.3 #4		
Federal: 4.19.4		
Widen corridor		\$10,000
Notes: Entry corridor is 32" (44" min) wide for a distance of 55" long.		
State: 1115B.3.1 #4.5		
Federal: 4.17.1

Floor 1		
20 - 1	Single User Restroom	Priority: 2
Replace or reposition dispensers or mirrors		\$200
Notes: Mirror is mounted so bottom of reflecting surface is 42" (40" max) AFF. Lower mirror.		
State: 1115B.8.1		
Federal: 4.19.6		
Replace or reposition dispensers or mirrors		\$500
Notes: Sanitary napkin dispenser is 48" (40" max) and towel dispenser is 49" (40" max) AFF.		
State: 1115B.8.3		
Federal: 4.23.7		
Replace or reposition dispensers or mirrors		\$100
Notes: Seat cover dispenser is 42" (40" max) AFF.		
State: 1115B.8.3		
Federal: 4.23.7		
Reposition toilet flush controls		\$750
Notes: Flush control not on wide side.		
State: 1115B.4.1 #5		
Federal: 4.16.5		
Replace or reposition fixtures		\$1,000
Notes: Space from the wall to the centerline of the toilet is 18.5" (18" req).		
State: 1115B.4.1 #1		
Federal: 4.17.3

Floor 1		
27 - 1	Auditorium	Priority:2
Provide accessible seating		\$750
Notes:	Seats with 24" min. clear leg space is not provided. Provide 1% of seats with 24" min. clear leg space.	
State:	1104B.3.4 #1	
Federal:	-	
Provide accessible seating		\$750
Notes:	Aisle seats with removable armrests are not provided. Provide 1% of fixed aisle seats with removable armrests as well as a sign identifying the location of these seats.	
State:	1104B.3.4 #1	
Federal:	-	
Provide accessible seating		\$500
Notes:	Wheelchair seating is 33" x 54" (33" x 60" min. side access). Enlarge the two wheelchair seating areas.	
State:	1104B.3.4	
Federal:	4.33.2	
Provide accessible seating		\$1,000
Notes:	Companion seating is not provided adjacent to the two wheelchair seating areas. Provide companion seating.	
State:	1104B.3.5	
Federal:	4.33.3

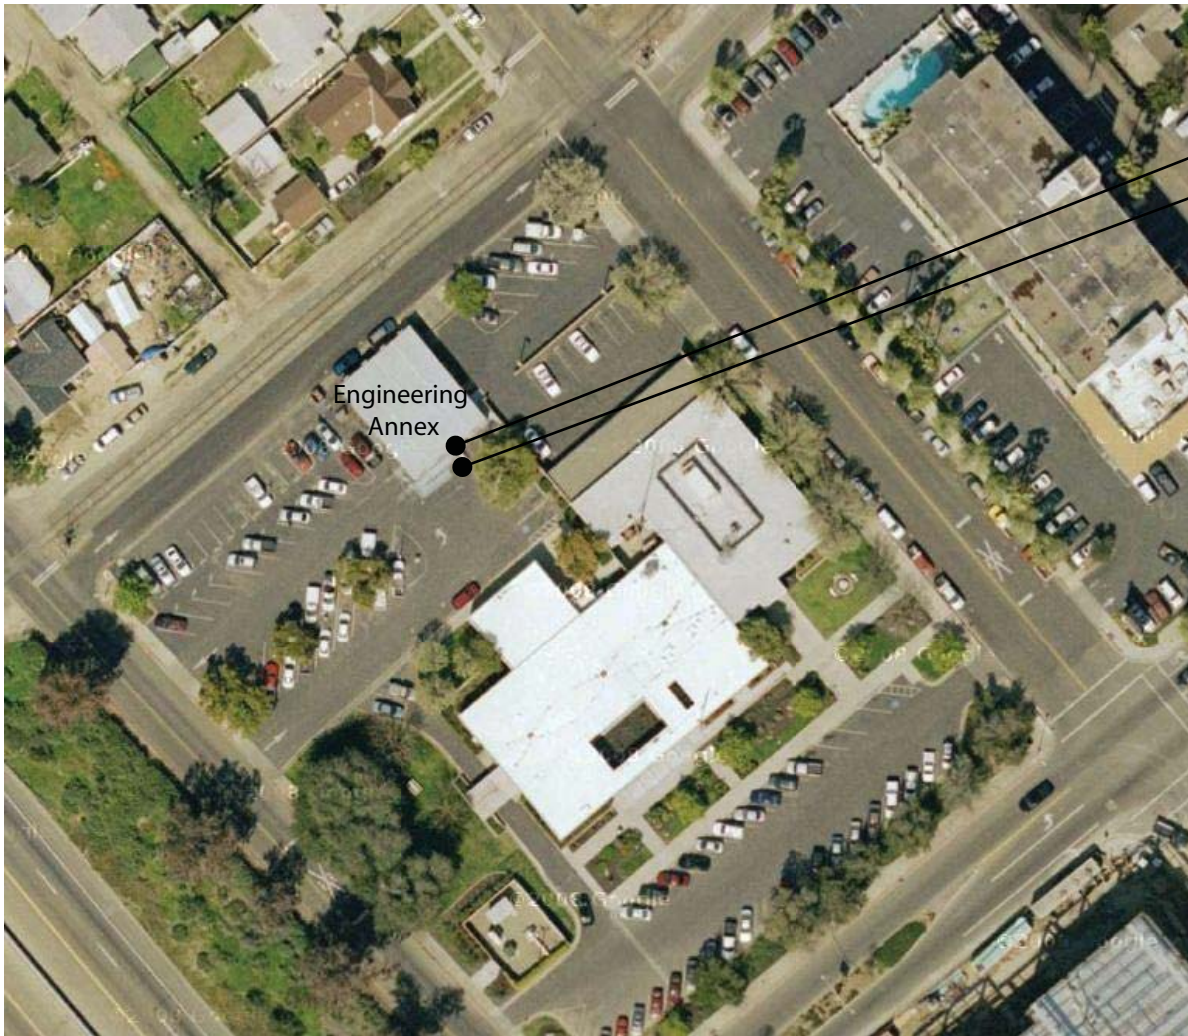
Engineering Annex - Exterior & First Floor
205 West 4th Street, Madera

Floor 1		
8 - 1	Door/Gate	Priority: 1
Adjust door closer		\$100
Notes: Operating effort is 9 lbs (5 lbs max).		
State: 1133B.2.5		
Federal: 4.13.11		
Install or modify permanent room signs		\$250
Notes: There is an exit sign but Braille is not provided.		
State: 1011.3 #3		
Federal: -		
Provide sign(s) indicating accessible entries and facilities		\$100
Notes: Accessible entry is not marked by the International Symbol of Accessibility.		
State: 1117B.5.8.1.2, 1127B.3		
Federal: 4.13.6		
Enlarge door opening		\$3,500
Notes: Height of clear opening is 78.5" (80" min) to door closer.		
State: 1008.11, 1133B.2.2		
Federal: 4.4.2

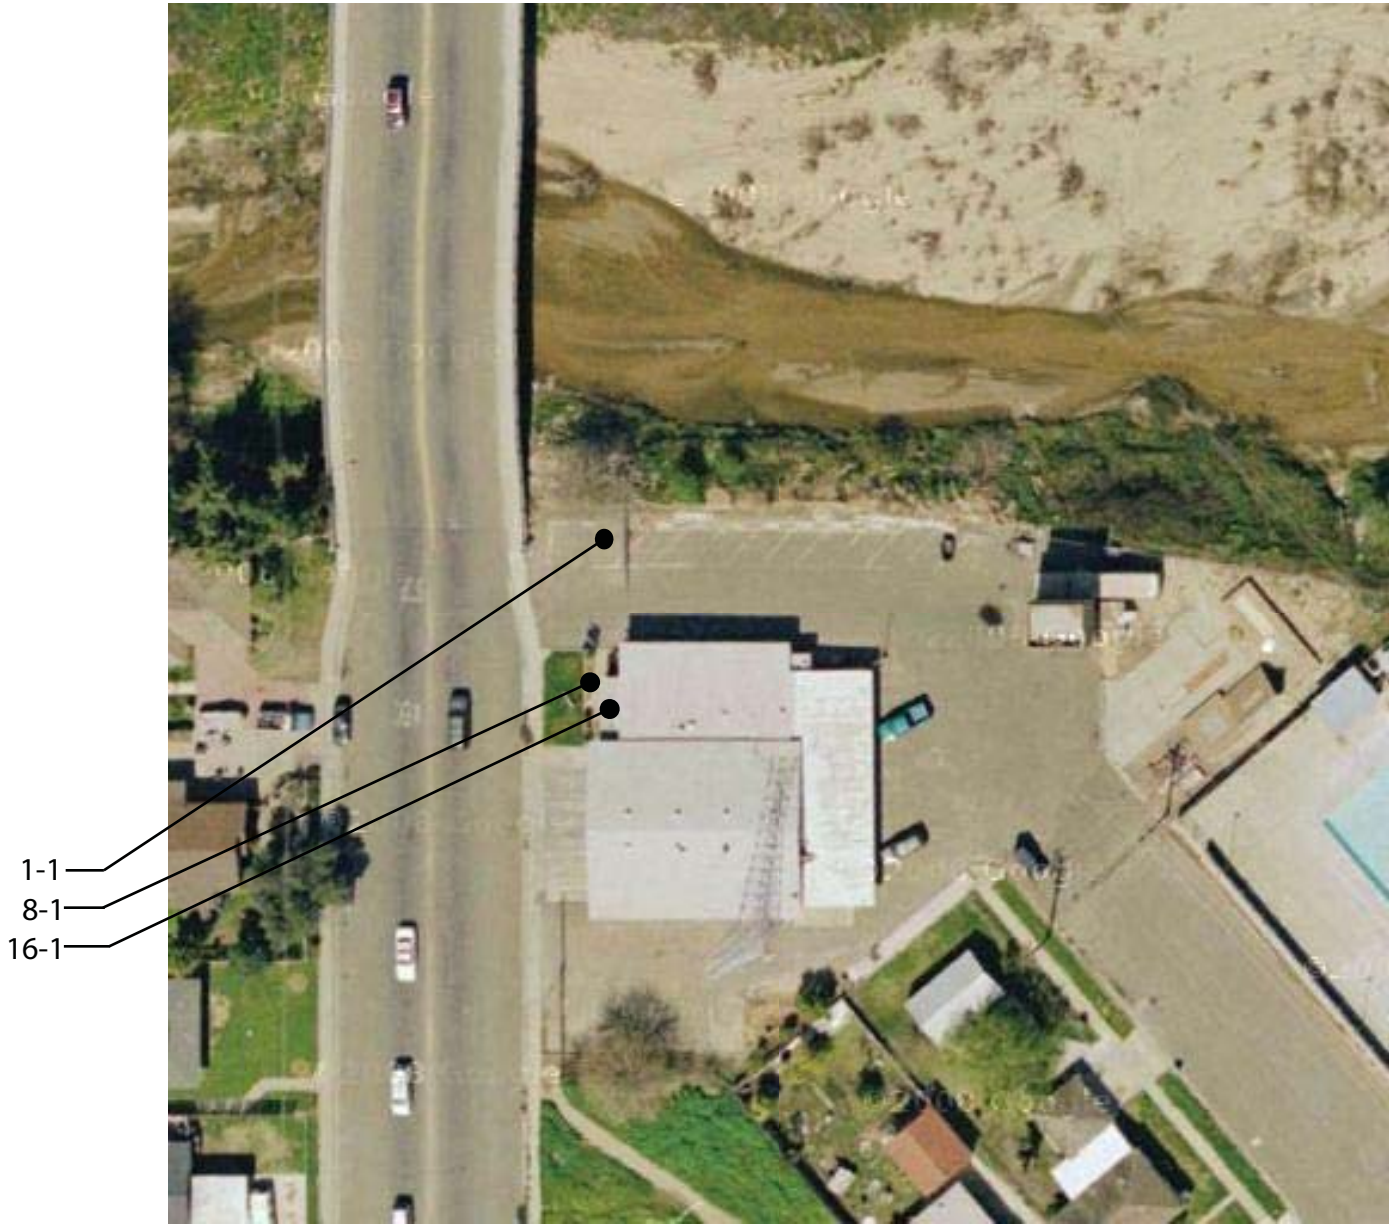
Fire Station #6 - Exterior & First Floor
317 Lake Street, Madera

Floor 1		
8 - 1	Door/Gate	Priority: 1
Provide an accessible path of travel		\$2,000
Notes: Accessible route to the door is not provided due to a step located on path of travel.		
State: 1133B.1.1.1.1		
Federal: 4.3.2		
Adjust door closer		\$100
Notes: Operating effort is 10 lbs (5 lbs max).		
State: 1133B.2.5		
Federal: 4.13.11		
Provide sign(s) indicating accessible entries and facilities		\$100
Notes: Primary entrance is not marked by an International Symbol of Accessibility.		
State: 1117B.5.8.1.2, 1127B.3		
Federal: 4.13.6		
Provide or modify door kickplate		\$100
Notes: Kickplate is 4.5" (10" min) high.		
State: 1133B.2.6		
Federal: -		
16 - 1	Transaction Counter	Priority: 2
Provide an accessible counter		\$4,000
Notes: Transaction counter is 42" (28" to 34") AFF.		
State: 1122B.5		
Federal: 4.32.4

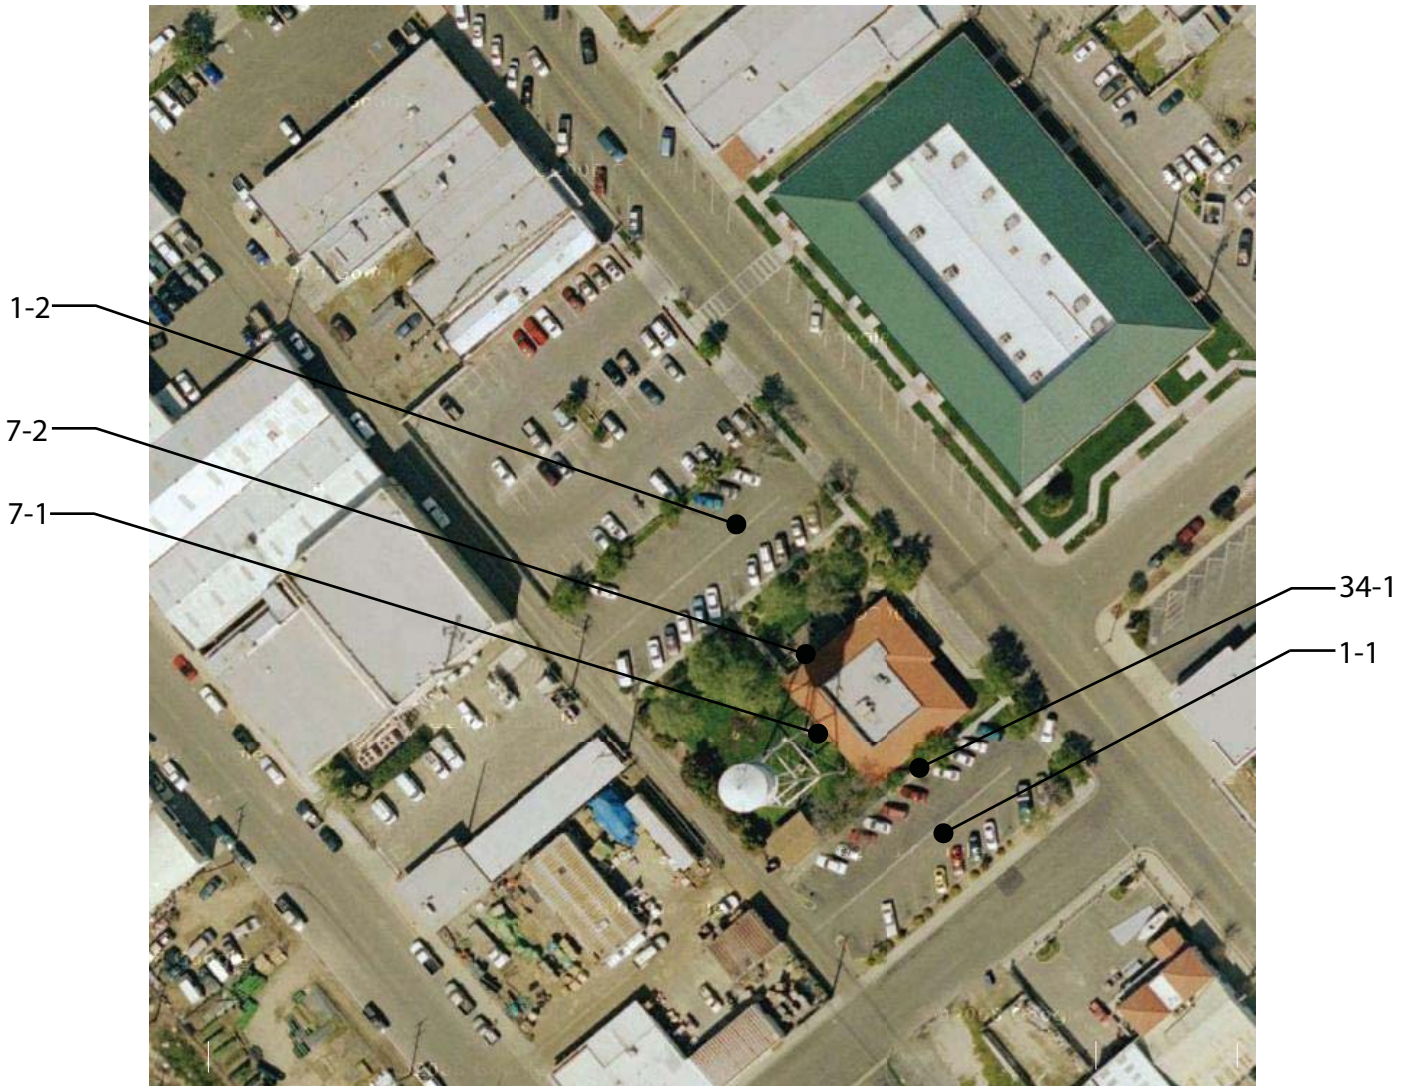
Frank Bergon Senior Center - Exterior
238 South D Street, Madera

Exterior		
7 - 1	Hazard	Priority: 4
Remove overhanging or protruding objects		\$100
Notes:	Light fixture protrudes 11.5" (4" max) and is 66.5" (not between 27" to 80") AFF on the path of travel to the primary entrance of the Senior Center. Provide something below the light fixture that is cane-detectable.	
State:	1133B.8.6.1	
Federal:	4.4.1	
7 - 2	Hazard	Priority: 4
Remove overhanging or protruding objects		\$100
Notes:	Light fixture protrudes 11.5" (4" max) and is 66.5" (not between 27" to 80") AFF on the path of travel to the primary entrance of the Senior Center. Provide something below the light fixture that is cane-detectable.	
State:	1133B.8.6.1	
Federal:	4.4.1	
34 - 1	Fixed Bench	Priority: 4
Increase or provide maneuvering or clear floor area		\$800
Notes:	30" x 48" min. companion seating are not provided at either ends of the bench pads.	
State:	-	
Federal:	-	
Provide accessible fixed bench		\$900

Notes:	Armrests are not provided.	
State:	-	
Federal:	-
