Appendix F: Facility Reports

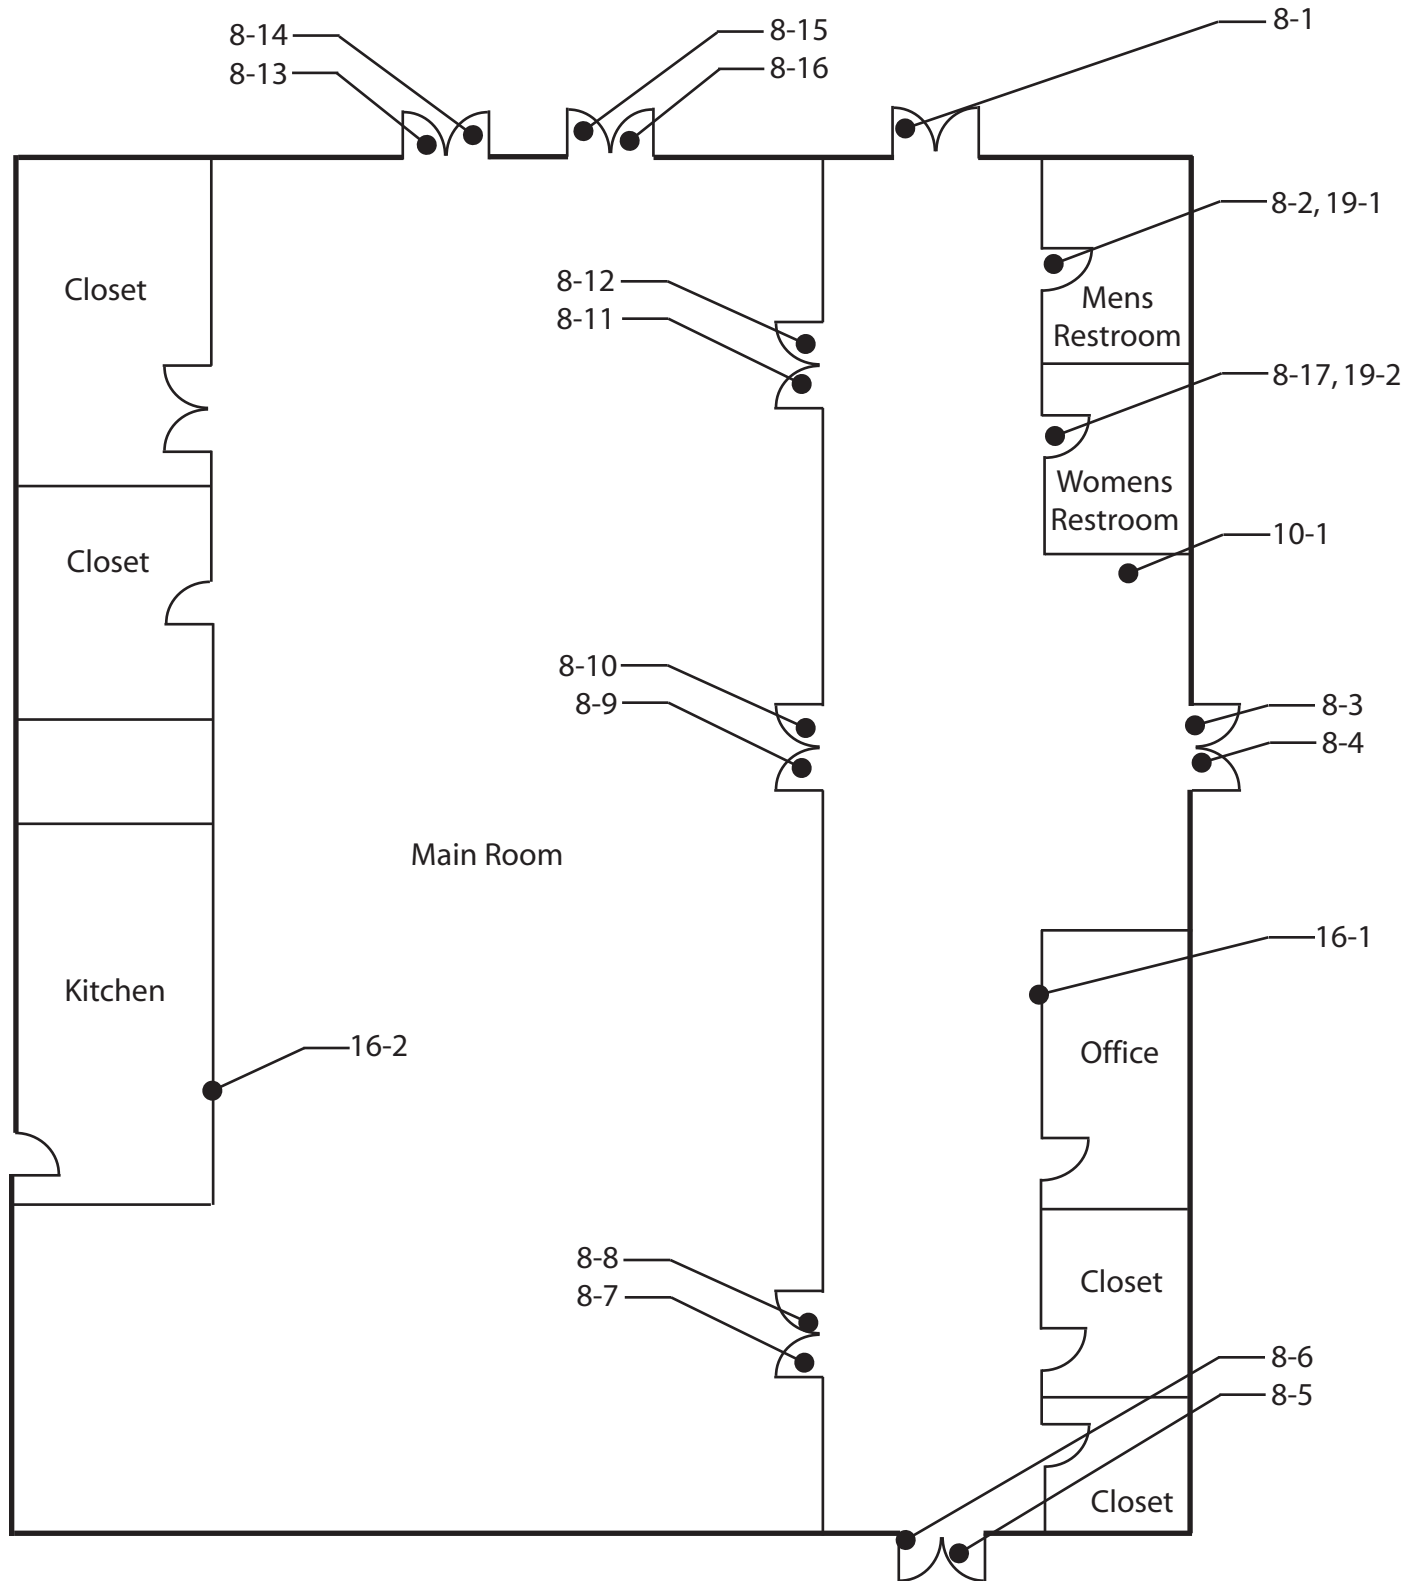
Frank Bergon Senior Center - First Floor
238 South D Street, Madera

State: 1115B.4.2 #1, 1115B.4.2 #2		
Federal: 4.18.2		
Provide or replace stall door hardware		\$100
Notes: U-shaped handle not provided on the back of the compartment door. Door is not self-closing.		
State: 1115B.3.1 #4.5		
Federal: 4.13.9		
Replace or reposition fixtures		\$1,000
Notes: Space from the wall to the centerline of the water closet is 18.5" (18" absolute).		
State: 1115B.7.1.3		
Federal: 4.17.3

Floor 1		
19 - 1	Multiple User Restroom	Priority: 2
Modify stall partitions and doors		\$500
Notes: Space from the wall to the edge of the toilet is 24.5" (32" min).		
State: 1115B.4.1 #1		
Federal: 4.17.3		
Modify stall partitions and doors		\$500
Notes: Compartment width is 50.5" (60" min).		
State: -		
Federal: 4.17.3		
Replace or reposition dispensers or mirrors		\$100
Notes: Seat cover dispenser is 46" (40" max) AFF. Lower seat cover dispenser.		
State: 1115B.8.3		
Federal: 4.23.7		
Replace or modify grab bars		\$100
Notes: Rear grab bar is 17.5" (12" max) from the back wall. Relocate grab bar.		
State: 1115B.4.1 #3.2		
Federal: 4.17.6		
Replace or modify grab bars		\$350
Notes: Side grab bar is positioned so the front end is 51" (54" min) from the back wall.		
State: 1115B.4.1 #3.1		
Federal: 4.17.6

Floor 1		
19 - 2	Multiple User Restroom	Priority: 2
Replace or reposition dispensers or mirrors		\$100
Notes: Seat cover dispenser is 46" (40" max) AFF. Lower seat cover dispenser.		
State: 1115B.8.3		
Federal: 4.23.7		
Replace or modify grab bars		\$100
Notes: Rear grab bar is 17.5" (12" max) from the back wall. Relocate grab bar.		
State: 1115B.4.1 #3.2		
Federal: 4.17.6		
Replace or modify grab bars		\$350
Notes: Side grab bar is positioned so the front end is 51" (54" min) from the back wall.		
State: 1115B.4.1 #3.1		
Federal: 4.17.6		
Replace or reposition dispensers or mirrors		\$200
Notes: Mirror is mounted so bottom of reflecting surface is 41" (40" max) AFF.		
State: 1115B.8.1		
Federal: 4.19.6		
Replace or reposition dispensers or mirrors		\$250
Notes: Towel dispenser is 41" (40" max) AFF. Lower towel dispenser.		
State: 1115B.8.3		
Federal: 4.23.7

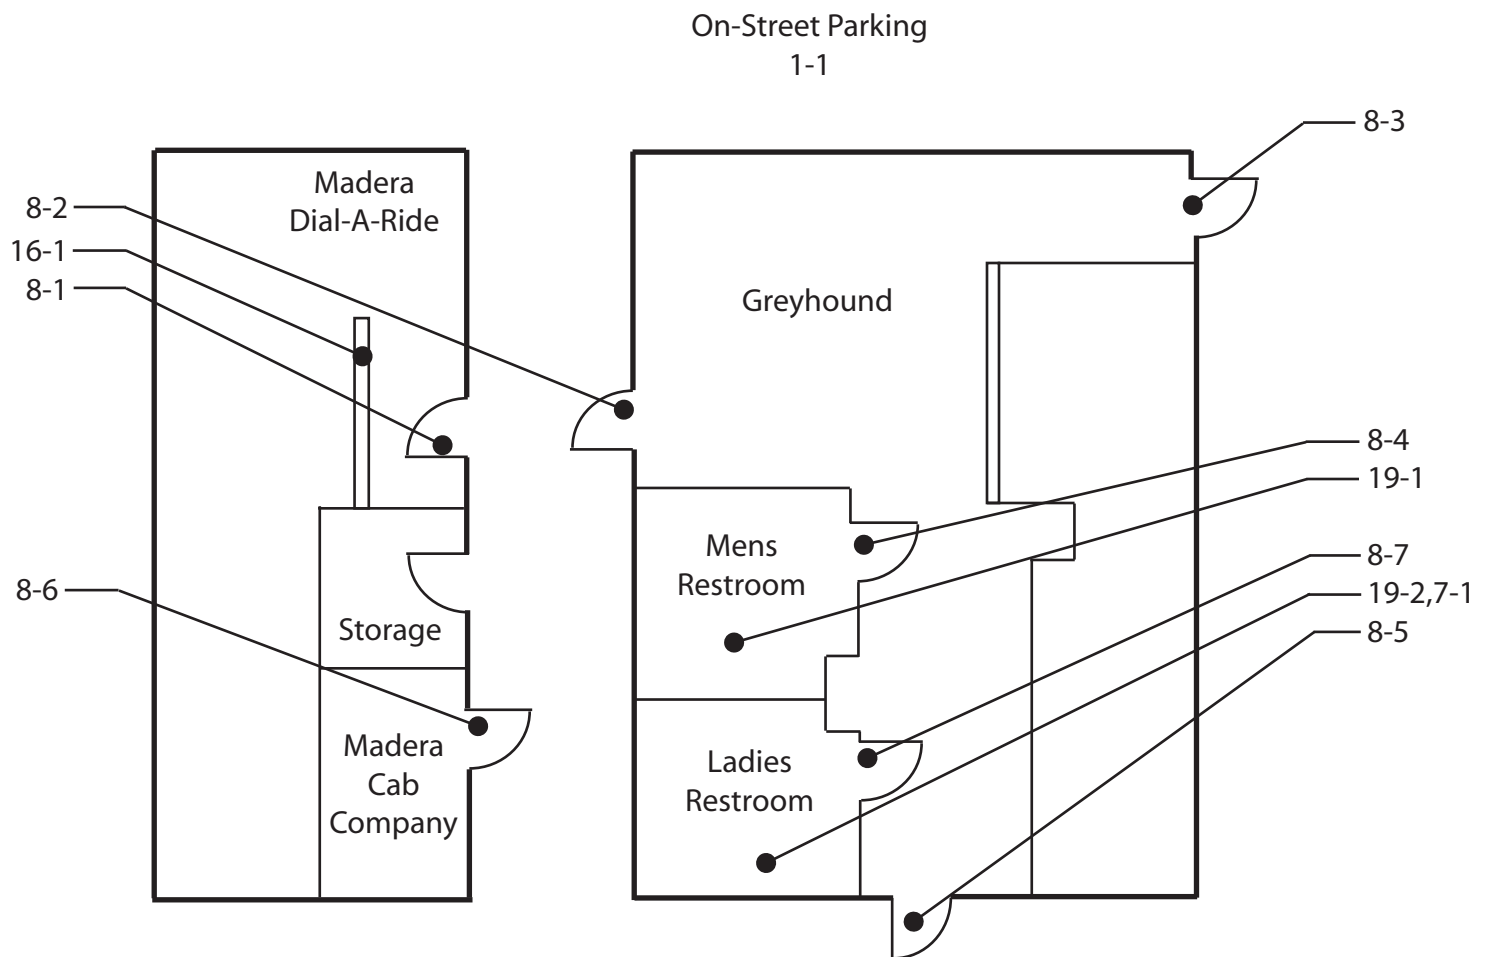
Intermodal Facility - Exterior & First Floor
123 North E Street, Madera

Floor 1		
7 - 1	Hazard	Priority: 1
Remove overhanging or protruding objects		\$100
Notes: Towel dispenser protrudes 9.5" (4" max) and is 51" (not between 27" to 80") AFF. Relocate towel dispenser.		
State: 1133B.8.6.1		
Federal: 4.4.1		
8 - 1	Door/Gate	Priority: 1
Provide sign(s) indicating accessible entries and facilities		\$100
Notes: International Symbol of Accessibility is not provided on the door.		
State: 1117B.5.8.1.2, 1127B.3		
Federal: 4.13.6		
Adjust door closer		\$100
Notes: Operating effort is 6 lbs (5 lbs max).		
State: 1133B.2.5		
Federal: 4.13.11		
Install or modify permanent room signs		\$250
Notes: There is an exit sign but Braille is not provided.		
State: 1011.3 #3		
Federal: -		
8 - 2	Door/Gate	Priority: 1
Provide sign(s) indicating accessible entries and facilities		\$100
Notes: International Symbol of Accessibility is not provided on the door.		
State: 1117B.5.8.1.2, 1127B.3		
Federal: 4.13.6

Floor 1		
8 - 7	Door/Gate	Priority:2
Adjust door closer		\$100
Notes: Operating effort is 10 lbs (5 lbs max).		
State: 1133B.2.5		
Federal: 4.13.11		
16 - 1	Transaction Counter	Priority:2
Provide an accessible counter		\$4,000
Notes: Madera Dial-A-Ride: Transaction counter is 42" (28" to 34") AFF.		
State: 1122B.5		
Federal: 4.32.4		
19 - 1	Multiple User Restroom	Priority:2
Replace or reposition dispensers or mirrors		\$250
Notes: Soap dispenser is 52" (40" max) AFF.		
State: 1115B.8.3		
Federal: 4.23.7		
Insulate water lines		\$100
Notes: Drain pipes are not insulated.		
State: 1115B.4.3 #4		
Federal: 4.19.4		
Provide or replace stall door hardware		\$100
Notes: U-shaped handle not provided on back of compartment door.		
State: 1115B.3.1 #4.5		
Federal: 4.13.9		
19 - 2	Multiple User Restroom	Priority:2
Modify lavatory/counter clearances		\$3,500
Notes: Lavatory next to wall has 13" (18" min) between wall and center of fixture.

State: 1115B.4.3 #2		
Federal: -		
Provide or replace stall door hardware		\$100
Notes: U-shape handle not provided on the back of compartment door.		
State: 1115B.3.1 #4.5		
Federal: 4.13.9		
Replace or reposition dispensers or mirrors		\$100
Notes: Coat hook is 66" (48" max) AFF.		
State: 1118B.5		
Federal: A4.27

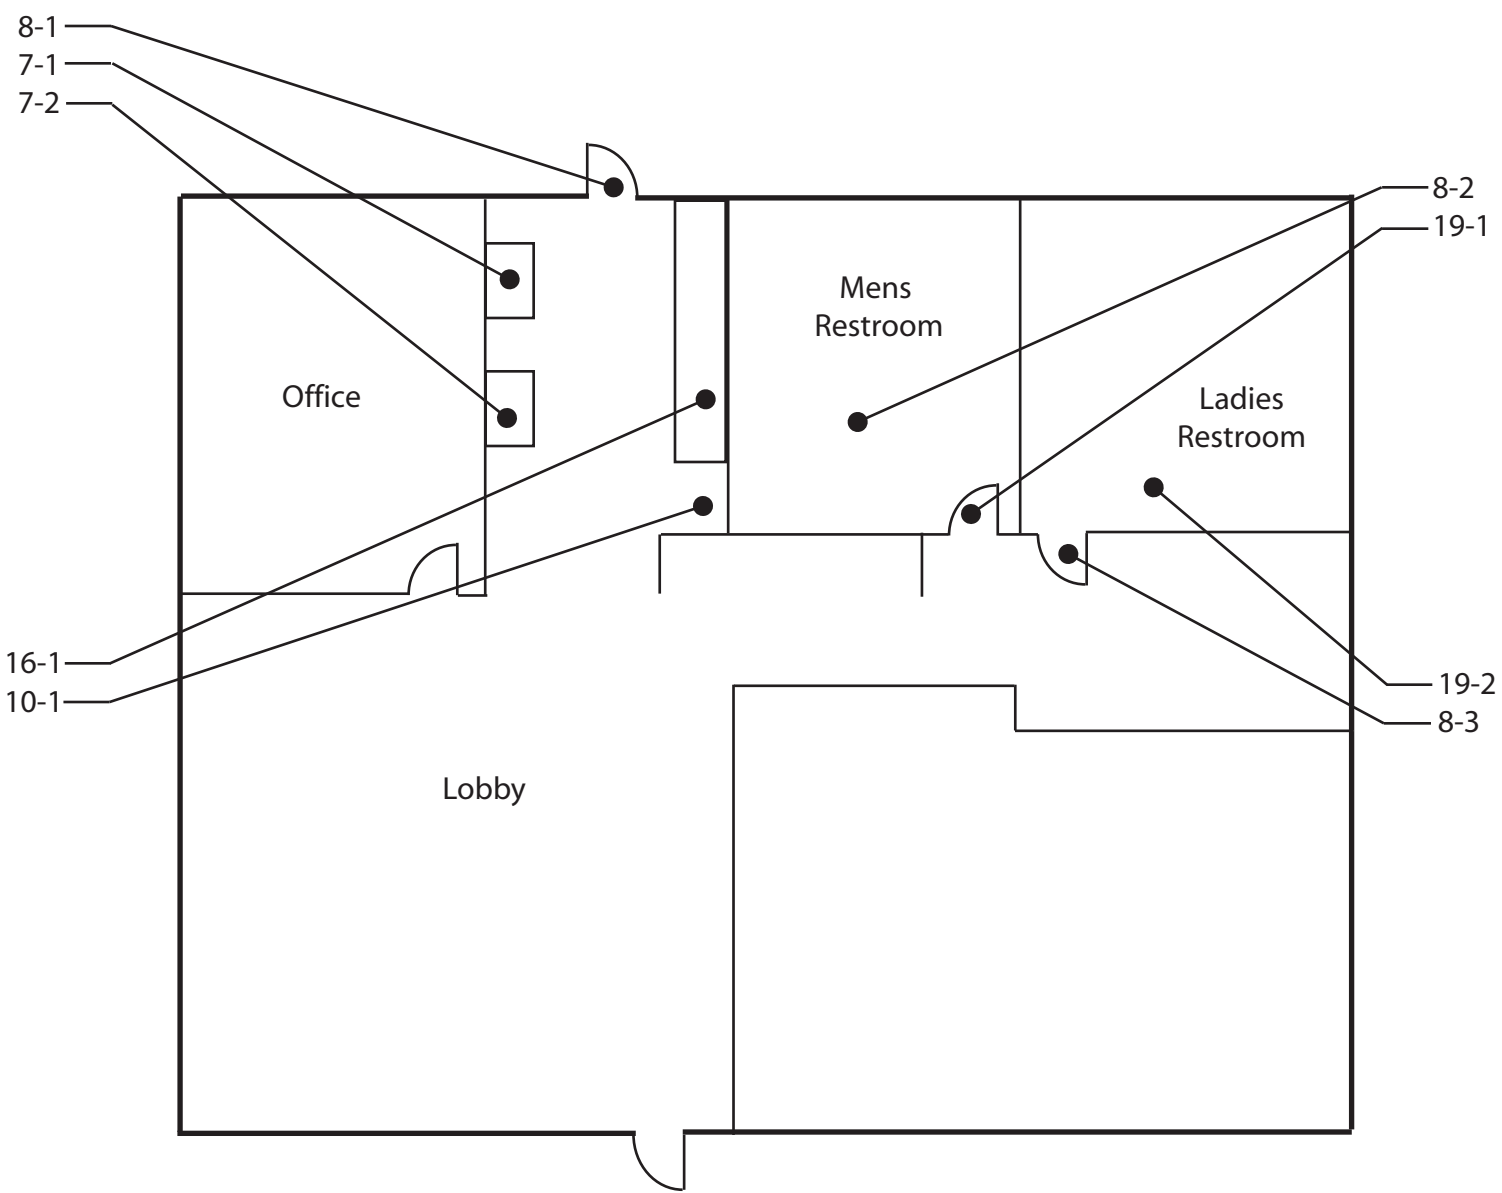
Madera Municipal Airport - First Floor
4020 Aviation Drive, Madera

Floor 1		
7 - 1	Hazard	Priority:2
Remove overhanging or protruding objects		\$100
Notes: Work counter protrudes 16" (4" max) and is 33" (not between 27" to 80") AFF.		
State: 1133B.8.6.1		
Federal: 4.4.1		
7 - 2	Hazard	Priority:2
Remove overhanging or protruding objects		\$100
Notes: Work counter protrudes 24" (4" max) and is 36" (not between 27" to 80") AFF.		
State: 1133B.8.6.1		
Federal: 4.4.1		
8 - 1	Door/Gate	Priority:1
Provide sign(s) indicating accessible entries and facilities		\$100
Notes: Accessible entry is not marked by the International Symbol of Accessibility.		
State: 1117B.5.8.1.2, 1127B.3		
Federal: 4.13.6		
Install or modify permanent room signs		\$250
Notes: Accessible permanent room sign stating "Airport Lobby" is not provided.		
State: -		
Federal: 1117B.5.7, 4.30.6		
Adjust door closer		\$100
Notes: Operating effort is 9 lbs (5 lbs max).		
State: 1133B.2.5		
Federal: 4.13.11		
8 - 2	Door/Gate	Priority:2

Floor 1		
8 - 3	Door/Gate	Priority: 2
Adjust door closer		\$100
Notes: Operating effort is 9 lbs (5 lbs max).		
State: 1133B.2.5		
Federal: 4.13.11		
Increase or provide maneuvering or clear floor area		\$2,500
Notes: Level space on the swing-side of the door is 47.75" (60" min).		
State: 1133B.2, 1133B.2.4.2, 1133B.7.5		
Federal: 4.13.6		
10 - 1	Drinking Fountain	Priority: 3
Replace or reposition drinking fountain		\$3,500
Notes: Hi-low fountain not provided. Clear knee space is not provided. Bubbler height and control are 40" (36" max).		
State: 1115B.4.6 #1, 1115B.4.6 #2, 1115B.4.6 #4, 1117B.4.6 #2		
Federal: 4.1.6, 4.15.2, 4.15.5		
16 - 1	Transaction Counter	Priority: 2
Provide an accessible counter		\$4,000
Notes: Work counter is 39" (28" to 34") AFF.		
State: 1122B.5		
Federal: 4.32.4

Notes: Mens Restroom - Mirror is mounted so bottom of reflecting surface is 44.5" (40" max) AFF.		
State: 1115B.8.1		
Federal: 4.19.6		
Replace or reposition urinal		\$1,500
Notes: Mens Restroom - Urinal is 27.5" (17" max) from the floor to the lip. Flush control is 52" (44" max) AFF.		
State: 1115B.4.2 #1, 1115B.4.2 #2		
Federal: 4.18.2

Floor 1		
19 - 1	Multiple User Restroom	Priority: 2
Provide or replace stall door hardware		\$100
Notes: Mens Restroom - U-shape handle not provided on the back. Compartment door not self-closing.		
State: 1115B.3.1 #4.5		
Federal: 4.13.9		
Replace or reposition dispensers or mirrors		\$100
Notes: Mens Restroom - Coat hook is mounted 67" (48" max) AFF.		
State: 1118B.5		
Federal: A4.27		
Replace or reposition fixtures		\$1,000
Notes: Mens Restroom - Space from the wall to the centerline of the toilet is 17.25" (18" absolute).		
State: 1115B.7.1.3		
Federal: 4.17.3		
Modify stall partitions and doors		\$500
Notes: Mens Restroom - Space from the wall to the side of the toilet is 15" (32" min).		
State: 1115B.4.1 #1		
Federal: 4.17.3		
Modify stall partitions and doors		\$500
Notes: Mens Restroom - Compartment width is 39.5" (60" min).		
State: -		
Federal: 4.17.3		
Reposition toilet flush controls		\$750
Notes: Mens Restroom - Flush control not on wide side.

Replace or reposition dispensers or mirrors		\$100
Notes: Ladies Restroom - Seat cover dispenser is 56" (40" max) AFF.		
State: 1115B.8.3		
Federal: 4.23.7		
Widen corridor		\$75
Notes: Ladies Restroom - Couch reduces path of travel into the restroom to 28" (44" min). Relocate couch.		
State: 1115B.3.1 #4.5		
Federal: 4.17.1

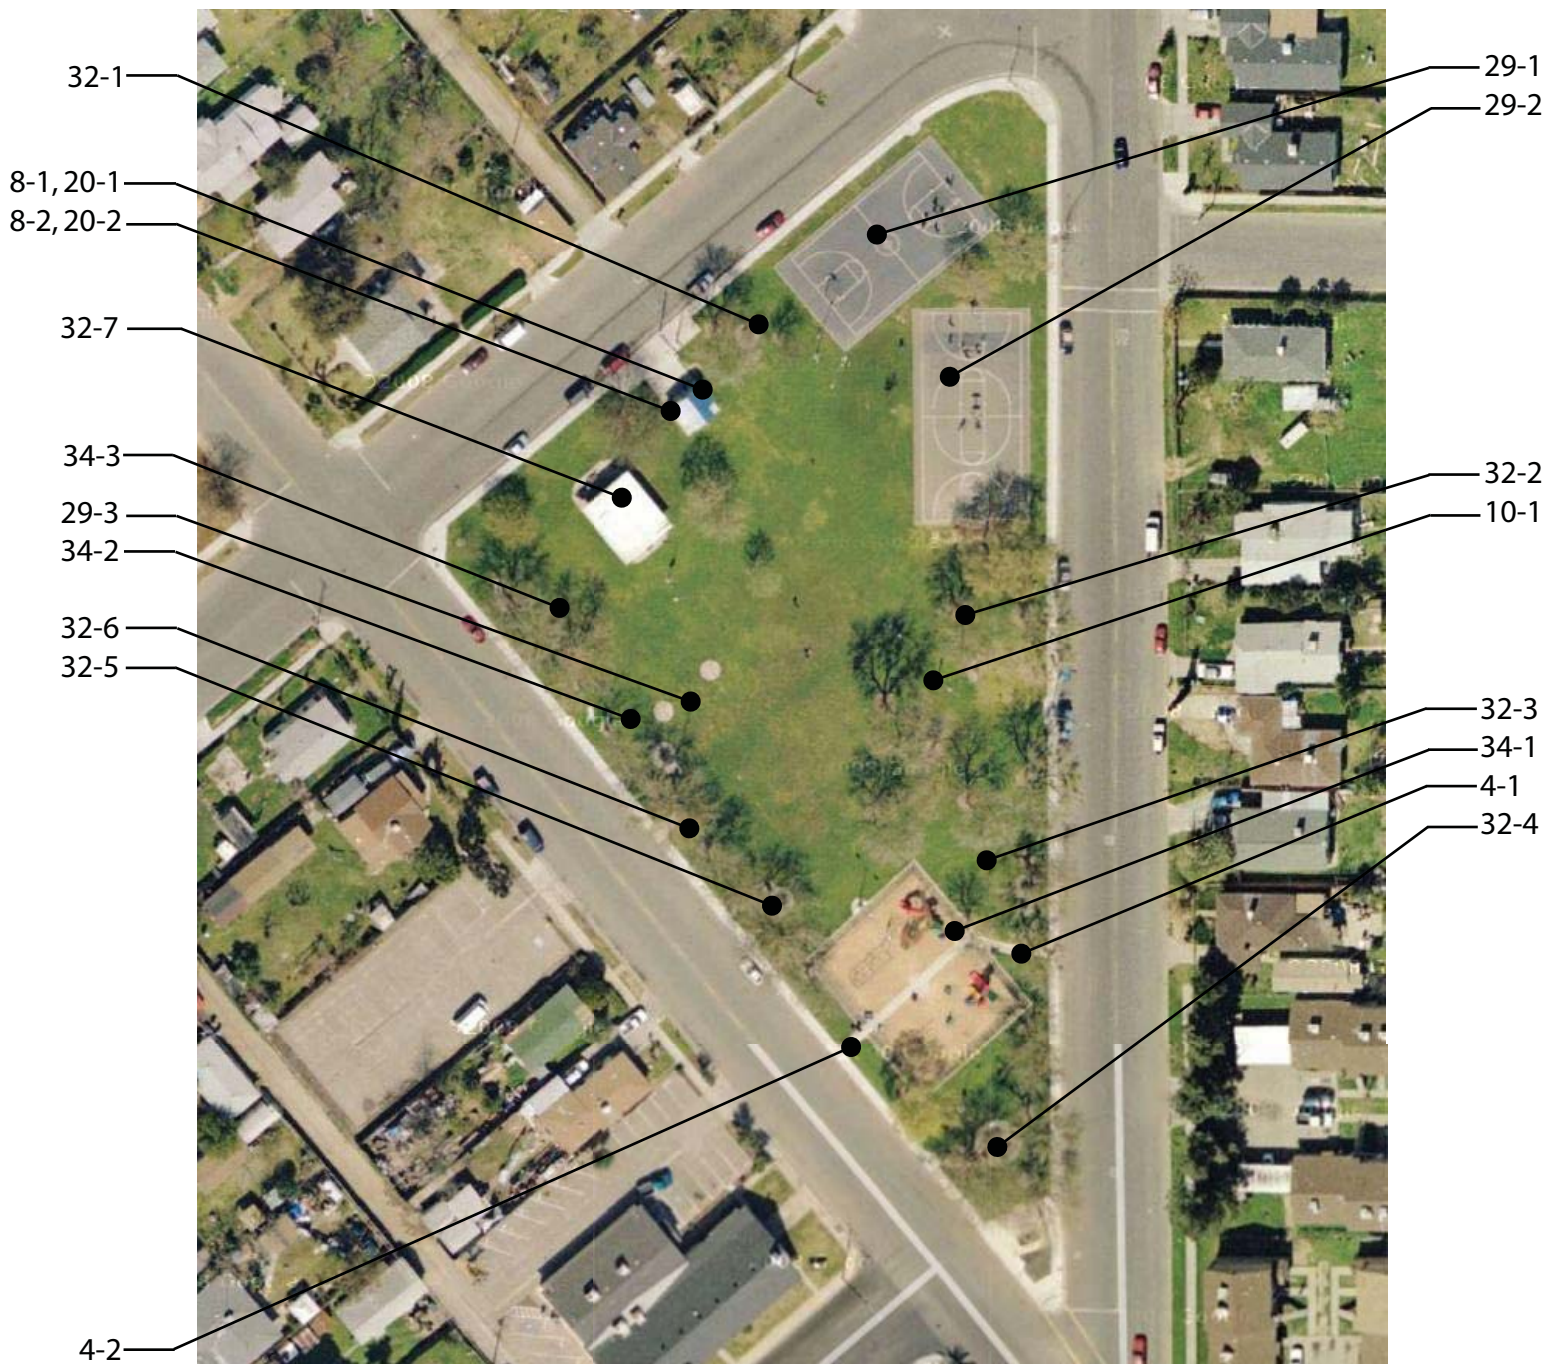
McNally Park - Exterior
Roosevelt Street & 12th Street, Madera

Exterior		
32 - 7	Picnic Area	Priority: 2
Provide an accessible path of travel		\$600
Notes:	Accessible route to the picnic area is not provided. Surface material is turf. It is 25' to the nearest sidewalk.	
State:	1132B.2 #2	
Federal:	-	
34 - 1	Fixed Bench	Priority: 4
Increase or provide maneuvering or clear floor area		\$3,200
Notes:	There are 4 benches in the play area. None provide 30" x 48" clear floor space for companion seating.	
State:	-	
Federal:	-	
34 - 2	Fixed Bench	Priority: 2
Provide an accessible path of travel		\$240
Notes:	Accessible route to the fixed bench is not provided. Surface material is turf. It is 10' to the nearest sidewalk.	
State:	-	
Federal:	-	
34 - 3	Fixed Bench	Priority: 4
Provide an accessible path of travel		\$240
Notes:	Accessible route to the fixed bench is not provided. Surface material is turf. It is 10' to the nearest sidewalk.	
State:	-	
Federal:	-

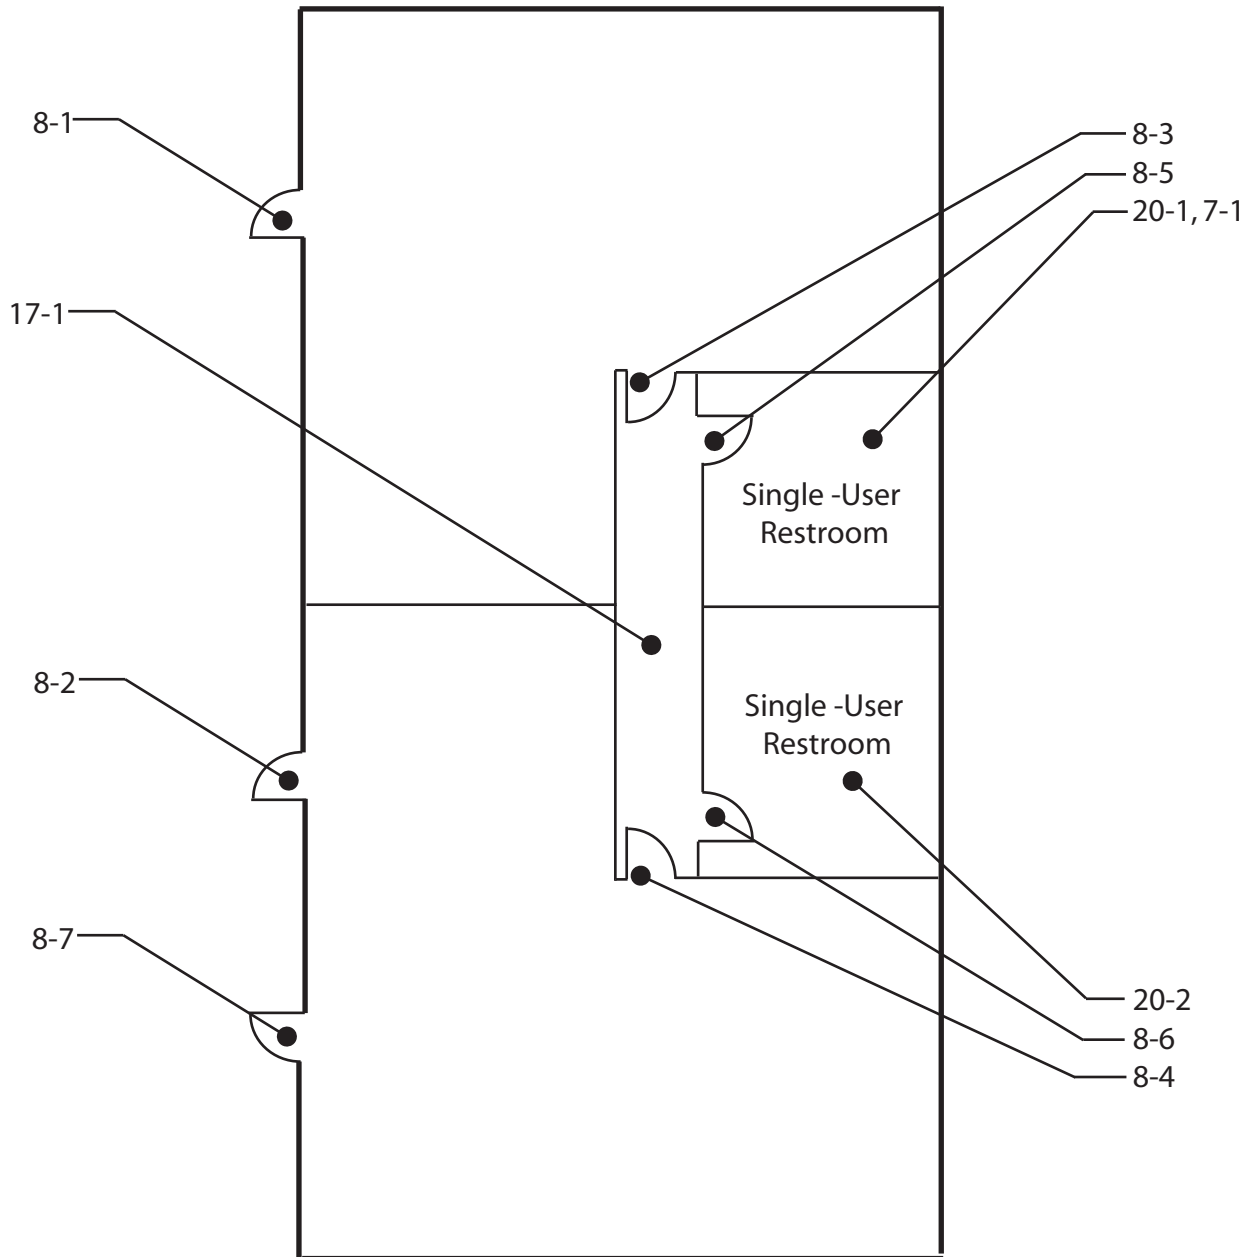
Mexican American Community Center - First Floor
716 Columbia Street, Madera

Floor 1		
20 - 2	Single User Restroom	Priority:2
Replace or reposition dispensers or mirrors		\$100
Notes: Seat cover dispenser is 51" (40" max) AFF.		
State: 1115B.8.3		
Federal: 4.23.7

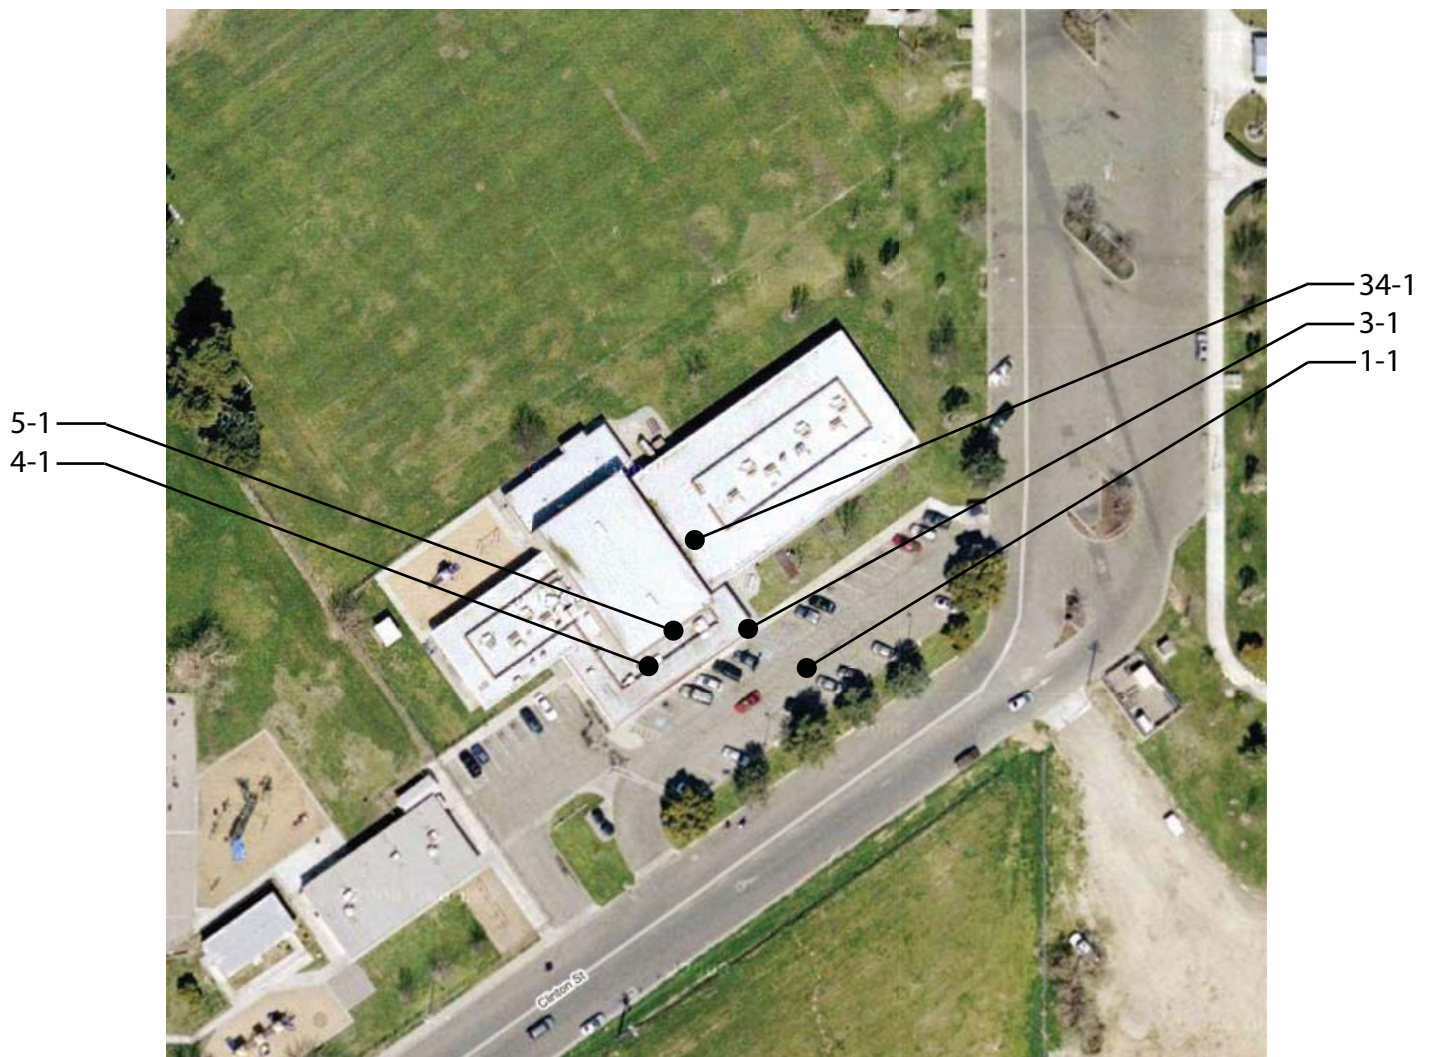
Millview Community Facility - Exterior
1901 Clinton Ave, Madera

Exterior		
4 - 1	Walk	Priority: 4
Widen walk		\$1,400
Notes: Sidewalk adjacent to parking lot has width of 29" (48" min). Walk is 56'4" long. Surface material is concrete. However, there is a ramp adjacent to the narrow walk.		
State: 1133B.7.1		
Federal: 4.3.7		
5 - 1	Ramp	Priority: 4
Regrade or replace ramp		\$28,500
Notes: Slope on the east side of the ramp is 11.3% (8.33% max). Handrails are not provided at this section. Ramp width is 43-3/4" (48" min). Dimensions: 56'10" L x 43-3/4" W.		
State: 1133B.5.2, 1133B.5.3		
Federal: 4.8.2, 4.8.3		
Install or modify handrails		\$2,000
Notes:		
State: 1133B.5.5.1		
Federal: 4.8.5 #1		
34 - 1	Fixed Bench	Priority: 4
Provide accessible fixed bench		\$900
Notes: Front edge of seat height is 16-3/4" (17" to 19") AFF. Armrests are not provided.		
State: -		
Federal: -

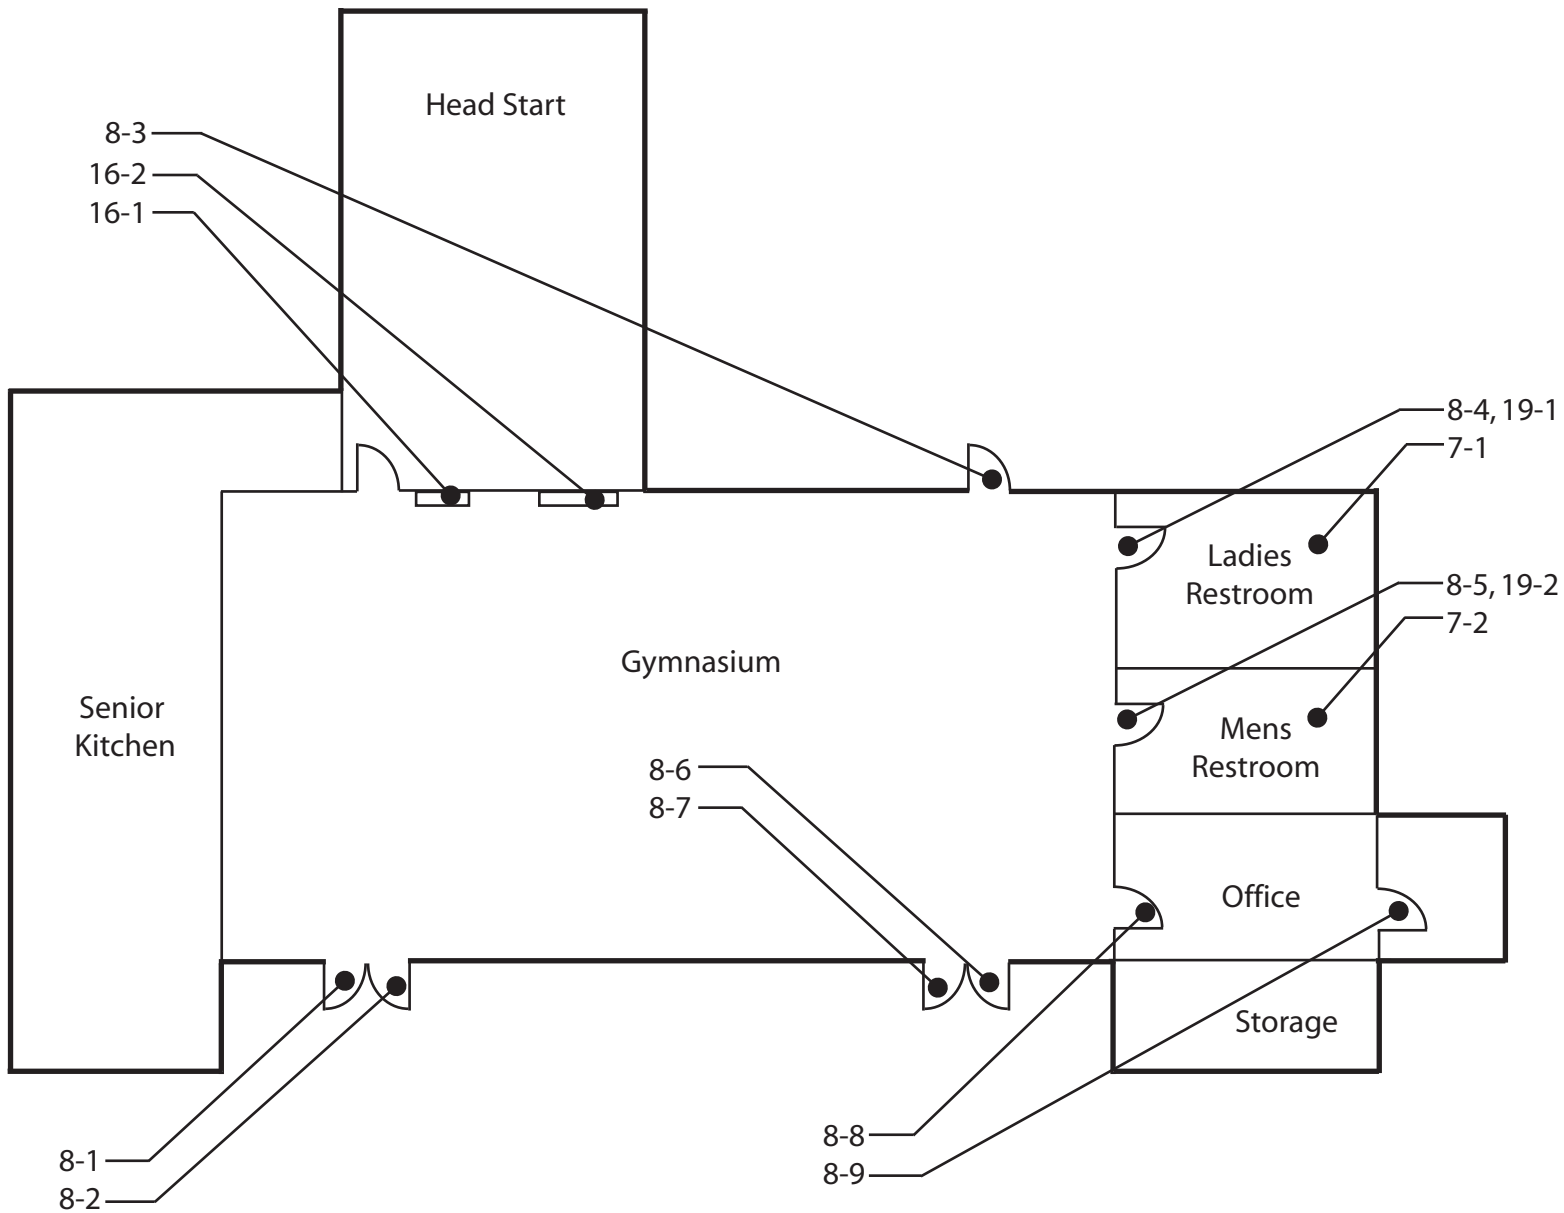
Millview Community Facility - First Floor
1901 Clinton Street, Madera

Floor 1		
19 - 2	Multiple User Restroom	Priority:2
Replace or reposition urinal		\$1,500
Notes: Mens Restroom - Urinal is 24.5" (17" max) AFF.		
State: 1115B.4.2 #1		
Federal: 4.18.2

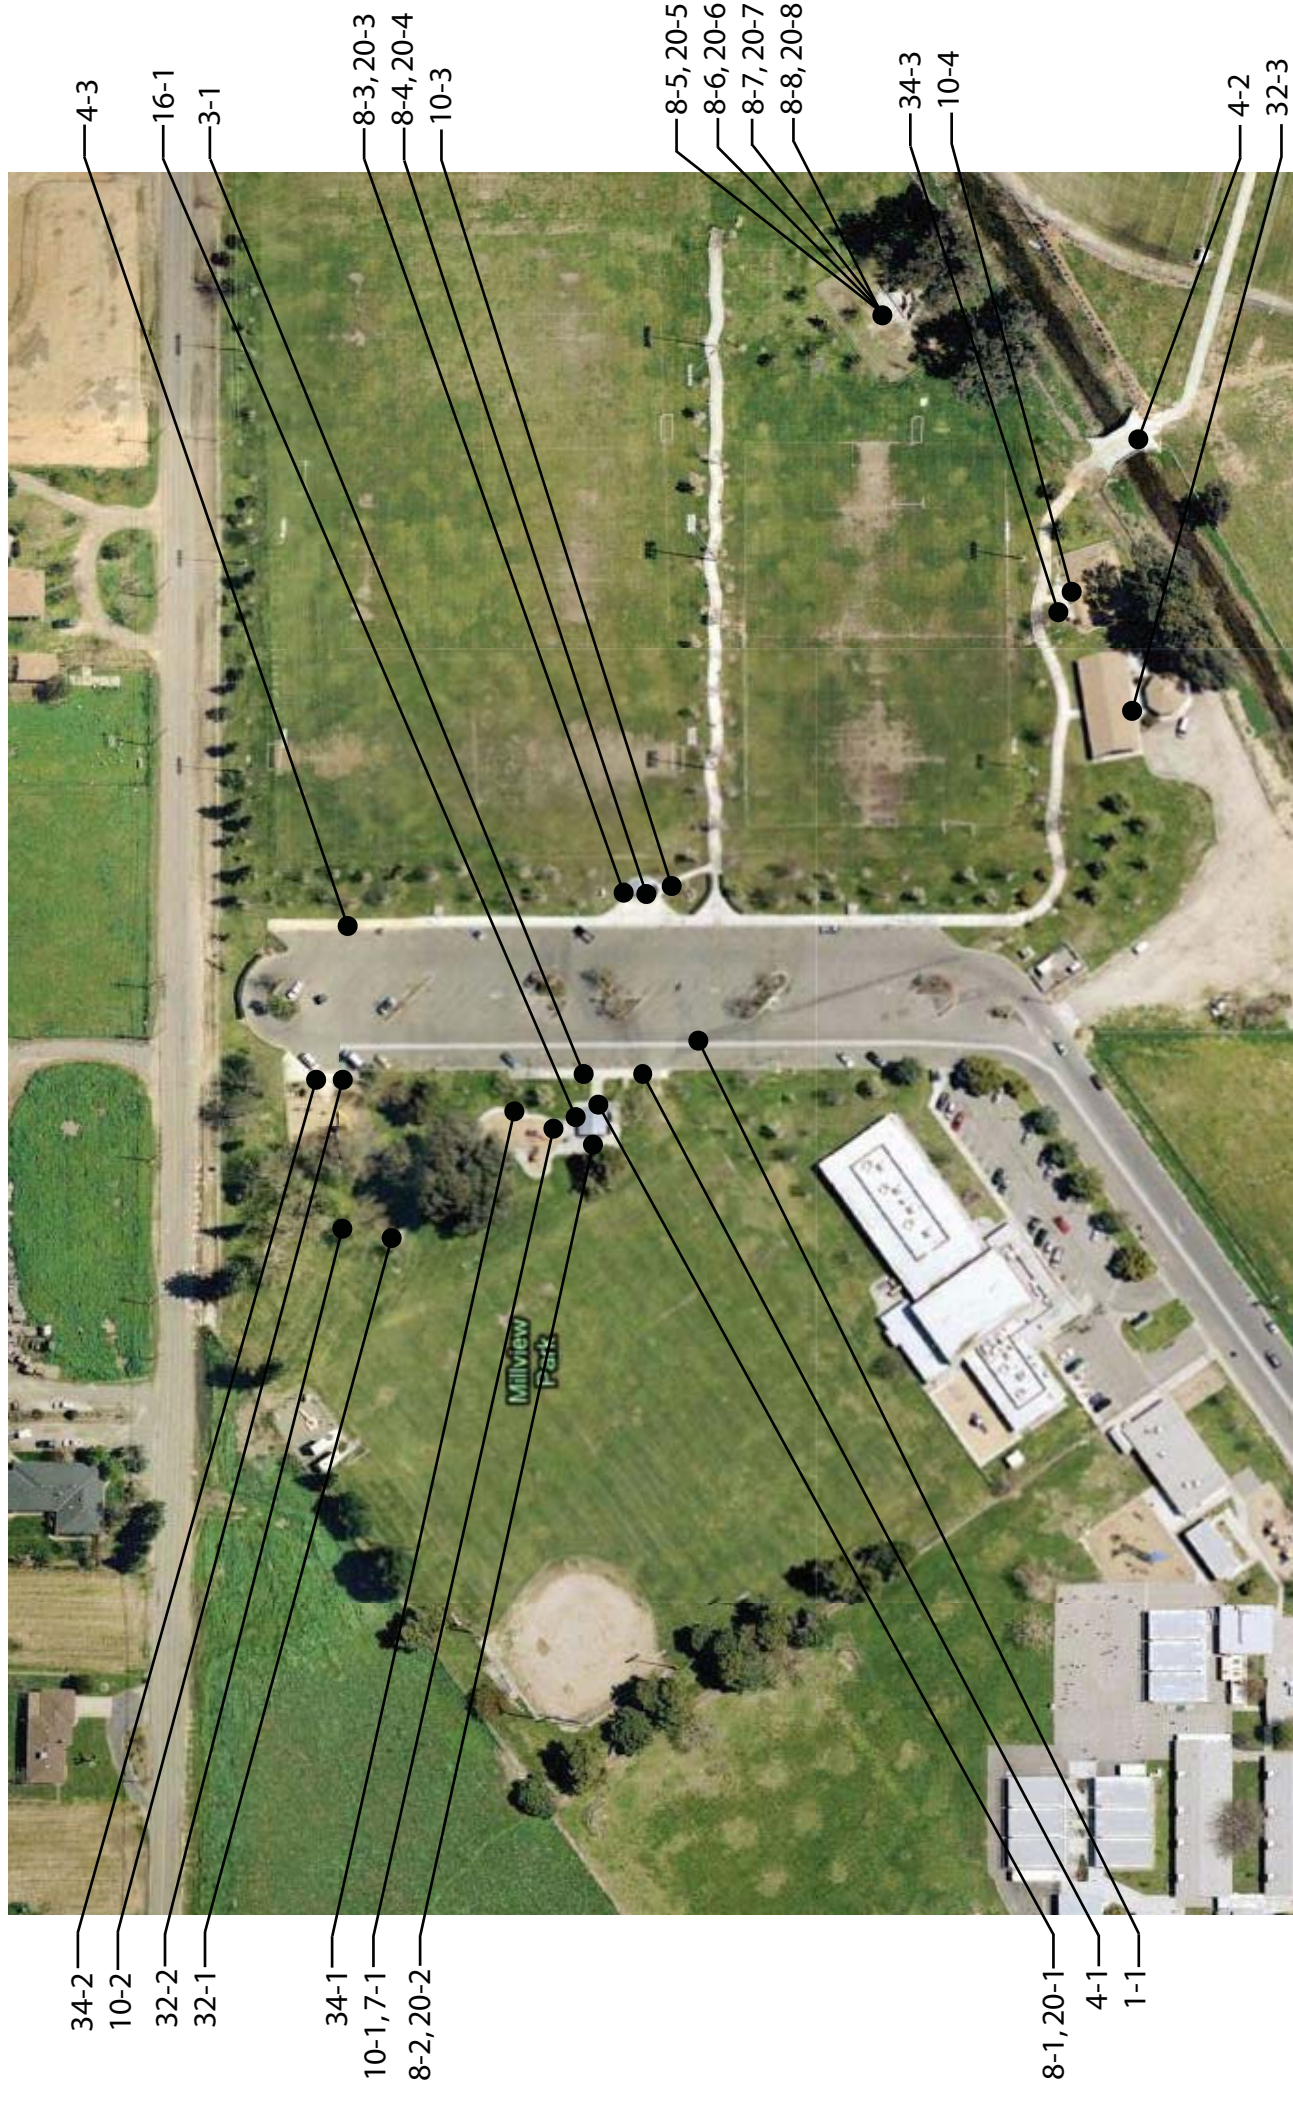
Millview Sports Complex - Exterior
1901 Clinton Ave, Madera

Exterior		
34 - 2	Fixed Bench	Priority: 4
Provide accessible fixed bench		\$1,800
Notes:	There are a total of 2 fixed benches at the play area. None of the benches have armrests.	
State:	-	
Federal:	-	
34 - 3	Fixed Bench	Priority: 4
Increase or provide maneuvering or clear floor area		\$1,600
Notes:	Two fixed benches do not provide 30" x 48" min. companion seating.	
State:	-	
Federal:	-	
Provide accessible fixed bench		\$1,800
Notes:	Two of the fixed benches do not provide armrests.	
State:	-	
Federal:	-

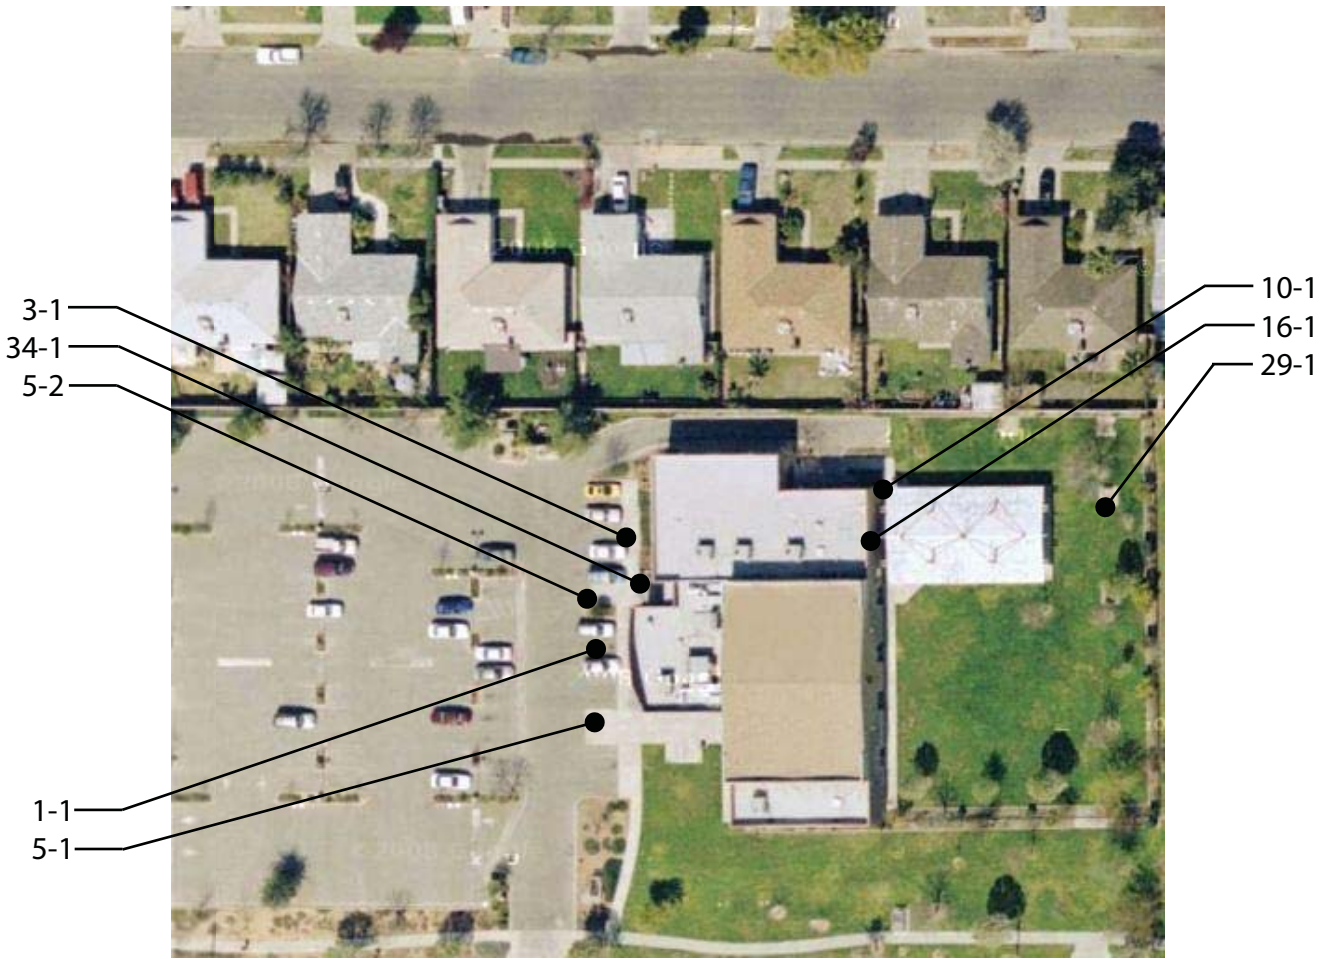
Pan-American Community Center - Exterior
703 East Sherwood Way, Madera

Exterior		
34 - 1	Fixed Bench	Priority: 4
Provide accessible fixed bench		\$900
Notes: Armrests are not provided.		
State: -		
Federal: -		
Increase or provide maneuvering or clear floor area		\$2,500
Notes: 30" x 48" min. companion seating is not provided.		
State: -		
Federal: -

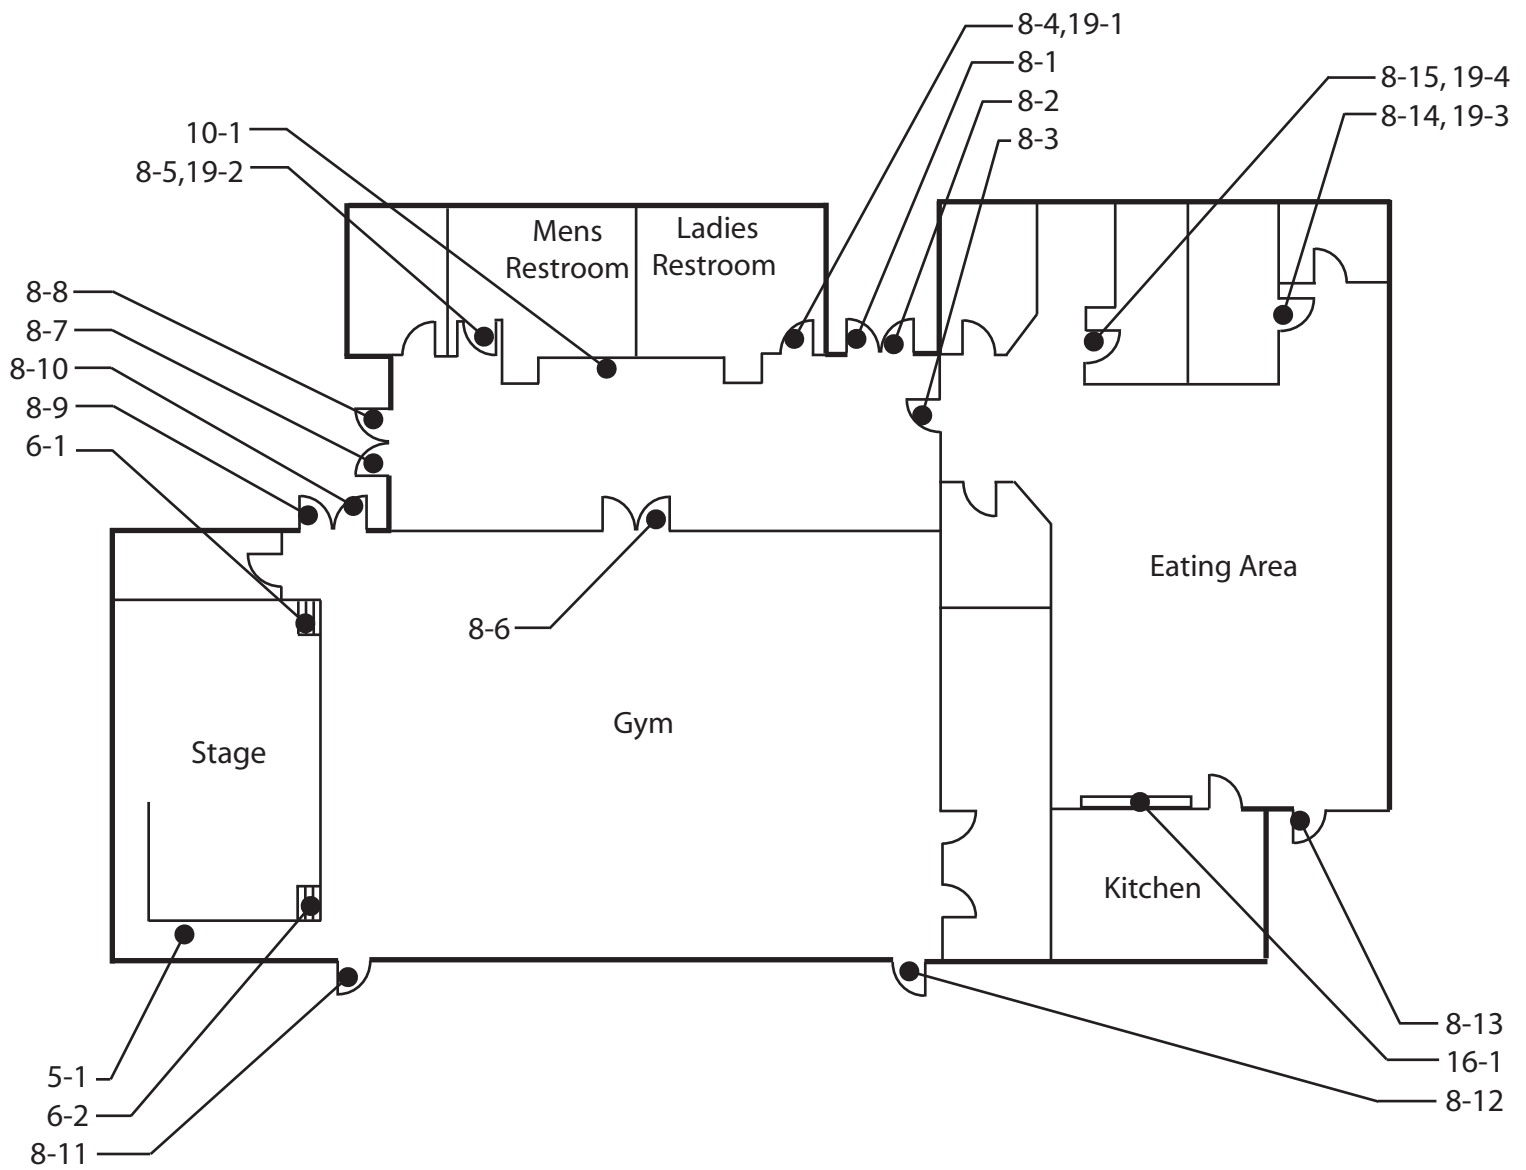
Pan-American Community Center - First Floor
703 East Sherwood Way, Madera

State: 1115B.3.1 #4.5		
Federal: 4.13.9		
Reposition toilet flush controls		\$0
Notes: Flush control not on wide side.		
State: 1115B.4.1 #5		
Federal: 4.16.5		
Install sign		\$250
Notes: Install sign directing the public to the accessible restrooms outside in the lobby area.		
State: 1115B.6, 1117B.5.1 #1		
Federal: 4.30.4
