Appendix F: Facility Reports

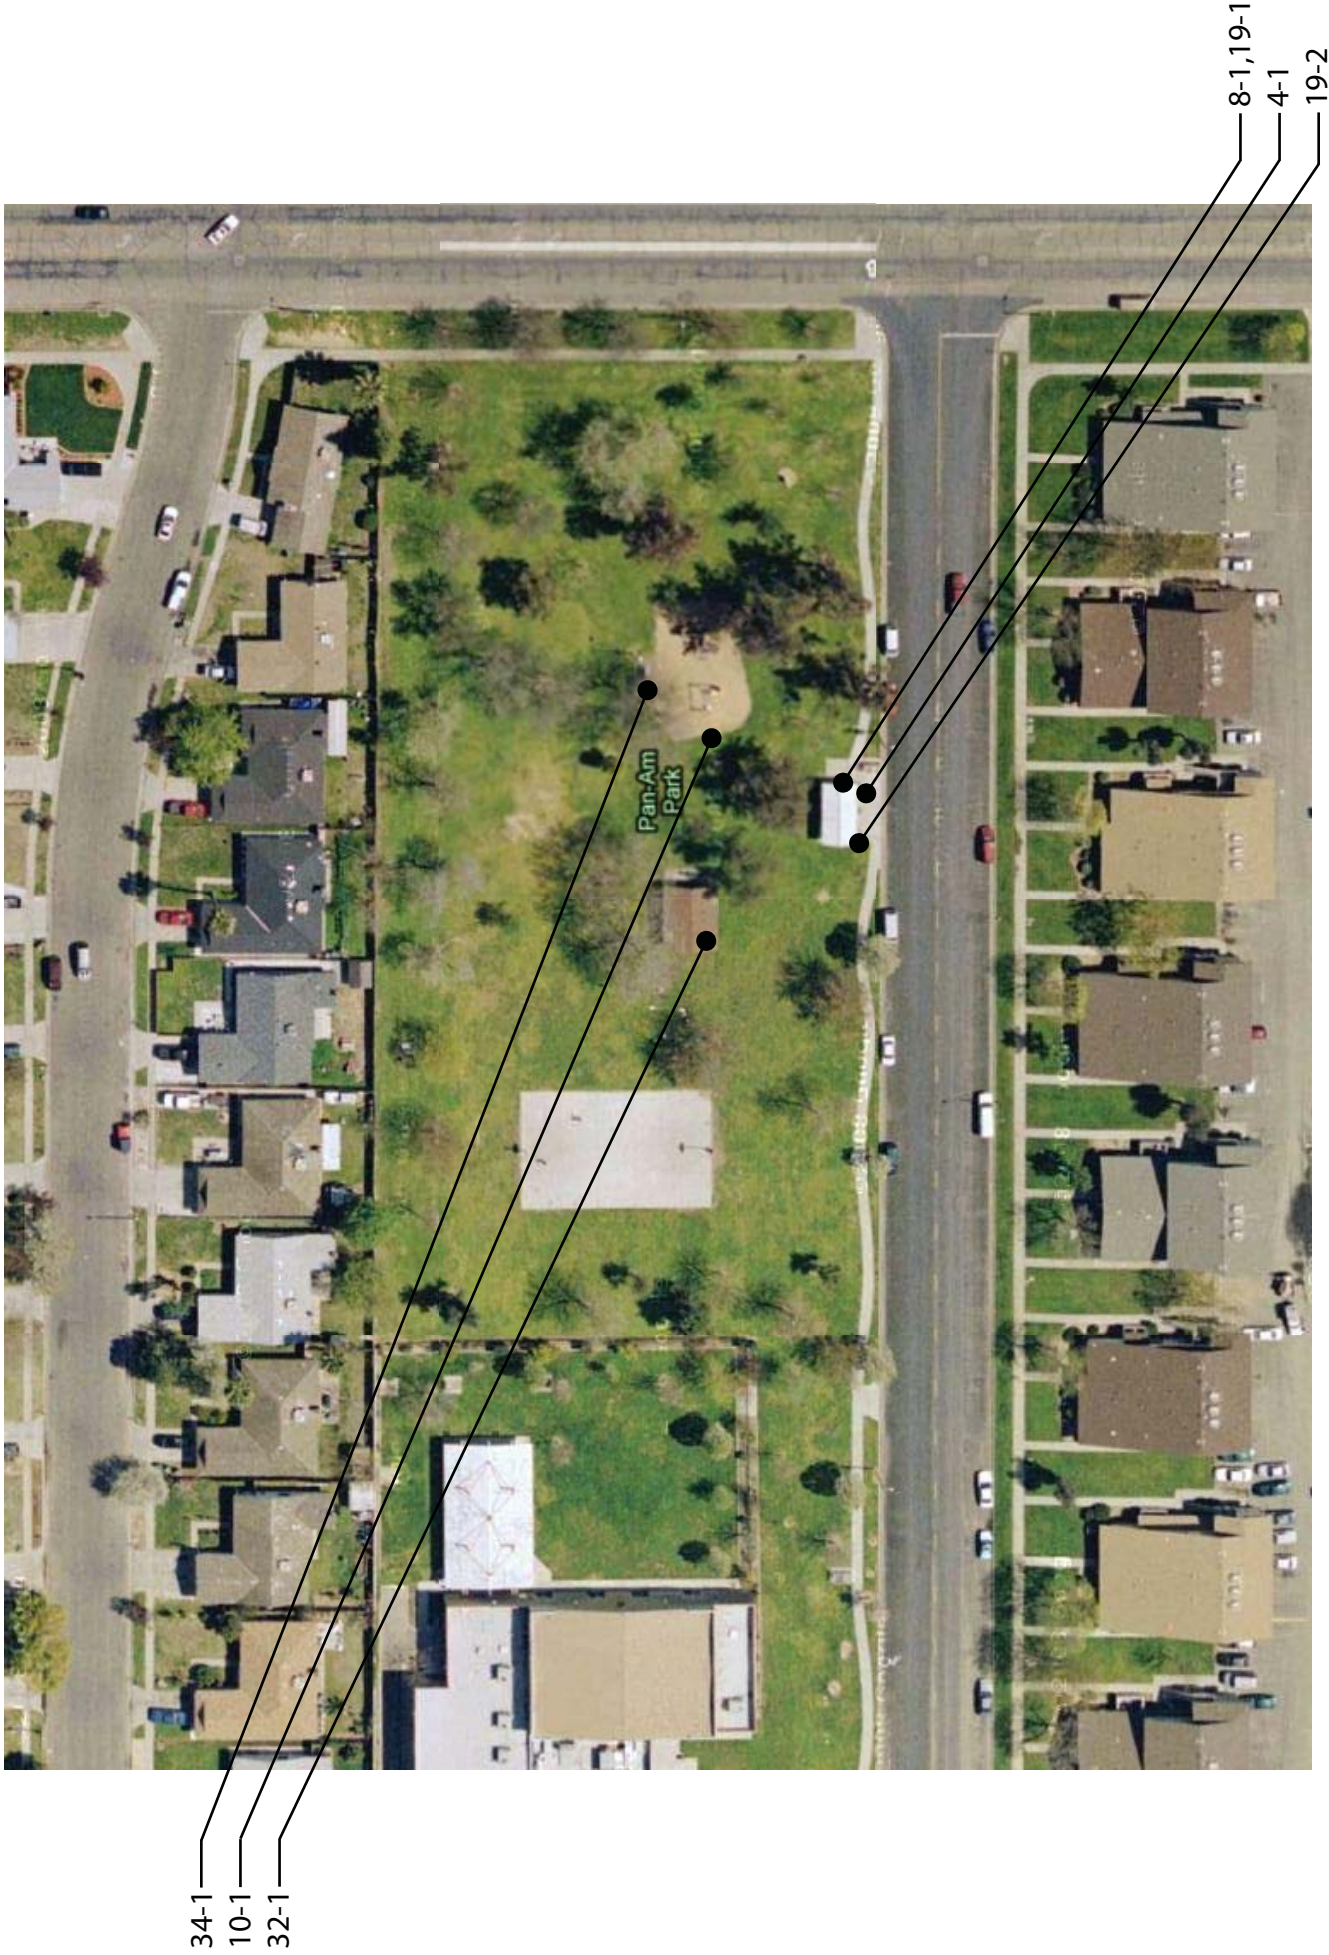
Pan-American Community Park - Exterior
703 East Sherwood Way, Madera

Notes: 30" x 48" min. companion seating is not provided for 4 of the 5 fixed benches.		
State: -		
Federal: -		
Provide accessible fixed bench		\$4,500
Notes: There is a total of 5 fixed benches. None of the benches have armrests.		
State: -		
Federal: -		
Regrade surface		\$800
Notes: Slope in front one of the fixed benches range from 3.6% to 4.4% (2% max). Surface material is concrete. Dimensions are 20'L x 5'3"W.		
State: -		
Federal: -

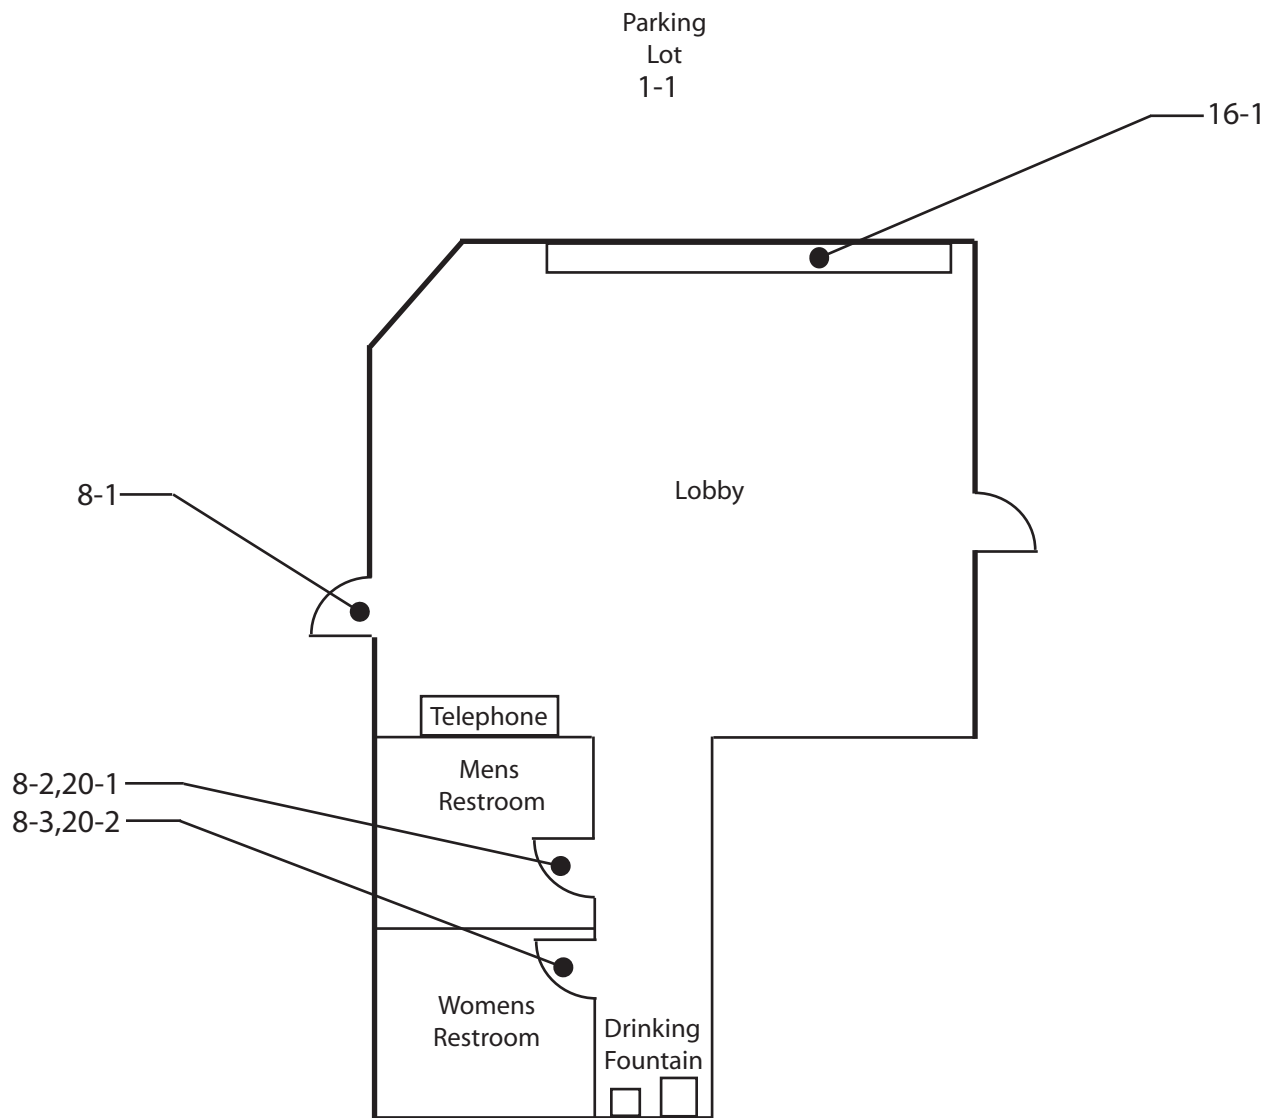
Police Facility - Exterior & First Floor
330 South C Street, Madera

Floor 1		
20 - 2	Single User Restroom	Priority: 2
Replace or reposition dispensers or mirrors		\$200
Notes: Mirror is mounted so bottom of reflecting surface is 40.5" (40" max) AFF.		
State: 1115B.8.1		
Federal: 4.19.6		
Replace or reposition dispensers or mirrors		\$250
Notes: Towel dispenser is 50" (40" max) AFF. Lower towel dispenser.		
State: 1115B.8.3		
Federal: 4.23.7		
Replace or reposition fixtures		\$1,000
Notes: Space from the wall to the edge of the toilet is 19.5" (32" min).		
State: 1115B.4.1 #1		
Federal: 4.17.3		
Replace or reposition fixtures		\$1,000
Notes: Space from the wall to the centerline of the toilet is 17.5" (18" req).		
State: 1115B.4.1 #1		
Federal: 4.17.3		
Replace or reposition dispensers or mirrors		\$200
Notes: Toilet paper dispenser is 36.5" (36" max) from the back wall. Relocate toilet paper dispenser.		
State: 1115B.8.3		
Federal: 4.23.7

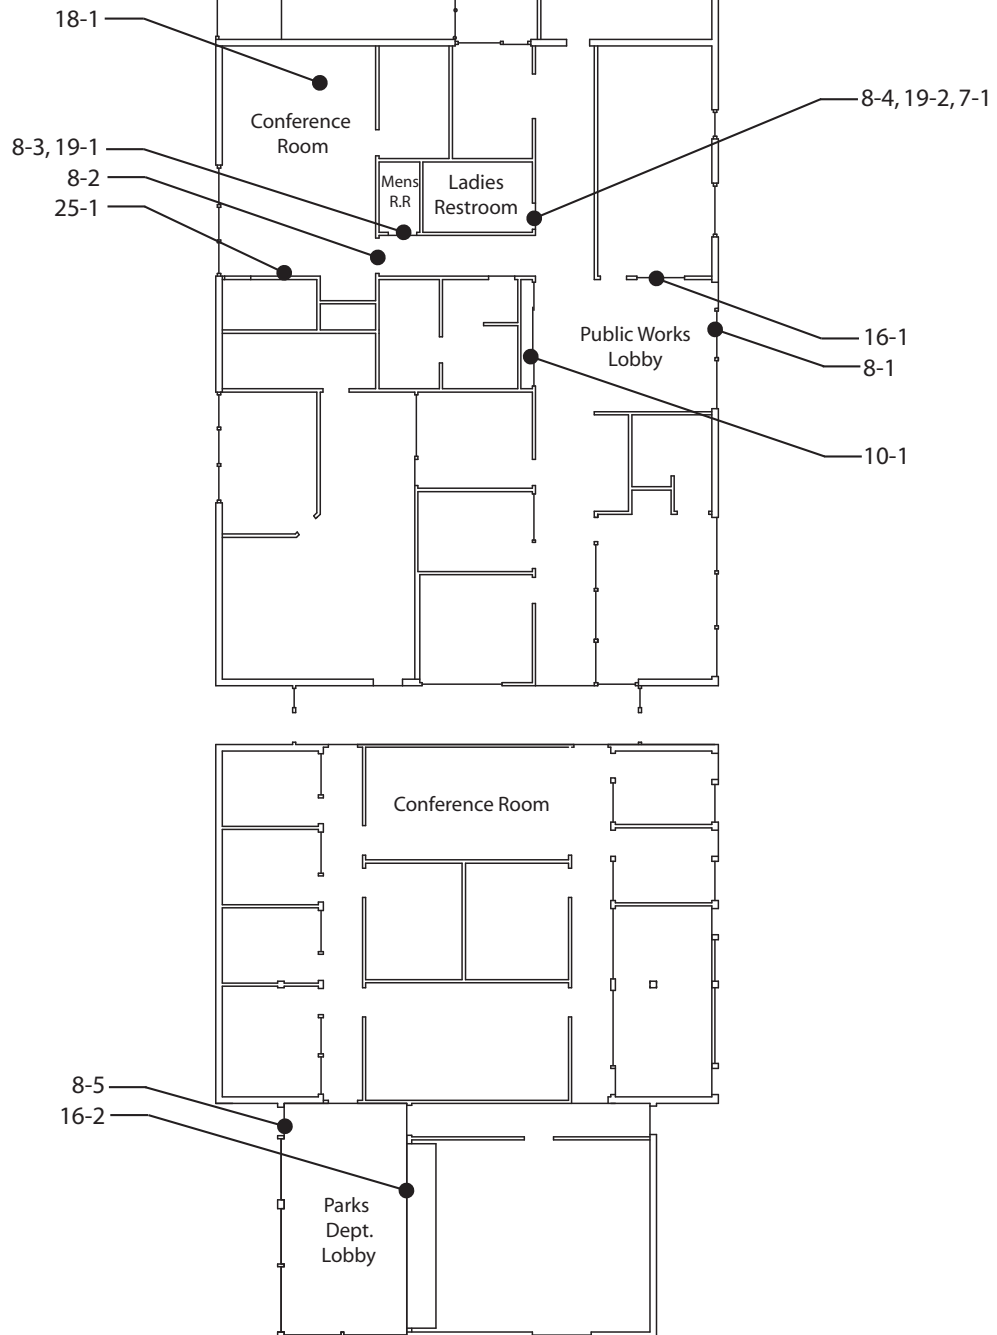
Public Works - First Floor
1030 South Gateway Street, Madera

Floor 1		
25 - 1	Kitchen	Priority: 4
Provide an accessible counter		\$4,000
Notes: Kitchen countertop as well as the sink countertop are 36.5" (34" max) AFF. Dimensions: 67.5"L x 23.75"W		
State: -		
Federal: 1115B.4.7 #1

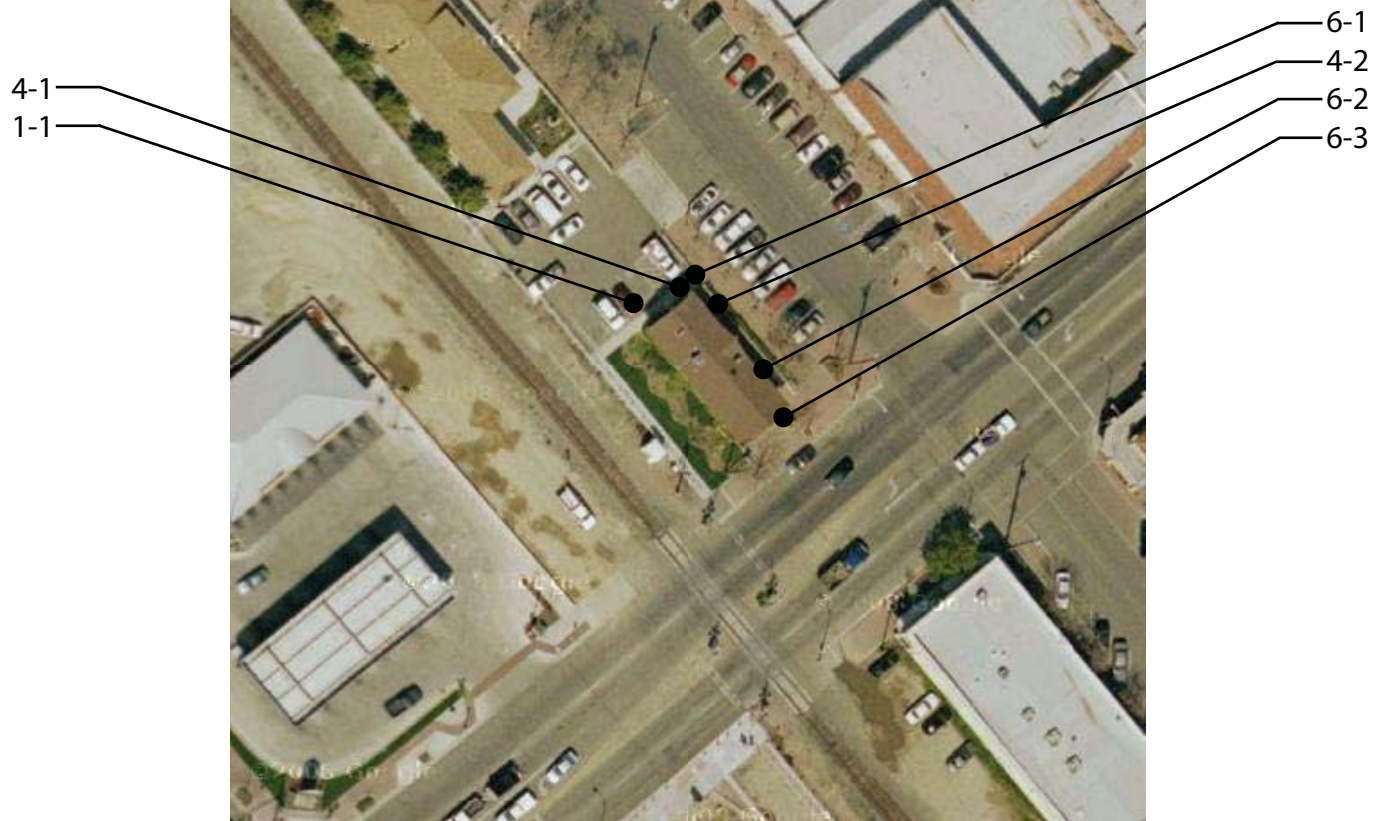
Redevelopment Center - Exterior
5 East Yosemite Ave, Madera

State: 1133B.4.4		
Federal: -		
Install or modify handrails		\$2,000
Notes: Top extensions are not continuous. Bottom extensions are not provided. Handrail top surface is not between 34" to 38" AFF. There are 2 risers.		
State: 1133B.4.1.1		
Federal: 4.9.4

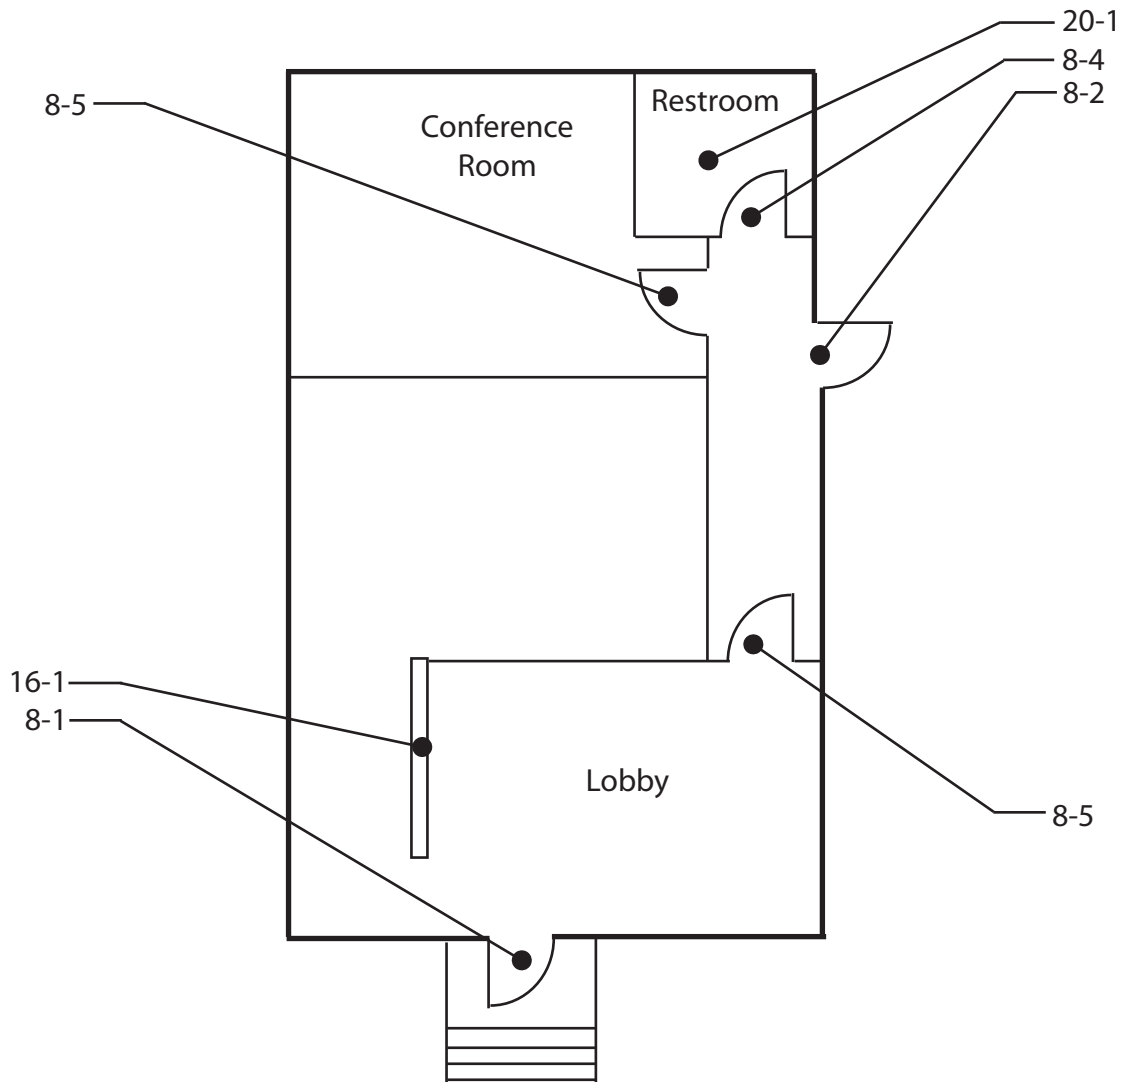
Redevelopment Center - First Floor
5 East Yosemite Ave, Madera

Floor 1		
20 - 1	Single User Restroom	Priority: 2
Replace or modify grab bars		\$450
Notes: Rear grab bar not provided. Side grab bar is centered 34" (33" req) AFF.		
State: 1115B.4.1 #3, 1115B.4.1 #3.2		
Federal: 4.17.6

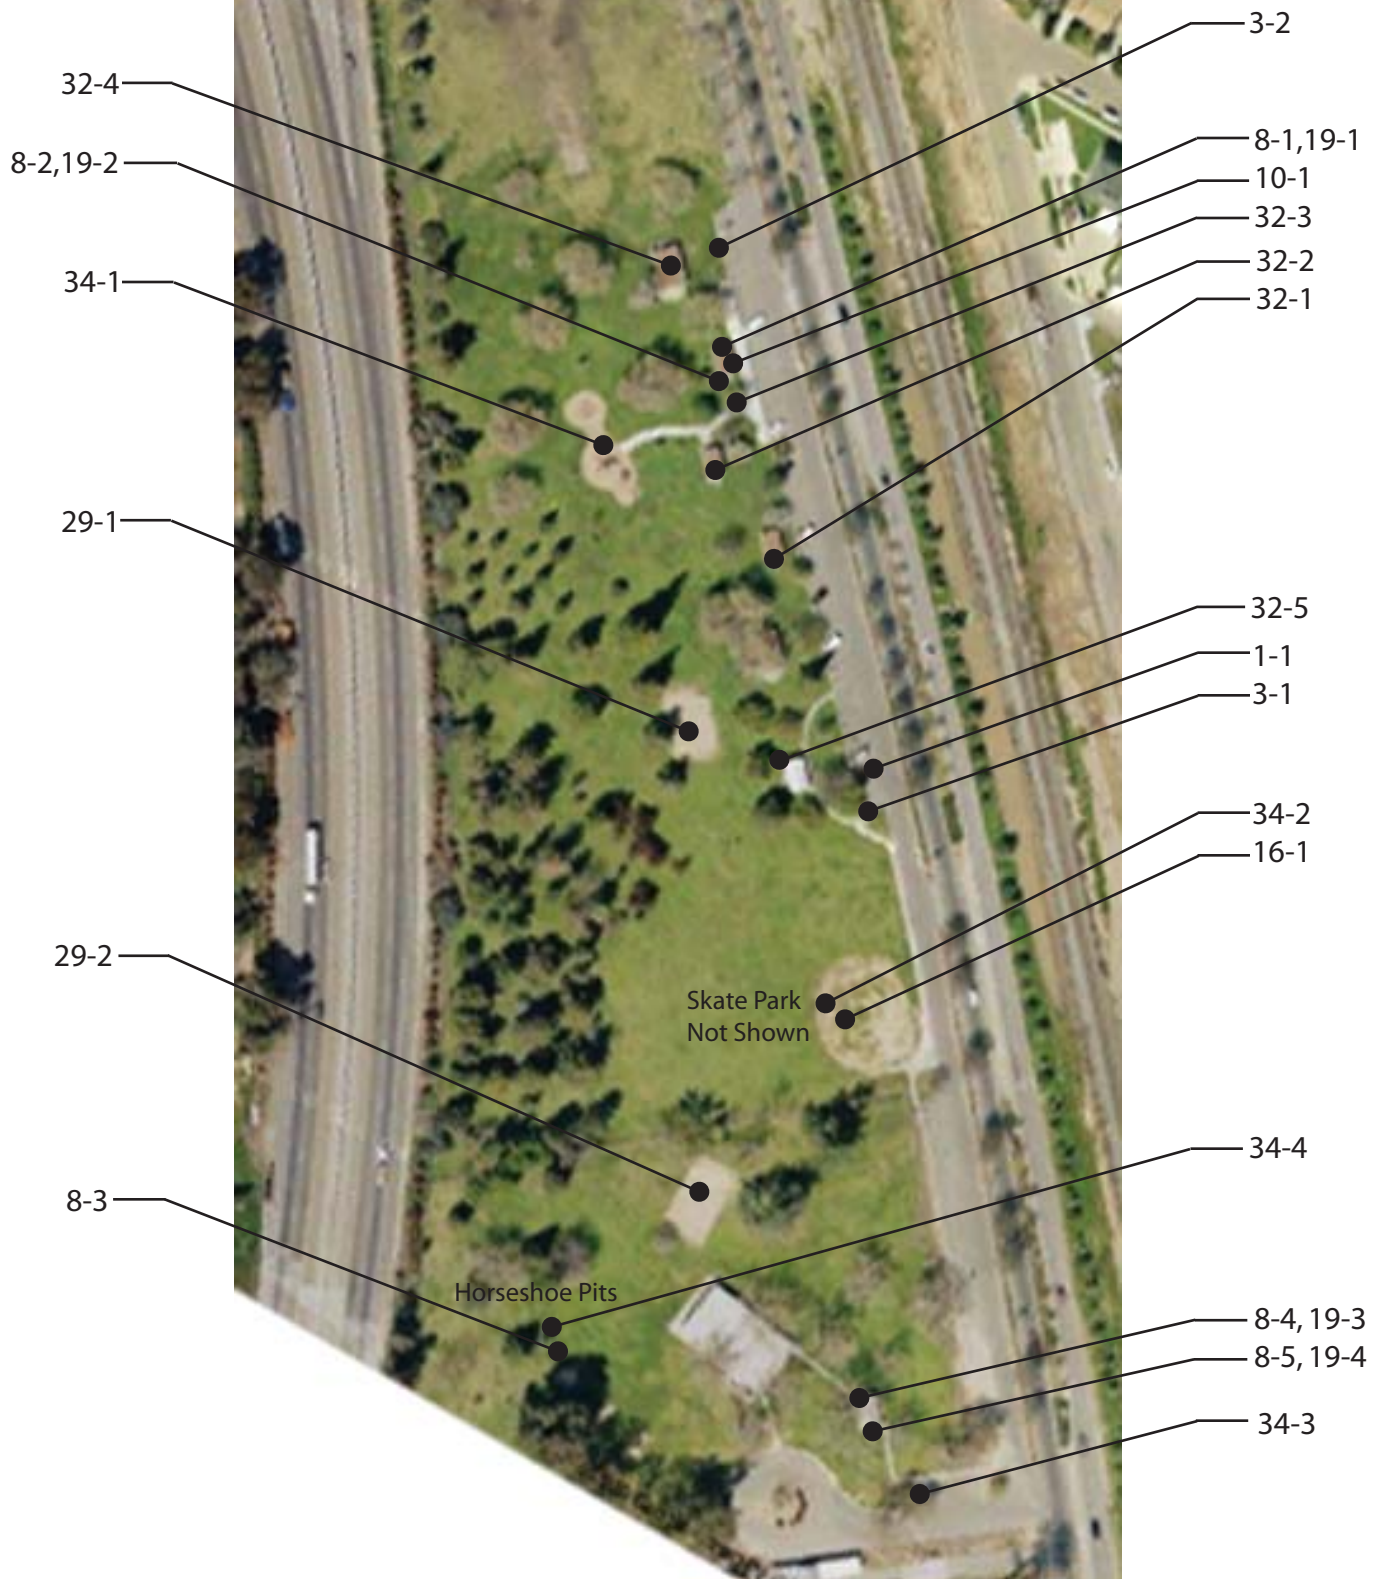
Rotary Park - Exterior
Gateway Drive, Madera

Exterior		
34 - 2	Fixed Bench	Priority: 4
Provide accessible fixed bench		\$900
Notes: There is 1 bench in front of the skate park concession stand. Bench does not have armrests. Front edge of seat height is 21.5" (17" to 19") AFF.		
State: -		
Federal: -		
34 - 3	Fixed Bench	Priority: 4
Provide accessible fixed bench		\$1,800
Notes: There are 2 benches. None of the benches have armrests. Front edge of seat height is 16" (17" to 19") AFF.		
State: -		
Federal: -		
34 - 4	Fixed Bench	Priority: 4
Provide accessible fixed bench		\$3,600
Notes: There are 4 benches surrounding the horseshoe pit. None of the benches have armrests.		
State: -		
Federal: -

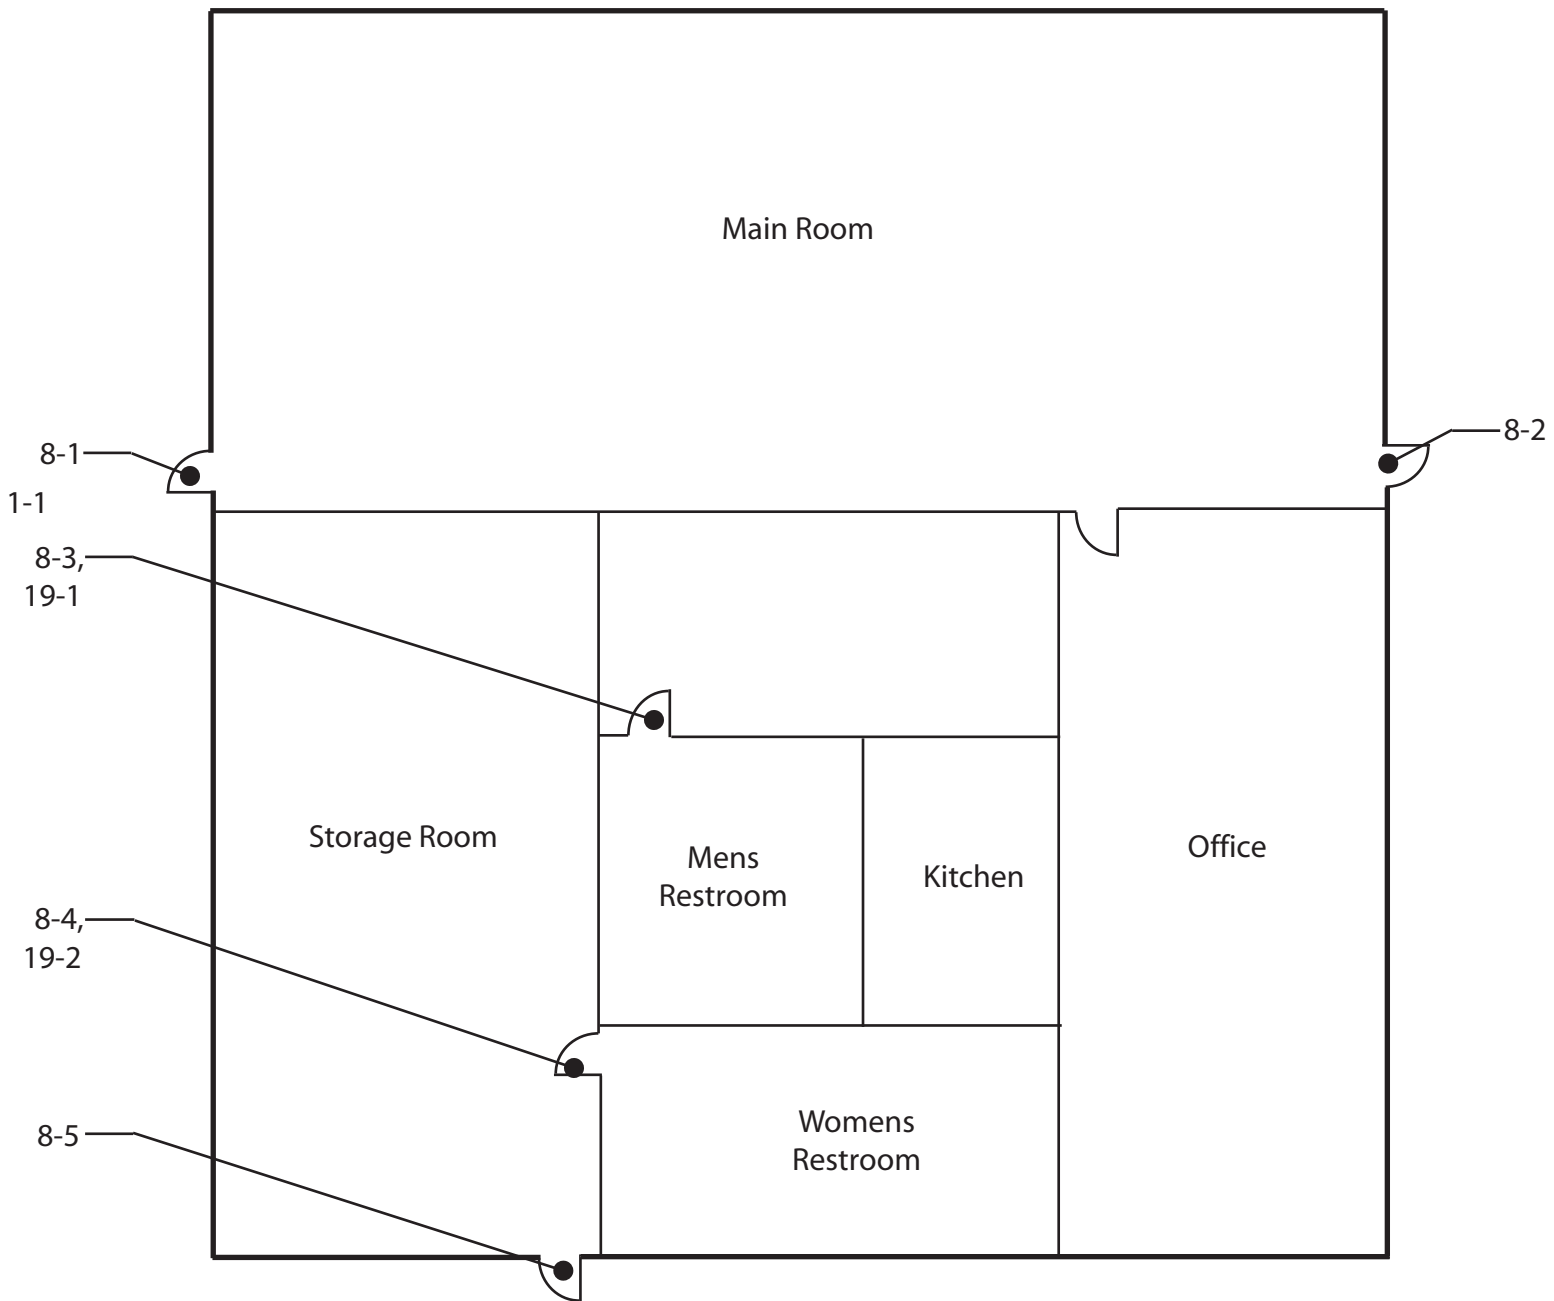
Westside Community Center - Exterior & First Floor
1124 West Yosemite Ave, Madera

Notes: Rear grab bar not provided.		
State: 1115B.4.1 #3.2		
Federal: 4.17.6		
Replace or reposition dispensers or mirrors		\$100
Notes: Coat hook mounted on compartment door is 67" (48" max) AFF.		
State: 1118B.5		
Federal: A4.27
