ADDENDUM NO. 2

RE: IFB 202122-11 BUILDING DEMOLITION

Revised Asbestos & Lead Survey Report

City of Madera Site Demolition Project 16557 Austin Street Madera, CA 93638

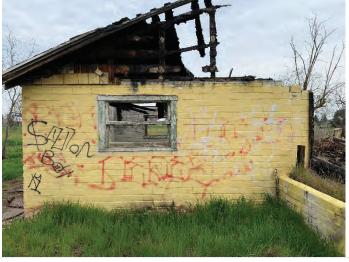
Shed

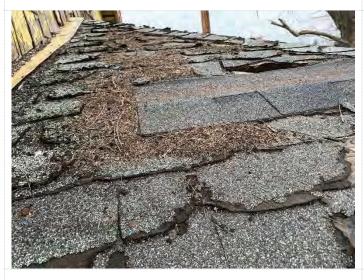
Composition Shingle Roofing

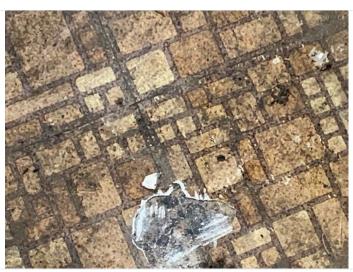
Linoleum & Mastic - Brown

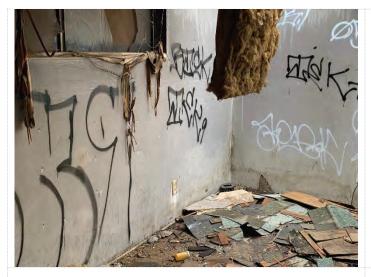
Drywall Main House

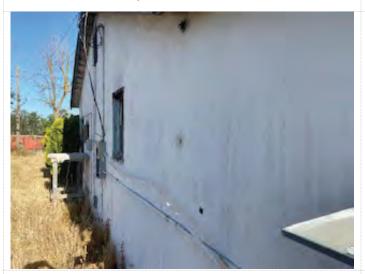
Stucco – House Two

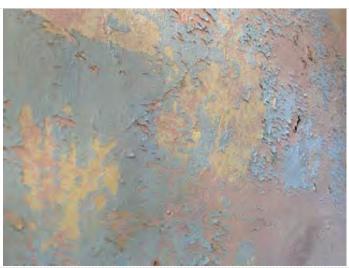
Plaster – House Two

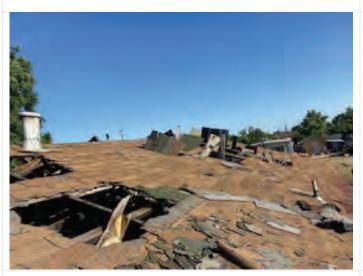
Rolled Composition Roofing – House Two

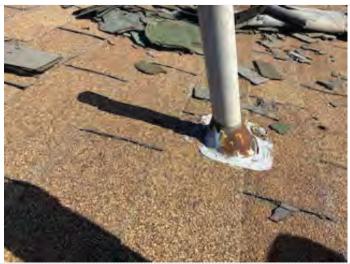
Penetration Mastic - Grey - House Two
