E-1 Informational Report on Waste Water Treatment Plant Primary Effluent Pump Station Repair and Request for Direction on Preferred Method (Report by Keith Helmuth)

INFORMATIONAL REPORT ON WATER TREATMENT PLANT PRIMARY EFFLUENT PUMP STATION REPAIR AND REQUEST FOR

City of Madera WWTP Primary Effluent Pump Station Emergency Repair Evaluation

October 9, 2018

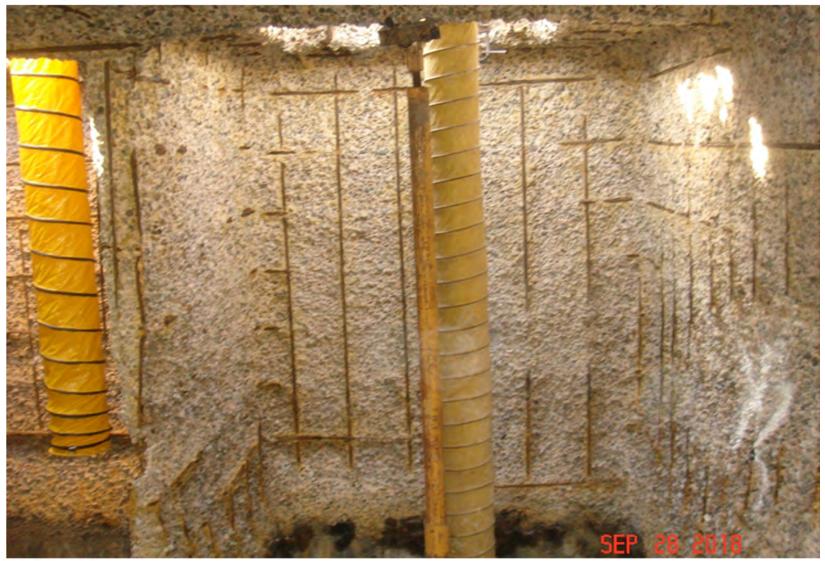
Figure 1 Discovered Condition of Concrete: Primary Effluent Pump Station Wetwell

The condition of the concrete within the Primary Clarifier Effluent Pump Station wetwell has deteriorated beyond the condition of the adjacent primary clarifier effluent channels, exposing much of the rebar to the corrosive environment. Based on photographs taken during the inspection (see Figures 1, 2, and 3), the wetwell concrete requires structural repair, in addition to the resurfacing and coating that are currently part of the Rehabilitation Project.

As shown in Figure 1, the interior mat rebar is exposed on the western exterior wall, interior baffle walls, and overhead slab where corrosive gas was exposed to the unprotected concrete. Further, there are areas within the wetwell that have deteriorated past the point of repair and have large sections of wall without any remaining structural integrity (both rebar and concrete is completely missing).

The bottom half of the structure can be repaired, as defined in the Contract Specifications. The top half of the structure will need to be removed and replaced because the level of deterioration makes it cost prohibitive to use the previously specified top coating repair system. The top of the exterior walls, interior baffle walls, and elevated slab have large sections of wall standing without any remaining structural integrity (both the rebar and concrete is missing). The intent of the rehabilitation is to replace the structure in 'like-kind' to the best of our ability with the understanding that materials used have changed since the construction of the original structure, approximately 50 years ago.

- Continue bypass pumping operation for an extended period of time (approximately four months)
- 2. Demolish and replace existing walls (exterior and interior), trough slabs, and top slabs, where reinforcing has been degraded beyond a state of repair. This demolition will occur through areas where non-degraded reinforcing exists.

This option will build a new modern pump station that will be seismically and structurally sound (in accordance with updated building codes), east of the existing pump station and allow the existing wetwell to be decommissioned. See Figure 1 for a preliminary layout of the new pump station.

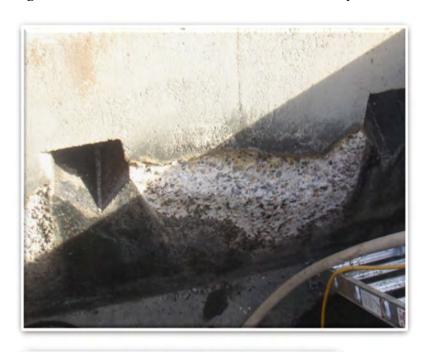
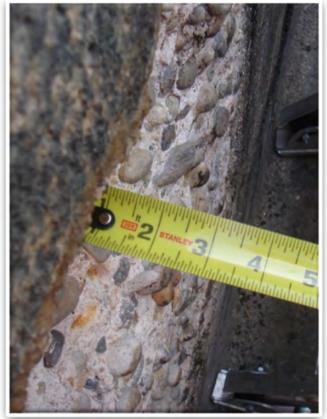
Figure 2 Known Condition of Concrete in Primary Clarifier Channel

During design, Stantec was able to visually observe several challenges at the plant that became the basis of the Rehabilitation Project construction contract, including repairing the primary clarifier effluent channel and pump station wetwell concrete. At the time of design, the Primary Effluent Pump Station (channel and wetwell) was identified as having corroded concrete requiring resurfacing and coating because the aggregate within the concrete walls was starting to show (with small areas where rebar had been exposed).

The channel was inspected by opening large sections of grating, but the wetwell could not been seen because it is under a solid concrete slab (supporting three vertical turbine pumps) and was fully submerged under water. Without having the ability to bypass the pump station, it was assumed that the level of concrete deterioration within the wetwell was similar to the primary effluent channel, as shown in Figure 2. Therefore, the design (and current construction scope of work) includes a 3-inch layer of resurfacing compound (polymer enhanced concrete) and a protective epoxy coating (to limit impacts from sulfur attack).

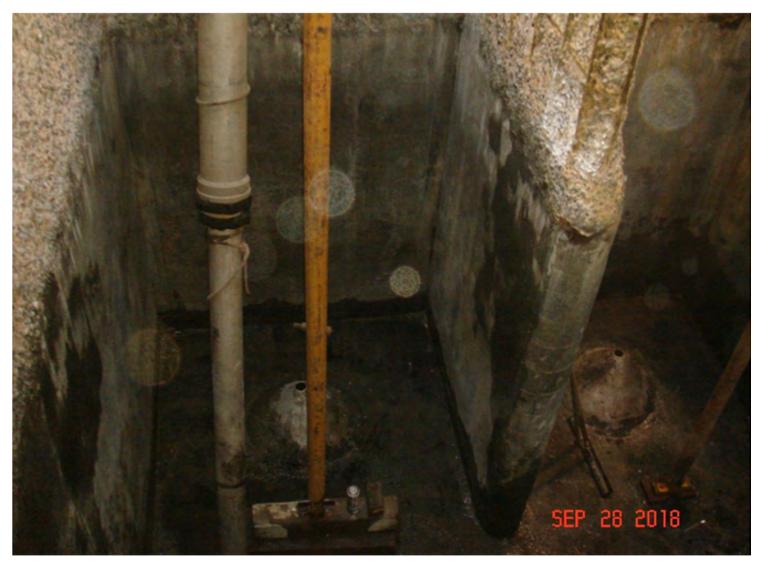
Figure 3 Submerged Concrete Condition: Primary Effluent Pump Station Wetwell

Once the water level inside the wetwell was lowered and Stantec had access to the Primary Effluent Pump Station, the extent of damage to the concrete baffle walls and ceiling (within the Wetwell) could be fully assessed and is identified as more severe than observed during the initial inspection. Years of exposure to hydrogen sulfide (H2S) has allowed the concrete inside the wetwell to corrode and expose much of the interior mat rebar (corroding the rebar and compromising the structural integrity of the top half of the wetwell).

This wetwell supports three massive vertical turbine pumps on the top slab (each weigh over 5 tons with 20" columns, ~20' tall, with coupled 50 HP motors) and is now considered unsafe. Stantec recommends that operators stay off the slab (to the extent possible) until structural remediation measures can take place and the Contractor keep their shoring inside the wetwell to secure the roof prior to rehabilitation.

As shown in Figure 3, damage to the walls is most extreme above the water level (where sulfur is released into gaseous form) and the concrete that remained submerged during operation is found to be in relatively good condition. The bottom half of the structure can therefore be repaired and coated, as defined in the Contract Specifications and included in the current scope of work.

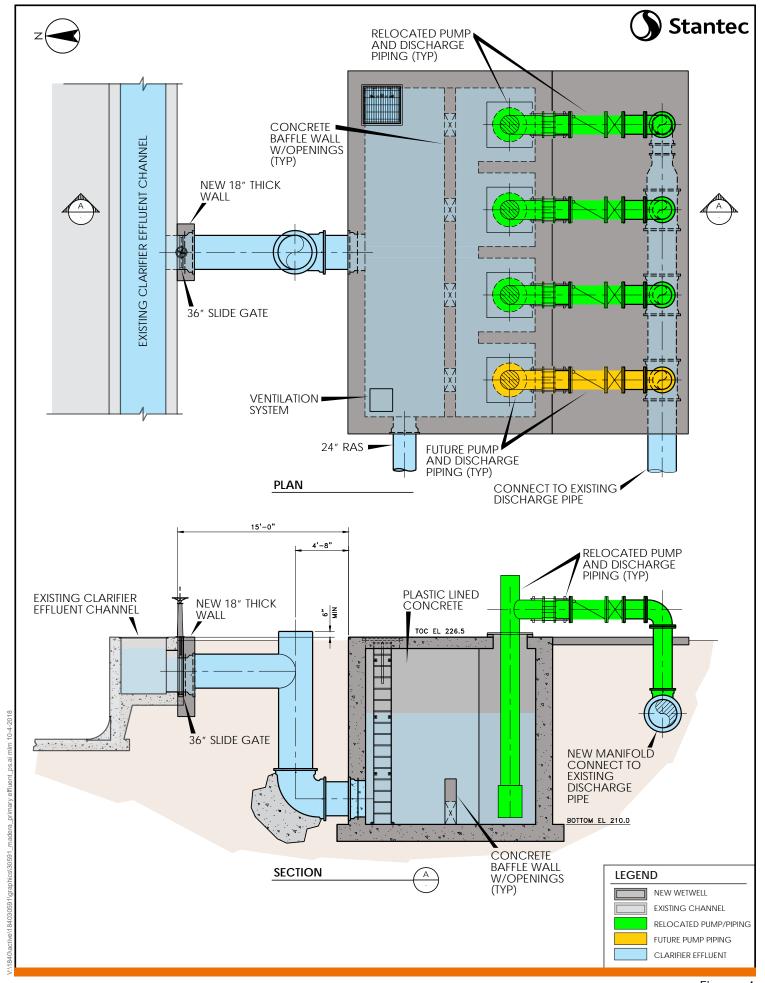
Figure 4 Primary Effluent Pump Station Plan and Section

- 2. Construct a new pump station, including:
 - a. Installing a larger wetwell, with sufficient room for a future fourth pump, to match the treatment plant capacity (totaling 37.6 MGD of reliable pumping capacity)

It is recommended to replace the existing structure with a new modern pump station because the benefits to the new structure far outweigh the additional capital costs, including reduced maintenance, increased reliability, longer life expectancy, designed in accordance with updated building codes, lowered risk of operation, increase safety.
