Appendix F: Facility Reports

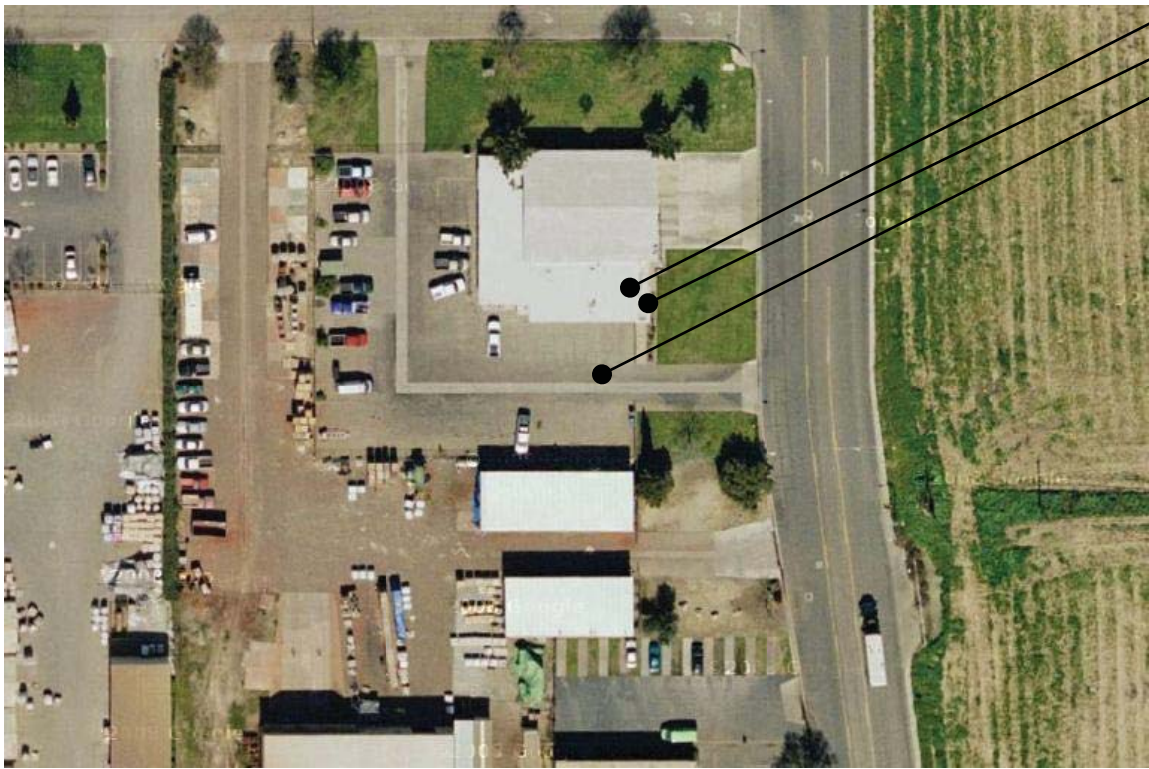
City Fire Dept #6

Floor 1		
8 - 1	Door/Gate	Priority: 1
Provide an accessible path of travel		\$2,000
Notes: Accessible route to the door is not provided due to a step located on path of travel.		
State: 1133B.1.1.1.1		
Federal: 4.3.2		
Adjust door closer		\$100
Notes: Operating effort is 10 lbs (5 lbs max).		
State: 1133B.2.5		
Federal: 4.13.11		
Provide sign(s) indicating accessible entries and facilities		\$100
Notes: Primary entrance is not marked by an International Symbol of Accessibility.		
State: 1117B.5.8.1.2, 1127B.3		
Federal: 4.13.6		
Provide or modify door kickplate		\$100
Notes: Kickplate is 4.5" (10" min) high.		
State: 1133B.2.6		
Federal: -		
16 - 1	Transaction Counter	Priority: 2
Provide an accessible counter		\$4,000
Notes: Transaction counter is 42" (28" to 34") AFF.		
State: 1122B.5		
Federal: 4.32.4

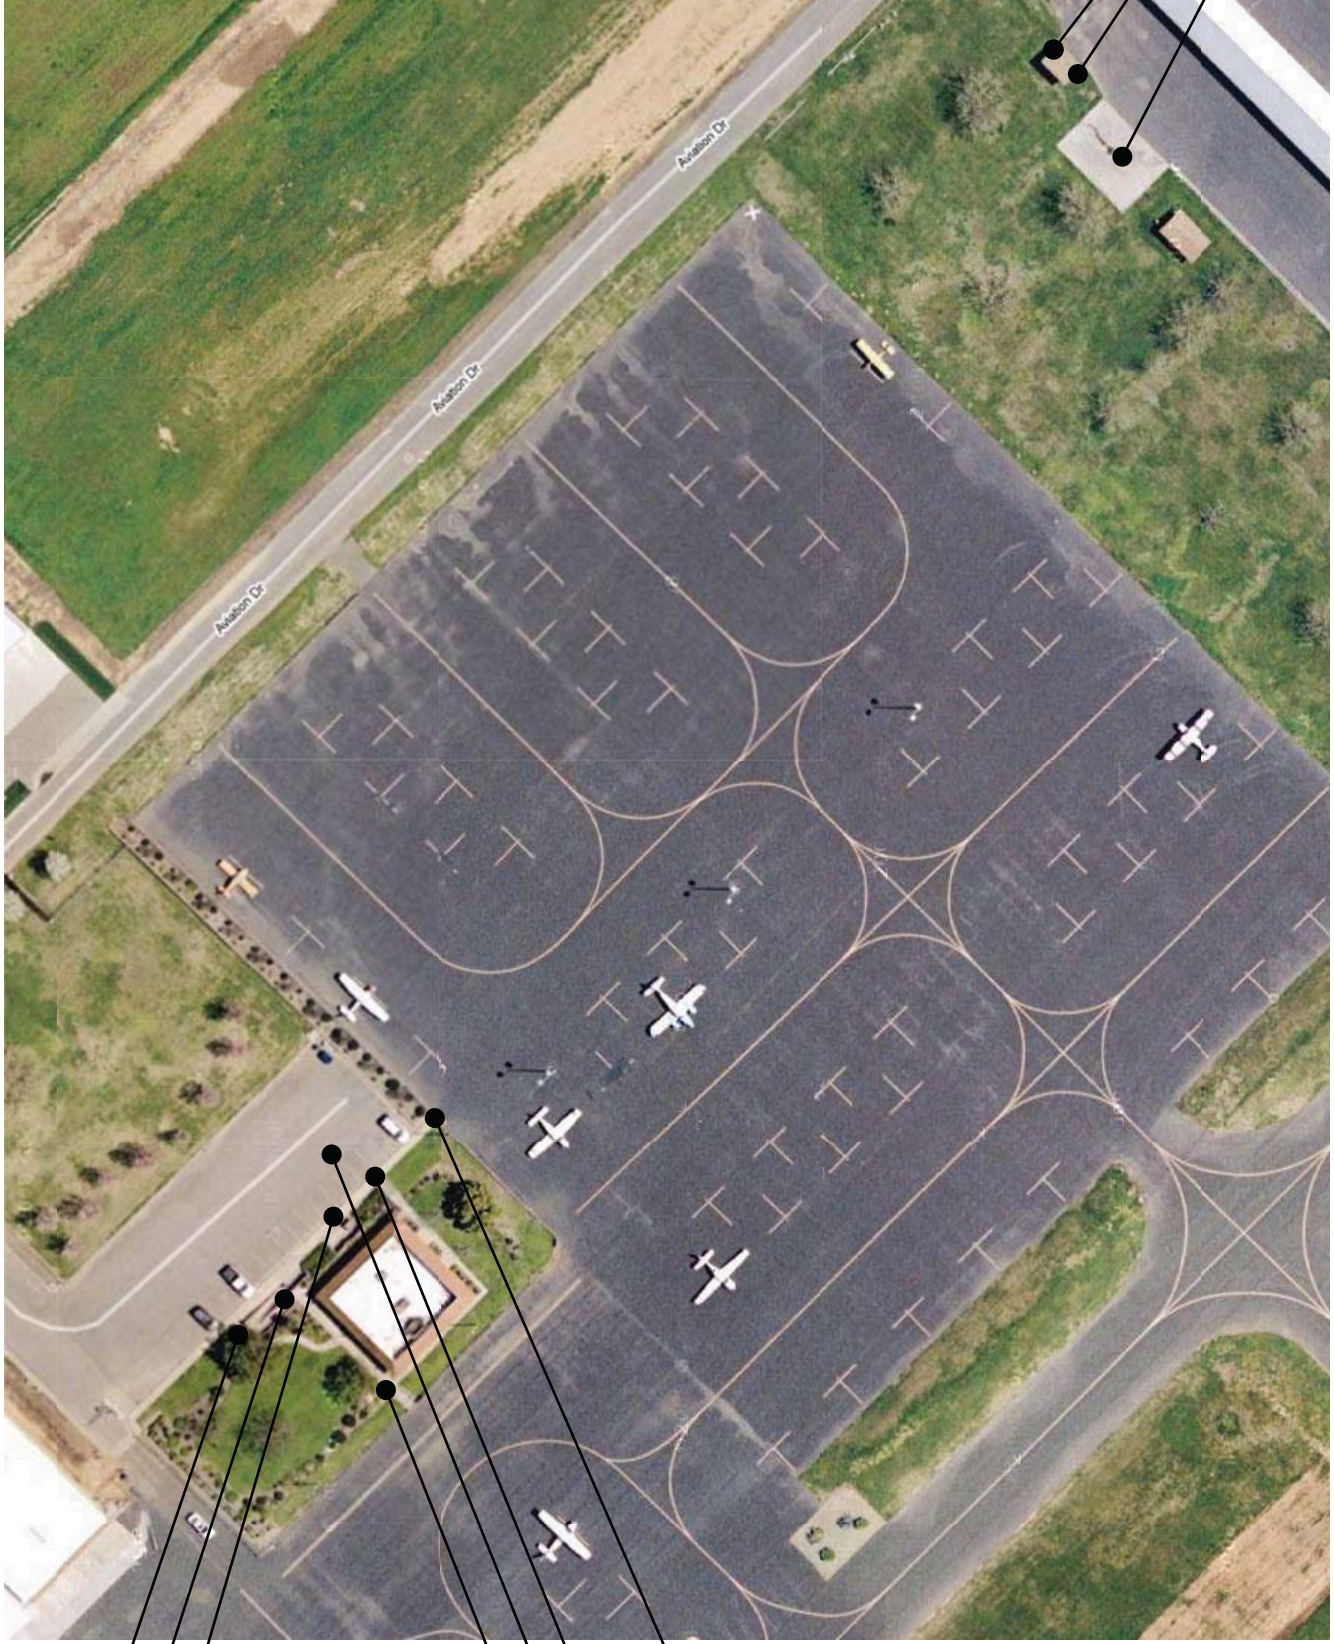
Floor 1		
8 - 7	Door/Gate	Priority:2
Adjust door closer		\$100
Notes: Operating effort is 10 lbs (5 lbs max).		
State: 1133B.2.5		
Federal: 4.13.11		
16 - 1	Transaction Counter	Priority:2
Provide an accessible counter		\$4,000
Notes: Madera Dial-A-Ride: Transaction counter is 42" (28" to 34") AFF.		
State: 1122B.5		
Federal: 4.32.4		
19 - 1	Multiple User Restroom	Priority:2
Replace or reposition dispensers or mirrors		\$250
Notes: Soap dispenser is 52" (40" max) AFF.		
State: 1115B.8.3		
Federal: 4.23.7		
Insulate water lines		\$100
Notes: Drain pipes are not insulated.		
State: 1115B.4.3 #4		
Federal: 4.19.4		
Provide or replace stall door hardware		\$100
Notes: U-shaped handle not provided on back of compartment door.		
State: 1115B.3.1 #4.5		
Federal: 4.13.9		
19 - 2	Multiple User Restroom	Priority:2
Modify lavatory/counter clearances		\$3,500
Notes: Lavatory next to wall has 13" (18" min) between wall and center of fixture.

State: 1115B.4.3 #2		
Federal: -		
Provide or replace stall door hardware		\$100
Notes: U-shape handle not provided on the back of compartment door.		
State: 1115B.3.1 #4.5		
Federal: 4.13.9		
Replace or reposition dispensers or mirrors		\$100
Notes: Coat hook is 66" (48" max) AFF.		
State: 1118B.5		
Federal: A4.27

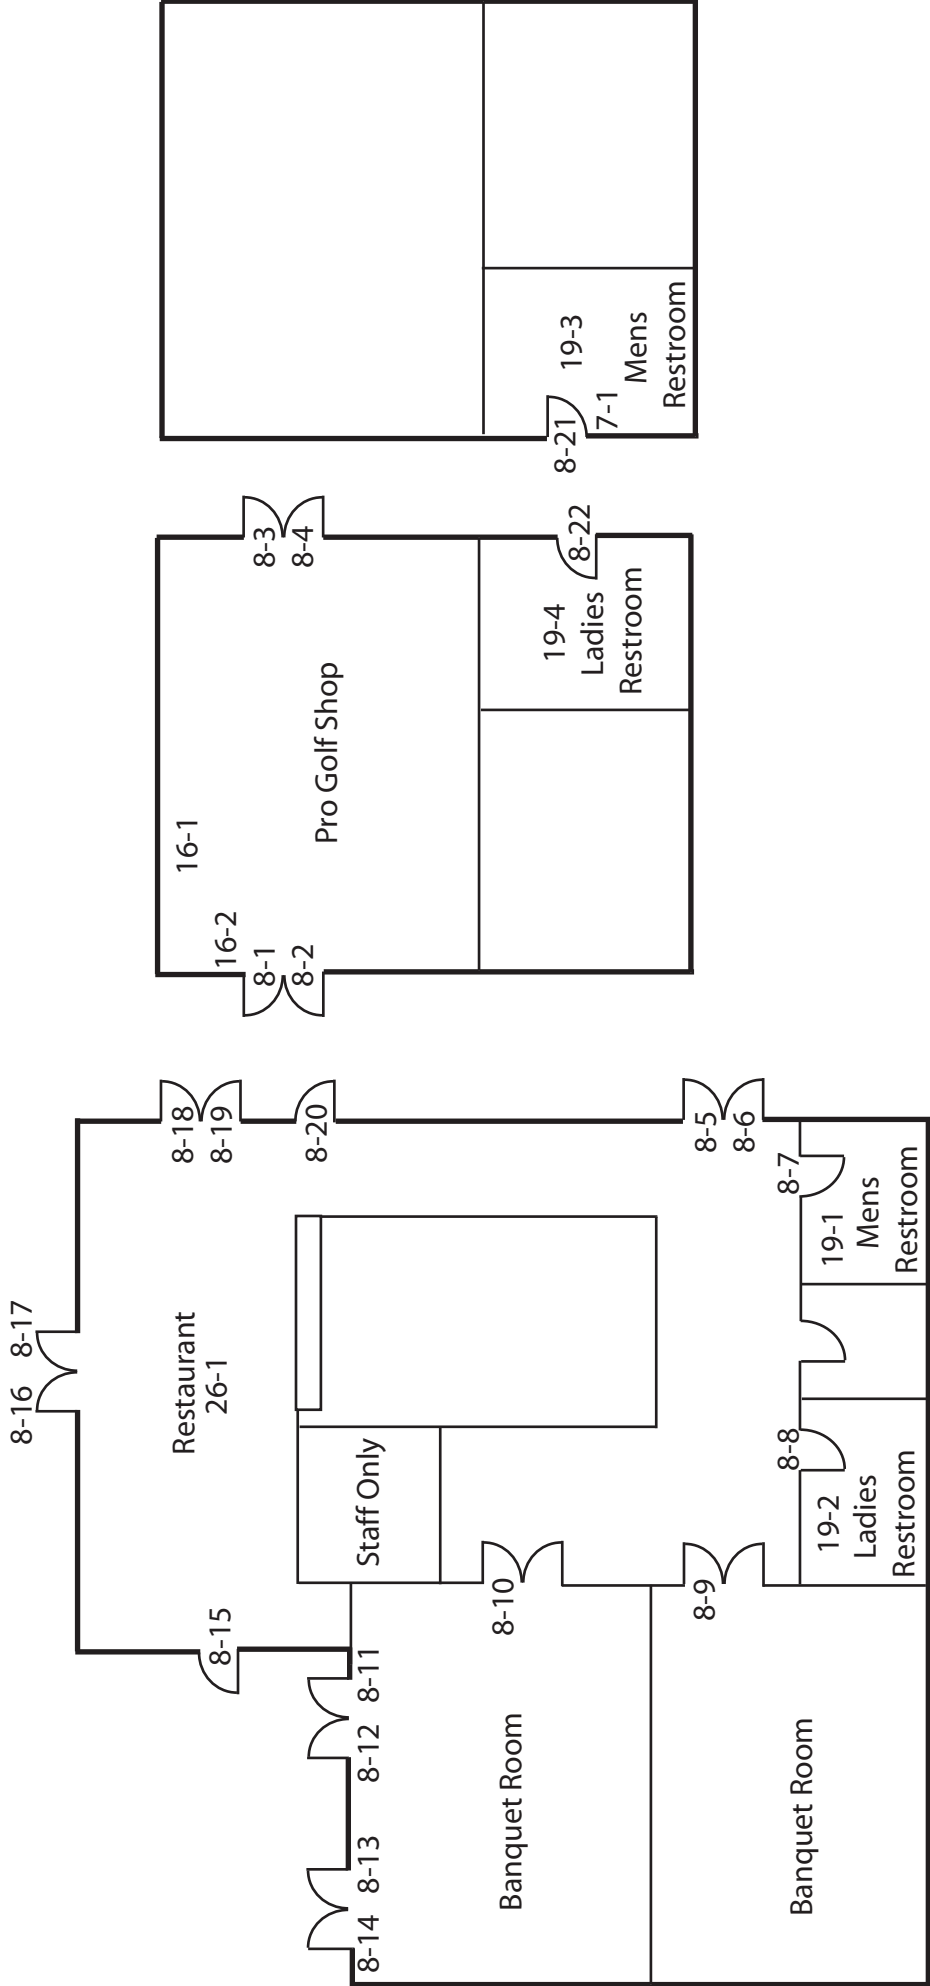
Madera**Madera Municipal Golf Course**

Floor 1		
7 - 1	Hazard	Priority: 2
Remove overhanging or protruding objects		\$100
Notes:	Hand dryer is on the path of travel to the urinal is creates a protruding hazard. Hand dryer protrudes 6.5" (4" max) and is 49" (not between 27" to 80") AFF. Relocate or remove hand dryer.	
State:	1133B.8.6.1	
Federal:	4.4.1	
8 - 1	Door/Gate	Priority: 1
Provide sign(s) indicating accessible entries and facilities		\$100
Notes:	Pro-Shop - Accessible entry is not marked by the International Symbol of Accessibility.	
State:	1117B.5.8.1.2, 1127B.3	
Federal:	4.13.6	
Install or modify permanent room signs		\$250
Notes:	Pro-Shop - There is an exit sign but Braille is not provided.	
State:	1011.3 #3	
Federal:	-	
Increase or provide maneuvering or clear floor area		\$2,500
Notes:	Pro-Shop - Slope on the swing-side of the door is 4.4% (2% max).	
State:	1133B.2, 1133B.2.4.2, 1133B.7.5	
Federal:	4.13.6	
Install or modify permanent room signs		\$250

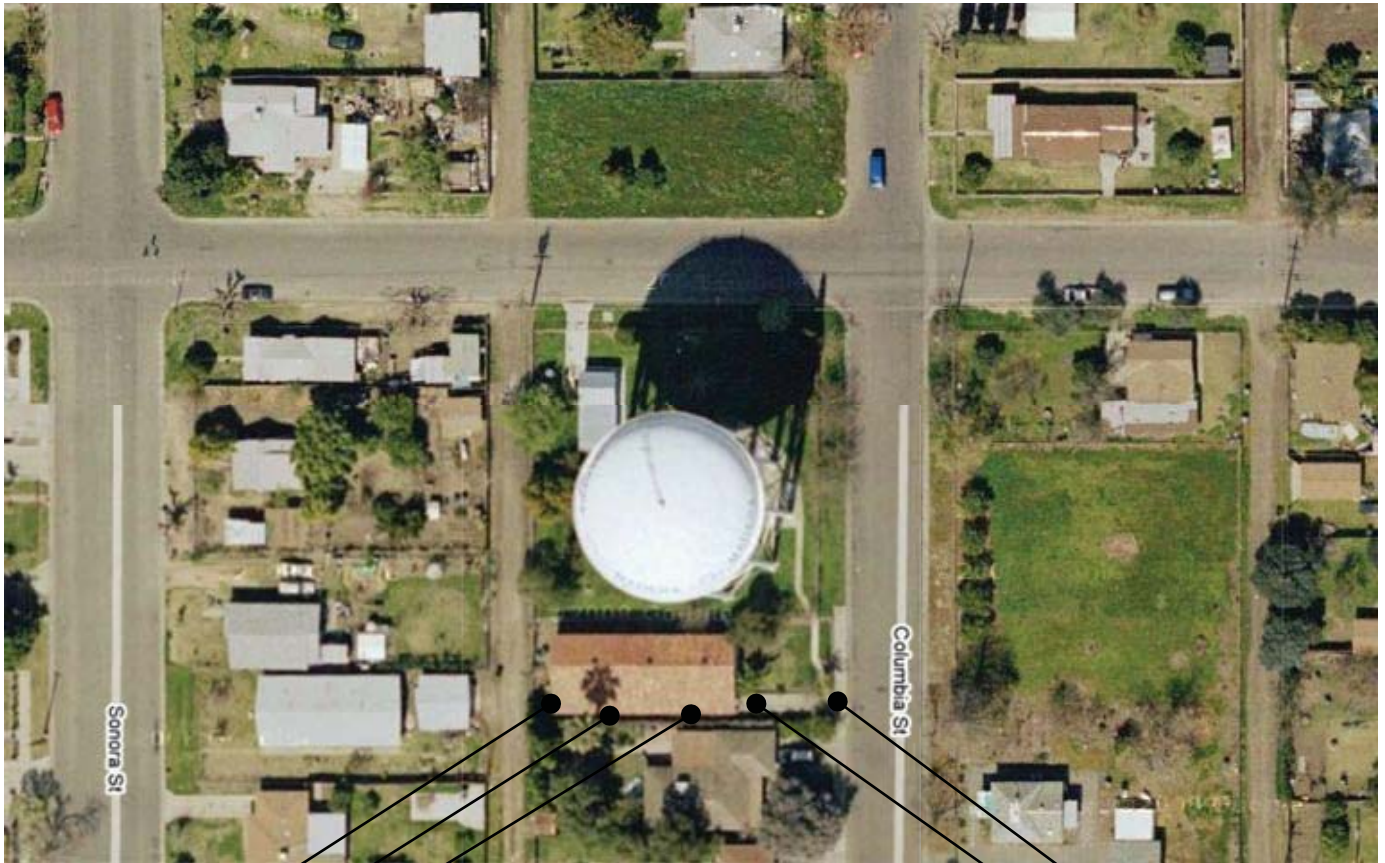
Madera**McNally Park**

Exterior		
32 - 7	Picnic Area	Priority: 2
Provide an accessible path of travel		\$600
Notes:	Accessible route to the picnic area is not provided. Surface material is turf. It is 25' to the nearest sidewalk.	
State:	1132B.2 #2	
Federal:	-	
34 - 1	Fixed Bench	Priority: 4
Increase or provide maneuvering or clear floor area		\$3,200
Notes:	There are 4 benches in the play area. None provide 30" x 48" clear floor space for companion seating.	
State:	-	
Federal:	-	
34 - 2	Fixed Bench	Priority: 2
Provide an accessible path of travel		\$240
Notes:	Accessible route to the fixed bench is not provided. Surface material is turf. It is 10' to the nearest sidewalk.	
State:	-	
Federal:	-	
34 - 3	Fixed Bench	Priority: 4
Provide an accessible path of travel		\$240
Notes:	Accessible route to the fixed bench is not provided. Surface material is turf. It is 10' to the nearest sidewalk.	
State:	-	
Federal:	-

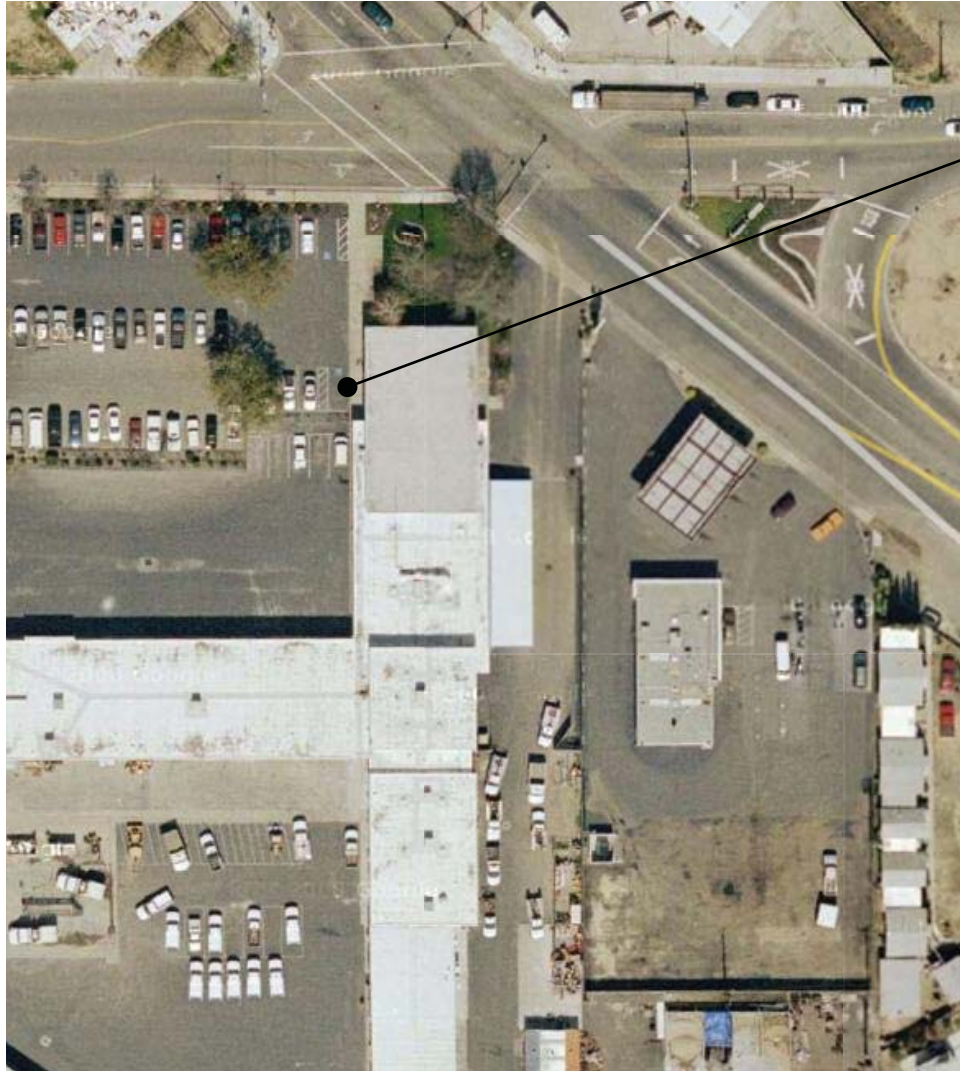
Police Facility

Floor 1		
20 - 2	Single User Restroom	Priority: 2
Replace or reposition dispensers or mirrors		\$200
Notes: Mirror is mounted so bottom of reflecting surface is 40.5" (40" max) AFF.		
State: 1115B.8.1		
Federal: 4.19.6		
Replace or reposition dispensers or mirrors		\$250
Notes: Towel dispenser is 50" (40" max) AFF. Lower towel dispenser.		
State: 1115B.8.3		
Federal: 4.23.7		
Replace or reposition fixtures		\$1,000
Notes: Space from the wall to the edge of the toilet is 19.5" (32" min).		
State: 1115B.4.1 #1		
Federal: 4.17.3		
Replace or reposition fixtures		\$1,000
Notes: Space from the wall to the centerline of the toilet is 17.5" (18" req).		
State: 1115B.4.1 #1		
Federal: 4.17.3		
Replace or reposition dispensers or mirrors		\$200
Notes: Toilet paper dispenser is 36.5" (36" max) from the back wall. Relocate toilet paper dispenser.		
State: 1115B.8.3		
Federal: 4.23.7
